Use of Spatial Data During and After the Blue Mountains Bushfires in October 2013

Graeme Paterson

Blue Mountains City Council

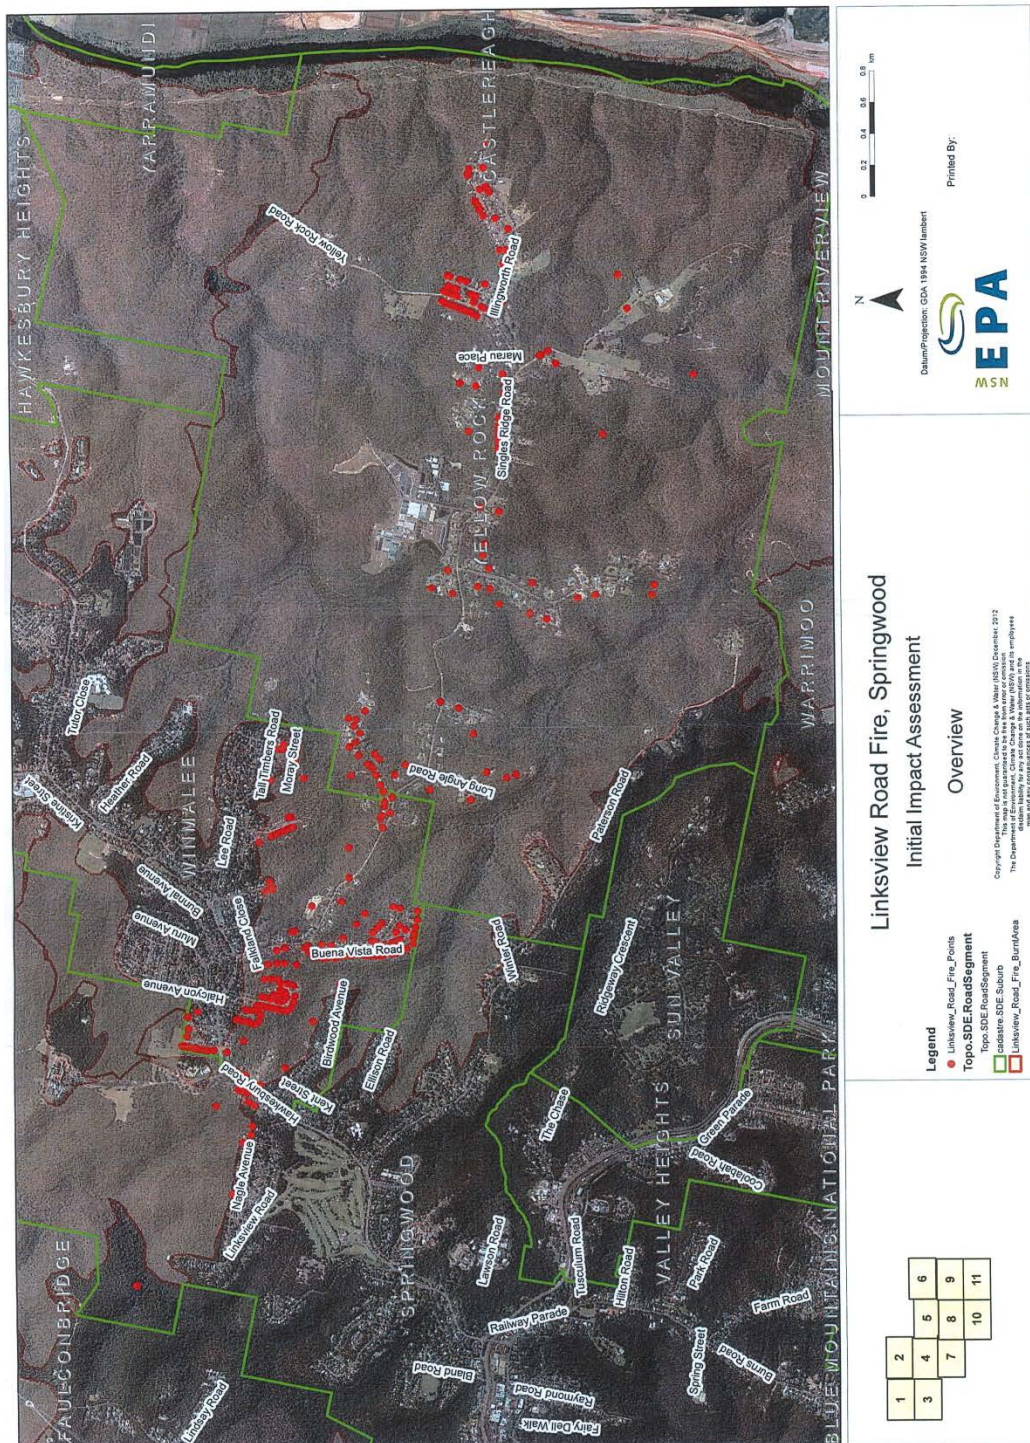
Figure 3: EPA aerial map of initial assessment of damage.

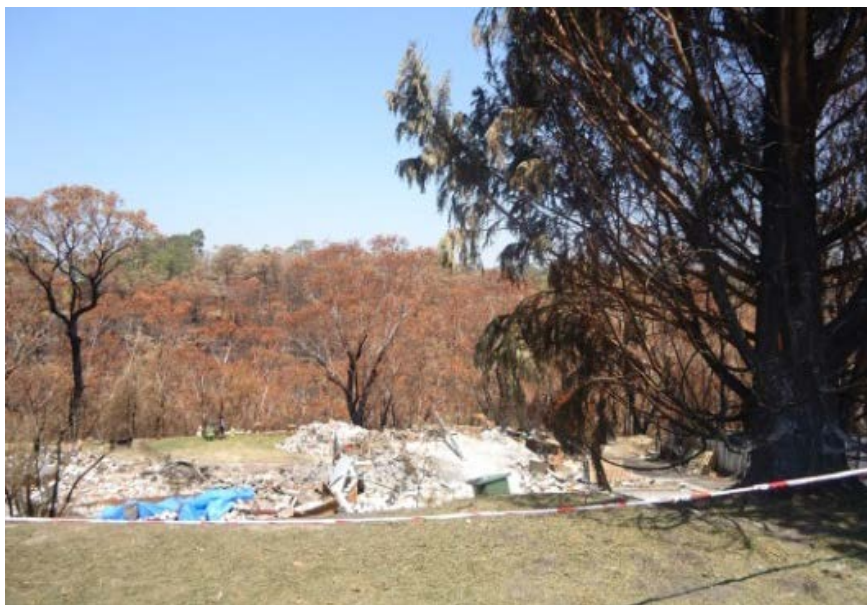
Figure 6: One of many houses destroyed.

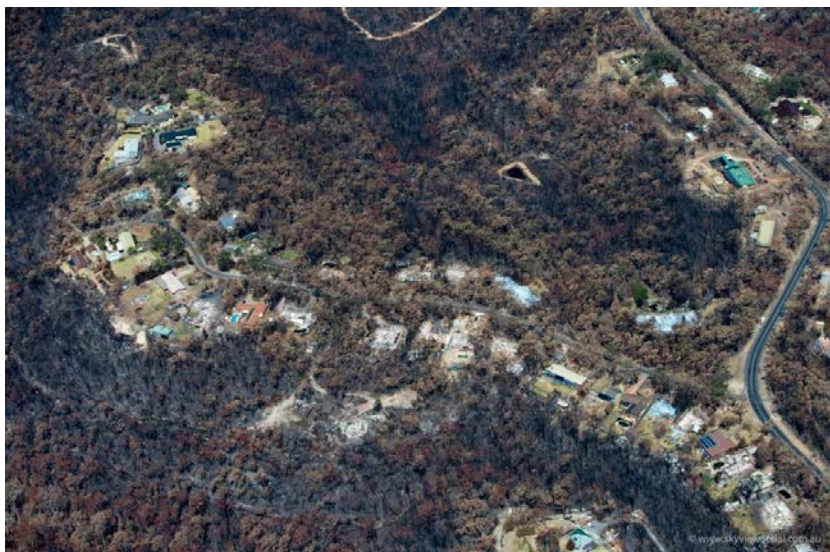
Figure 10: Pattern of damage.

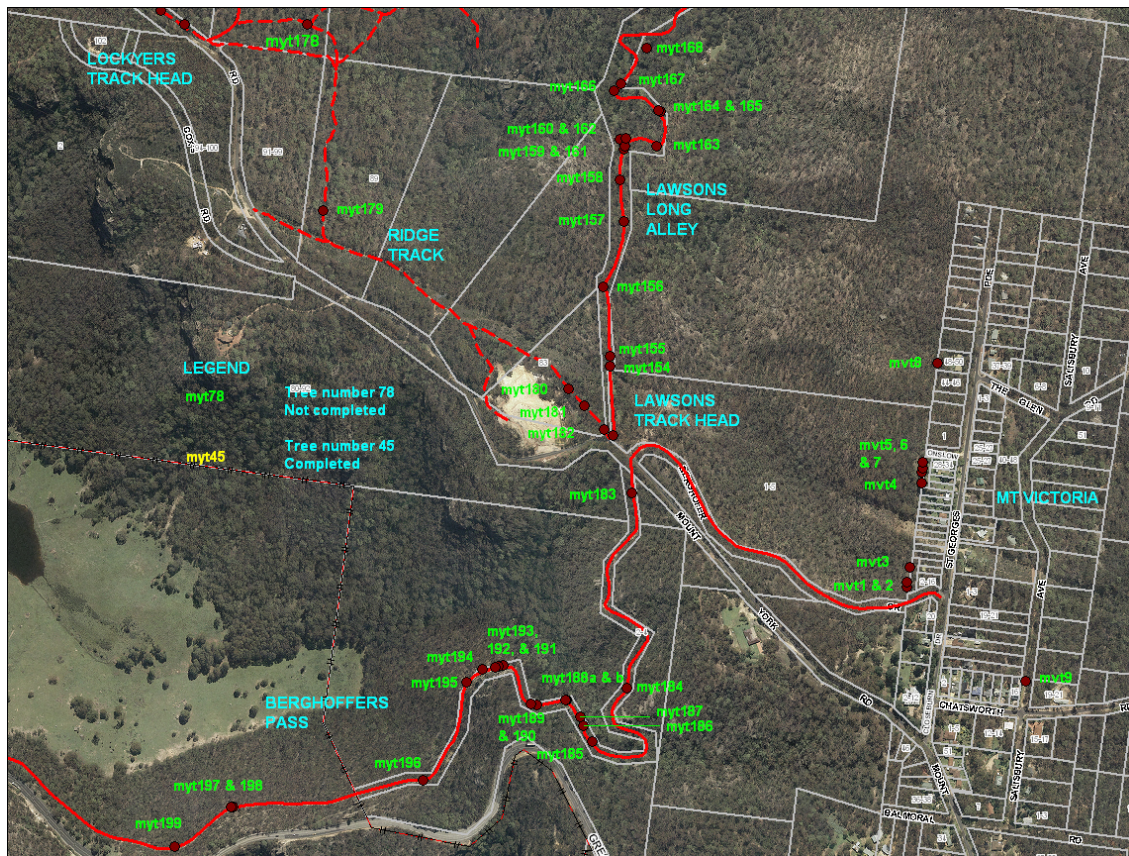
All these areas were walked, and qualified staff inspected and assessed every tree that could have an impact on public safety. If a tree required attention, it was numbered, photographed, surveyed by backpack-mounted GPS and mapped onto the MapInfo workspace in the tablet (Figure 13). Trees were assessed as high or medium priority for works.

- Had fallen and were blocking roads and accesses.
- Were standing but damaged and had potential to fall.
- Had limbs that could fall.
- Had potential for causing injury to people or further damage to nearby property.

Figure 13: Plan of dangerous trees at Berghoffers Pass and Mt Victoria.

After the mapping was completed, contractors were engaged to clear the trees. In areas that had reasonable access, the trees were cut, logged and chipped. These chips were then used in other parks and reserves where needed. In areas of no access, the trees were generally logged up and then moved further into the bush. This was a practical measure that needed to be undertaken, although the volumes of timber in this situation were not large.

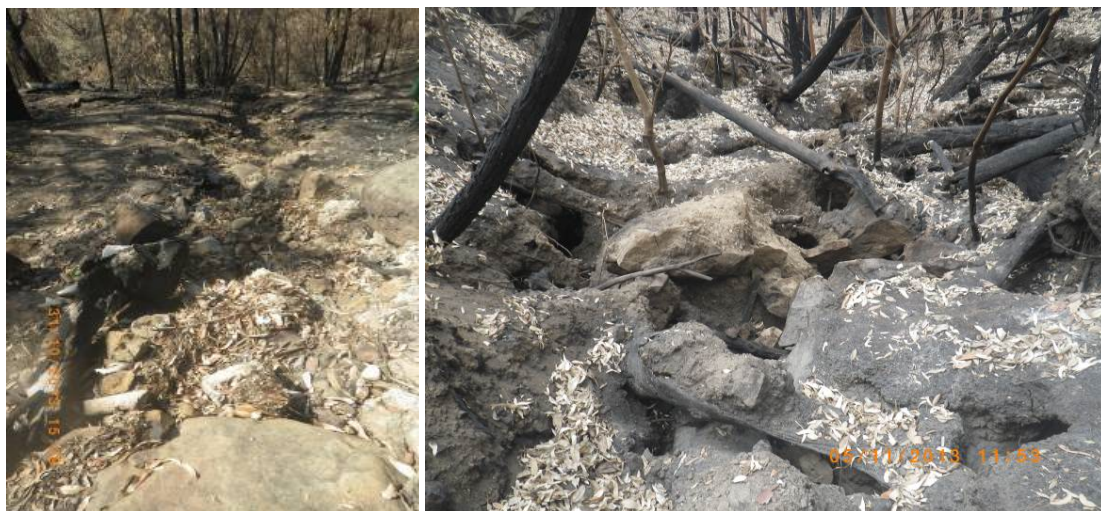
A high level of concern emerged with the stability of the soil after the fires burnt all the ground cover. These burnt areas had exposed top soil, which was very fine and friable. There was high potential for erosion and contamination issues in the event of rain. Erosion was possible as sheet erosion across slopes and concentrated erosion in drainage channels and watercourses (Figure 14). Contamination of the bush soils was possible from contaminants being washed from properties that were damaged or destroyed.

Figure 14: Typical drainage channel (left) and typical drainage line (right).

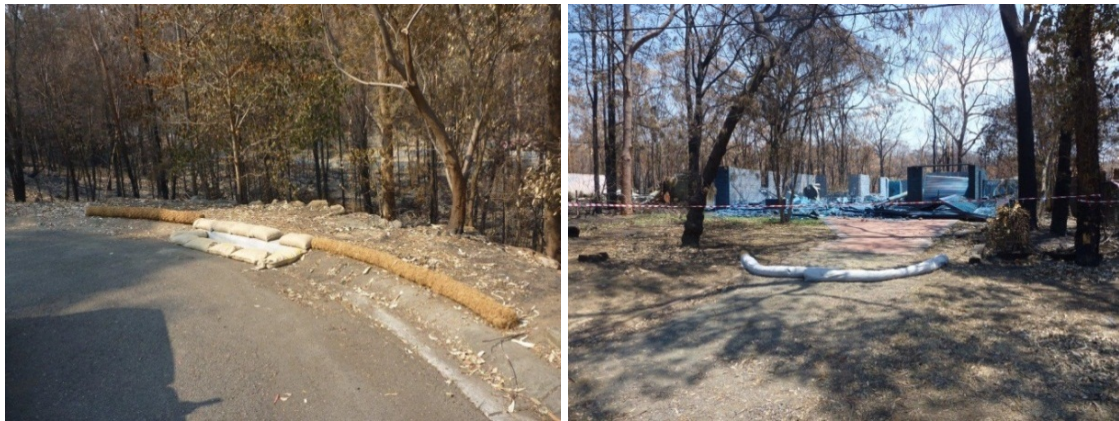
Figure 15: Typical treatment drainage pits (left) and typical treatment hardstand areas (right).

A range of sediment and run-off control devices were put in place immediately by Council staff and the Defence Forces. Such devices included (Figure 15):

- Sandbags and filter geofabric over all drainage pits. This was aimed at preventing contaminants and silt from washing into the bush.
- Utilising kerbing as detention basins in low points. This was quite effective in one cul-de-sac, where the drainage pits were blocked and the kerb levels were raised with coir logs.
- Installing sedimentation fencing and sand bag reinforcement at drainage outlets.
- Installing coir logs along drainage channels to form small retardation dams to reduce the velocities of run-off. These were located between 10 and 20 m intervals along watercourses depending on the gradients of the drainage channels.
- Installing coir logs at areas of possible contaminant flow from damaged properties, such as across driveways and hardstand areas.

There were periods of rain following the fires, but no high-intensity storms. After each day of rain, all the structures were inspected and strengthened or adjusted if necessary. Street sweeping trucks were also continuously circulating, vacuuming the roads of sediments and contaminants. This was a key to the effectiveness of the measures that were put in place.

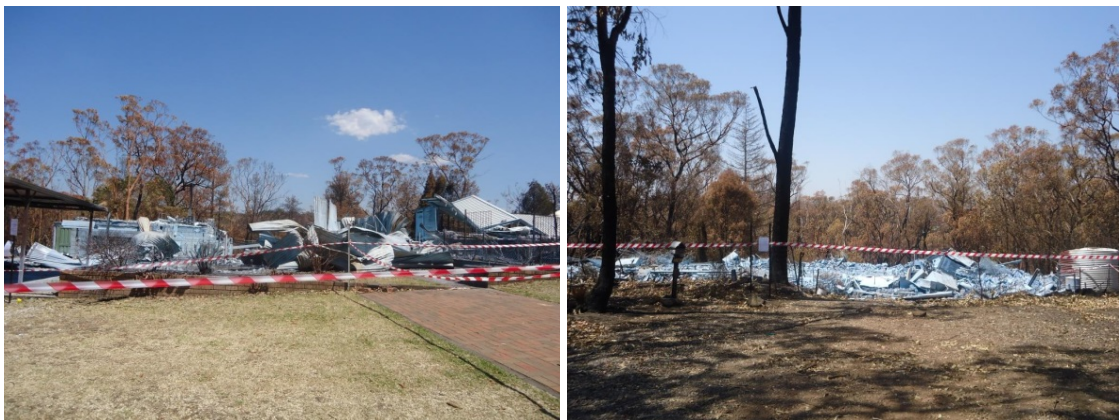
One of the critical safety aspects to be dealt with in the fire areas was the presence of asbestos in many of the homes that had been destroyed or damaged. It presented a safety issue for windborne particles, for people accessing the properties and for run-off during rain into the surrounding properties or bushland. Consequently, all houses were inspected by Public Works and those found to have asbestos were sprayed with a binding agent until they could be safely removed. The blue binding agent was quite noticeable throughout the fire area (Figure 16).

Figure 16: Houses with asbestos.
