# Coastal Erosion: An “Elegantly Simple Solution” at Harrington

**Grant Calvin**

MidCoast Council

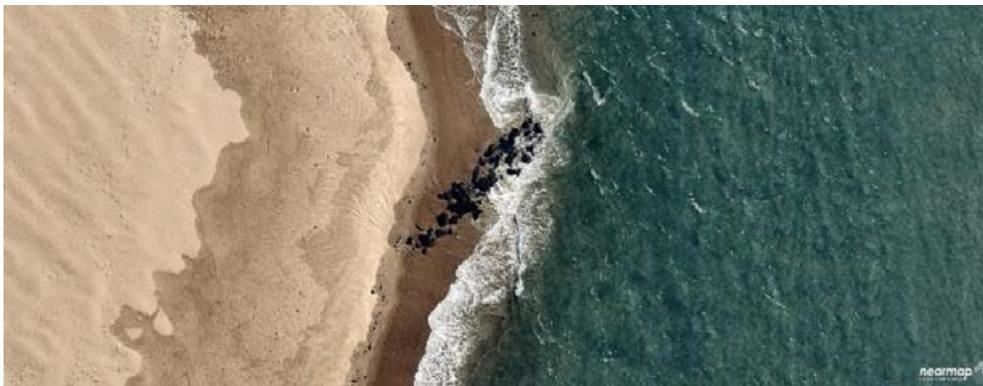
Erosion along this beach has been subject to numerous studies (see section 9). To date none of these has made the connection between these seemingly innocuous rocks and the dramatic and devastating erosion that occurs on the adjoining beaches when the river interacts with these rocks (Figure 1). For comparison, if a similar 300 m shift in the beach alignment occurred at Collaroy, an erosion site of recent interest, the residents on The Avenue, located a couple of blocks west of Pittwater Road, would have ocean frontage (Figure 2).

Figure 1: Shoal of rocks on the beach that play their part in the occurring beach erosion.

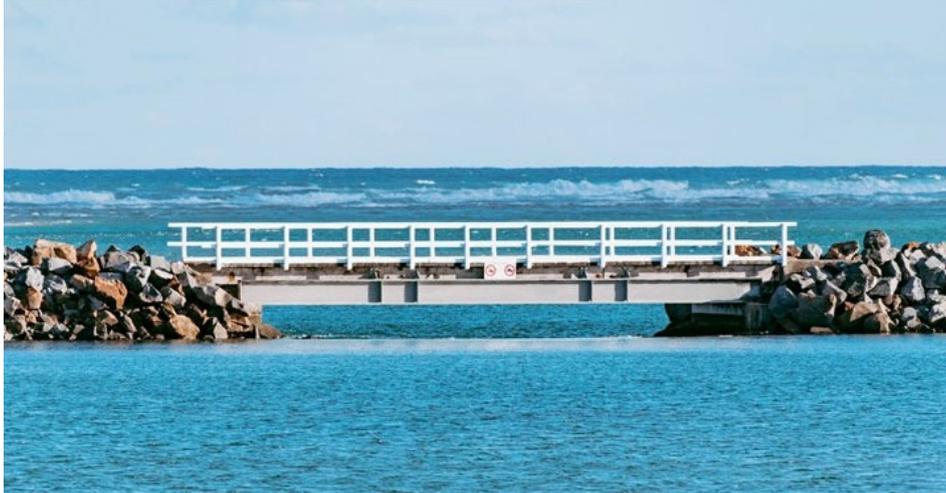
The jet of water spewing through the rock sea wall we observed from Pilot Hill that particular lunch time was coming through this hole in the wall. Nearly a half a kilometre from the corner below us on Pilot Hill, this jet of water looked to be literally bending the river. Locally known as the gantry, the timber bridge has been replaced and updated in the intervening years. It still is not really suitable for boat traffic (Figure 14).

Figure 14: Gantry bridge, spanning a 13.5 m gap in the rock sea wall.

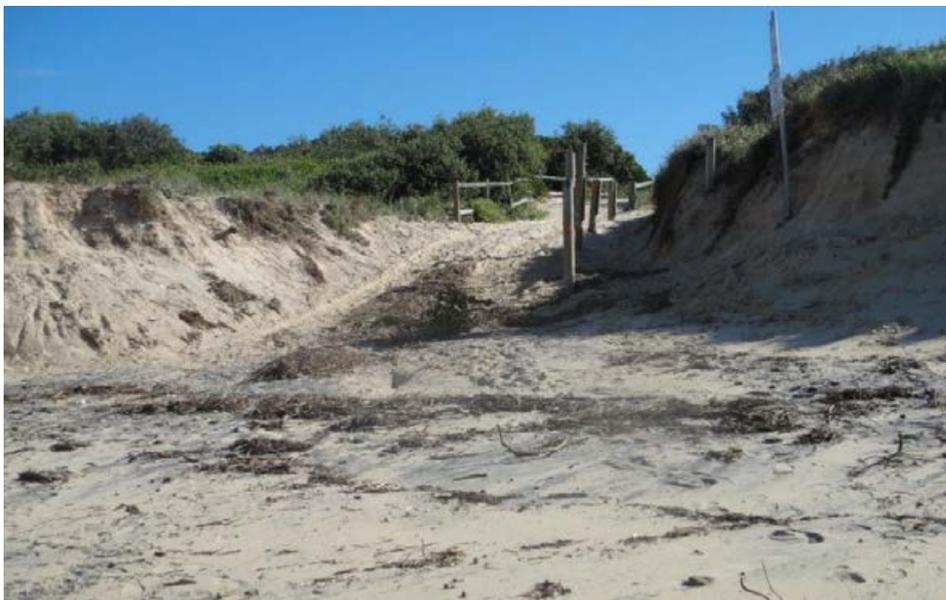
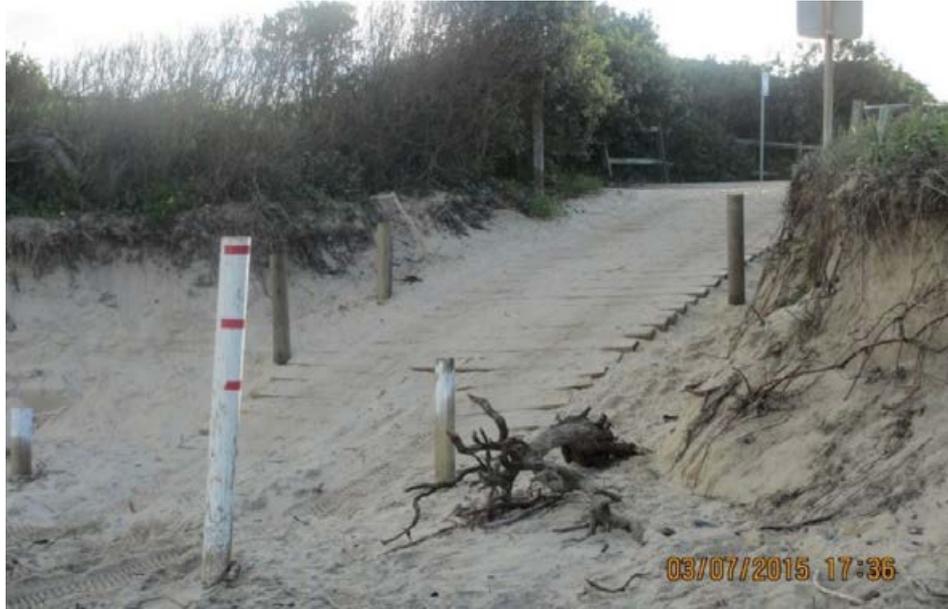
Over this period, features photographed one time were completely gone the next. This made continuity of images difficult. For example, between 2012 and 2015, the beach at the 4WD access point receded, causing access to be reconstructed, each time a little steeper (Figures 21 & 22). Note that at least three panels of southern fence were gone, and the vegetation was suffering.

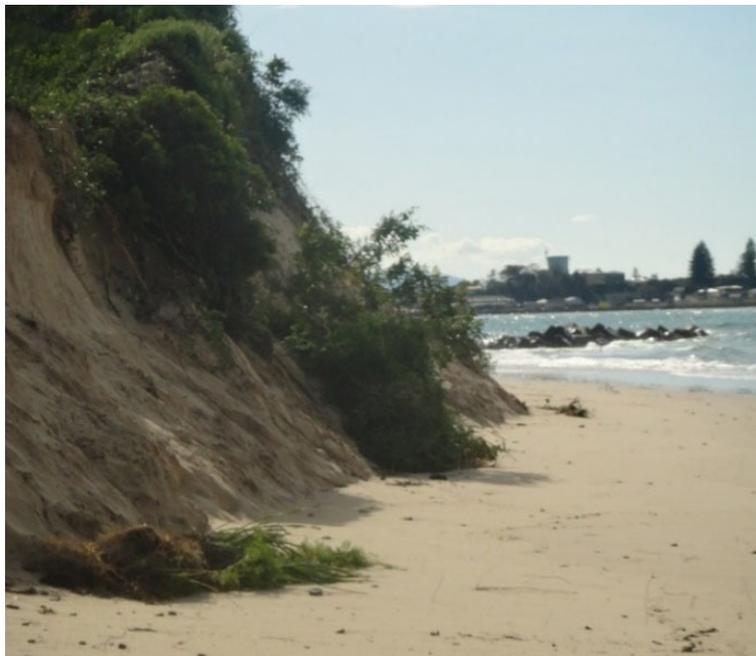
Figure 23: Northern tip of Mitchells Island showing high dunes near the end of the rocks, September 2012.

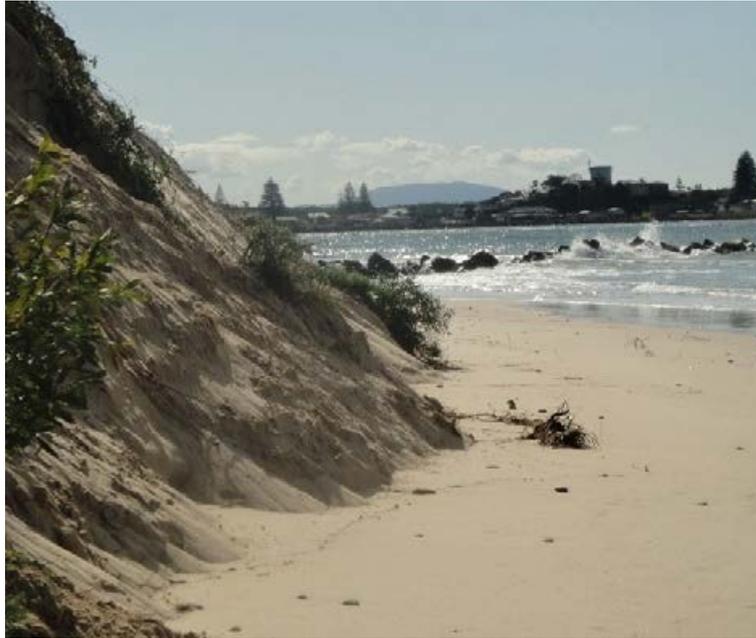
Figure 24: Northern tip of Mitchells Island showing ocean waves breaking on the rocks of the northern end of the south barrier bank, September 2012.

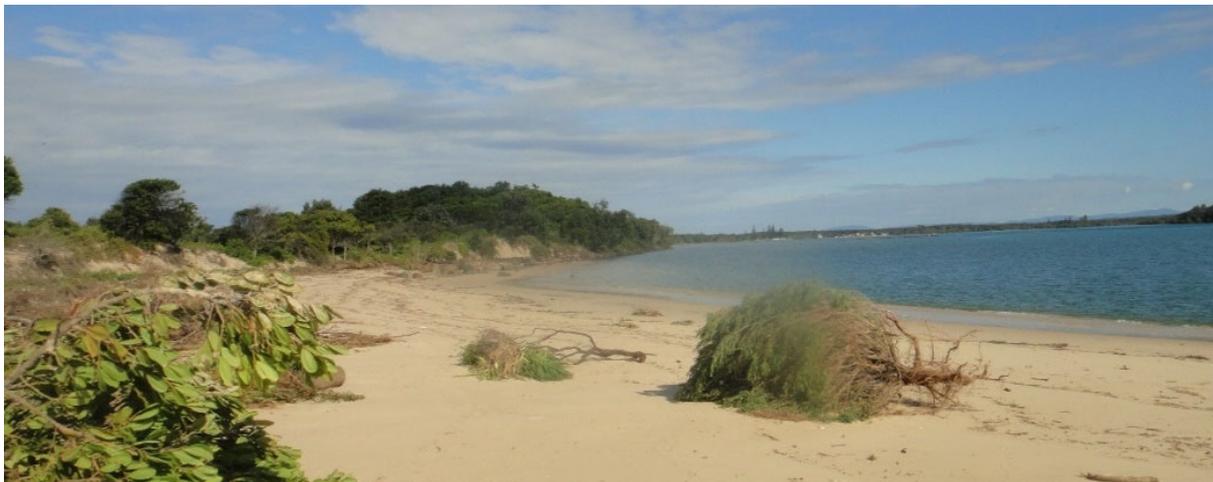
Figure 25: Looking upriver, September 2012.

From down near the rocks, looking upriver, trees have been left strewn about from the waves washing across the sand spit at high tide (Figure 25). The edge of a tuckeroo grove planted by the local Dunecare/Landcare group can be seen on the far left of the photograph. Rocks can be seen along the shoreline. Works around 1901-04 had placed the rocks to protect the southern sand spit. This was the start of the important barrier bank on the southern sand spit described by Coode (1889). Darley (1881) also described how the southern sand spit warranted rock protection with a stone dyke.

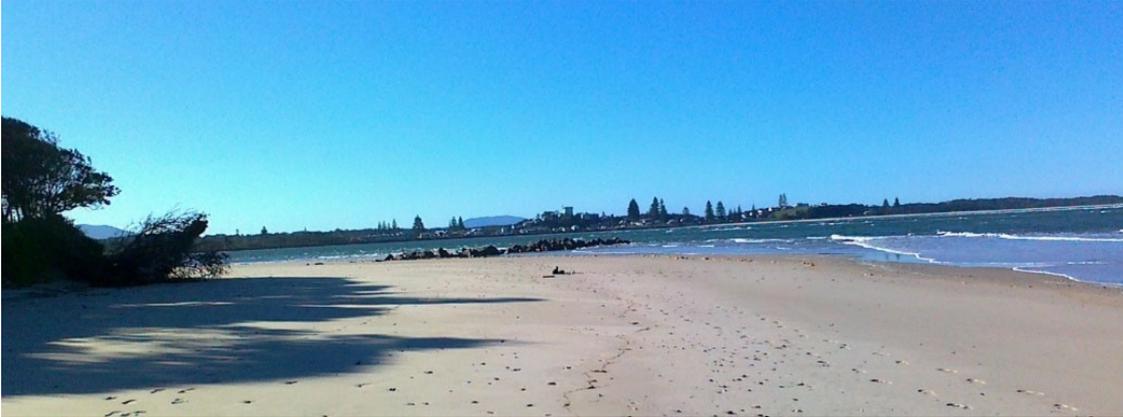
Figure 26: Looking north, July 2013.

By July 2013, all the high dunes had disappeared (Figure 26). Much more of the barrier bank rocks was visible extending out into the river. Waves break along the shore where the beach alignment now meets the river at these rocks. The eastern side of the tuckeroo grove can be seen on the left of the photograph adjacent the drop off to the beach.

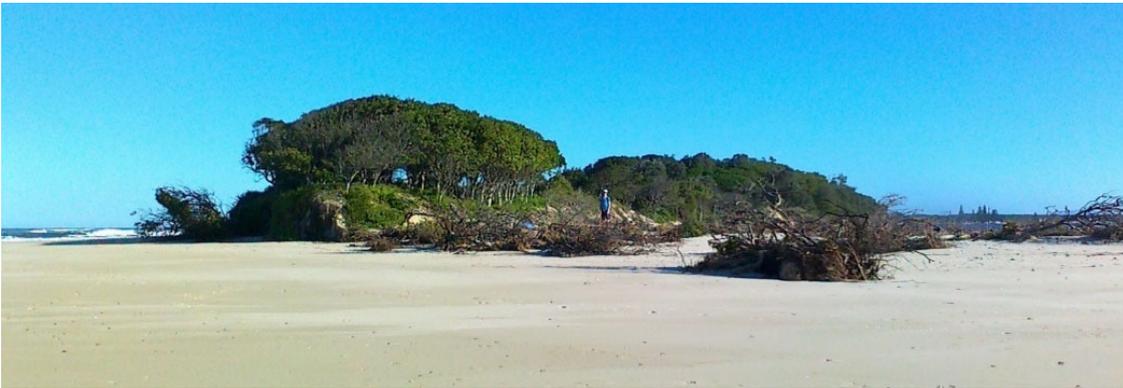
Figure 27: Looking south, July 2013.

Looking back from the remnant rock wall in 2013, the grove of tuckeroo trees is right on the edge of the beach scarp (Figure 27). Waves have been flowing from the sea into the river between the rock wall and the vegetation on the spit.

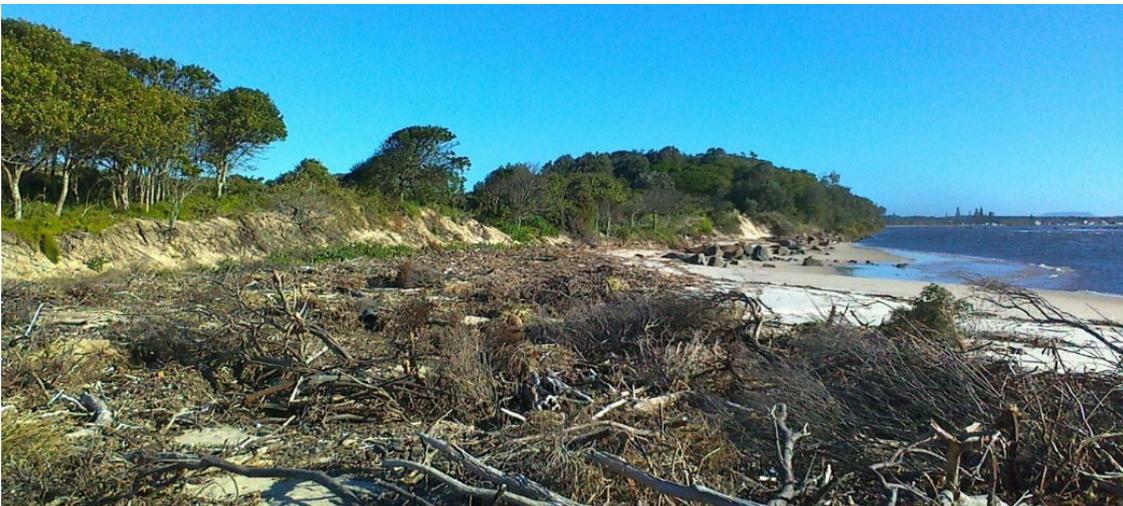
Figure 28: Looking upriver, July 2013.

Looking back upriver from the northern end of the spit, the tuckeroo grove is on the left (Figure 28). Vegetation is still being strewn across the sand spit from wave action. The sections of the south barrier bank rocks can be seen along the edge of the river. Manning Point village is visible in the distance.

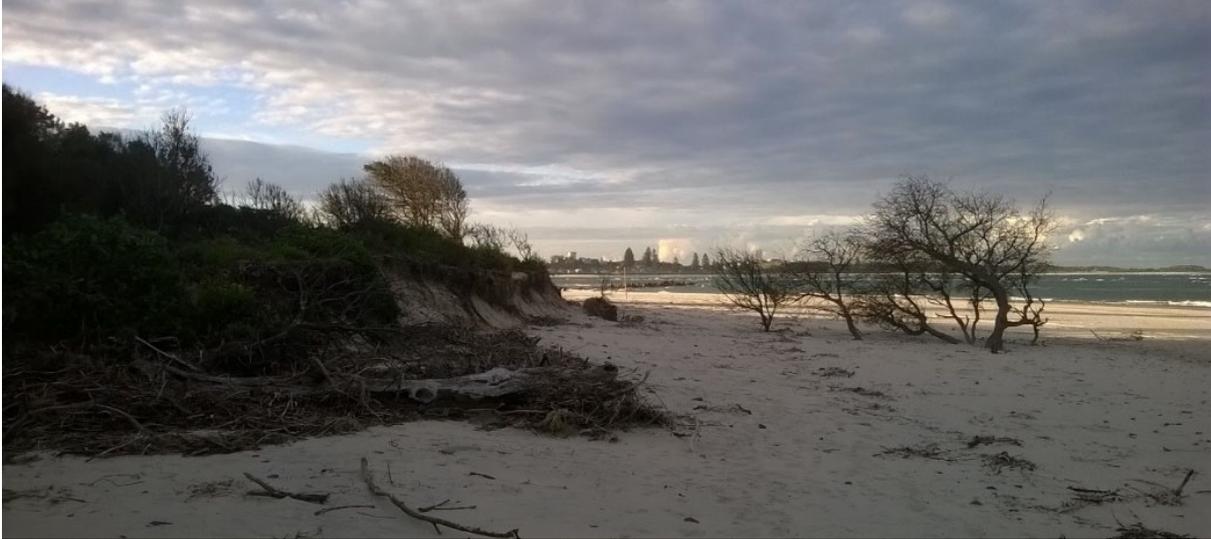
Figure 29: Looking north, June 2015.

By June 2015, the grove of planted tuckeroos was gone (Figure 29), and the remnant northern end of south barrier bank rocks can be seen much further from the vegetation than in 2013. The distance to the water tower at Harrington appears to be much greater than in 2012 (see Figures 23 & 24).

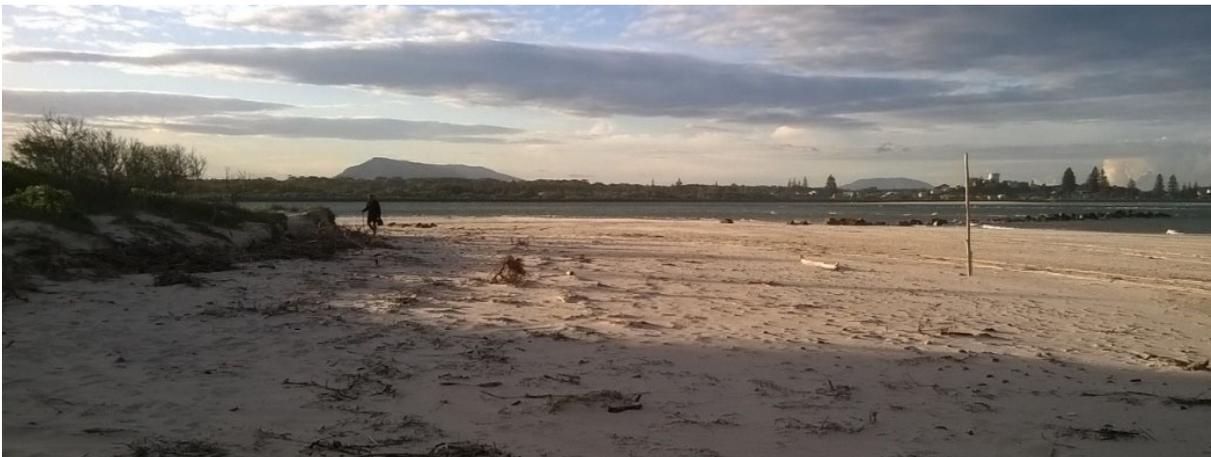
Figure 30: Looking north, June 2015.

Comparison with the 2012 photographs shows a disturbing amount of sand has been removed in the intervening 3 years. Closer to the entrance of the river, the expanse of sand between the vegetation and the rock wall is evident (Figure 30). Waves washing over the sand spit in 2015 have washed away the fallen vegetation from the beach. Again, the water tower at Harrington is visible in the distance.

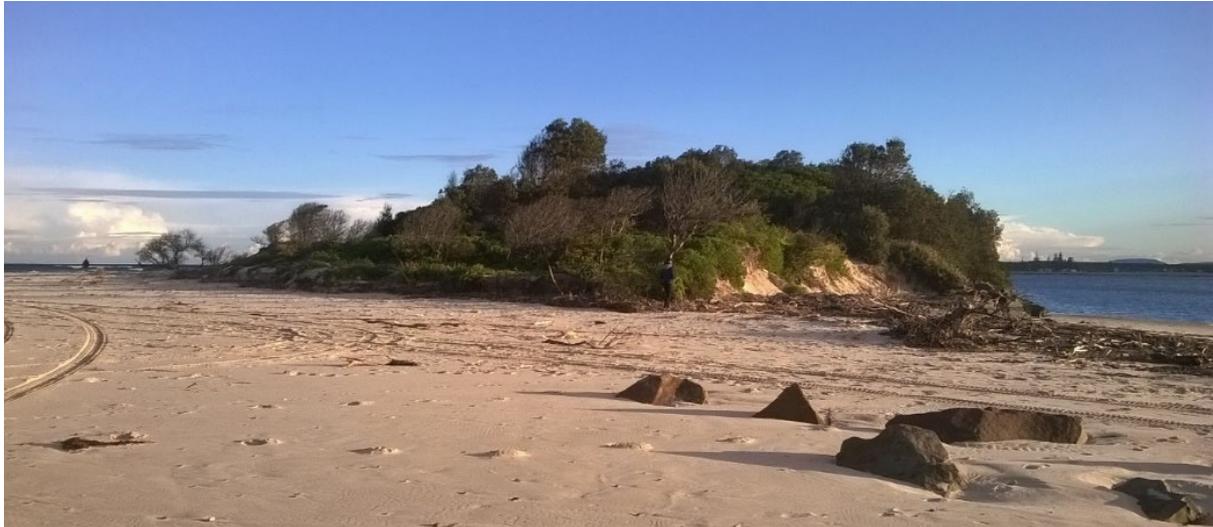
Figure 31: Looking south, June 2015.

Looking south from the sand spit, it can be seen that the entire tuckeroo grove prominent only 2 years earlier had completely disappeared (Figure 31). Rocks from the barrier bank poked through the sand. The beach alignment to the south had marched even further westward since the 2013 images.

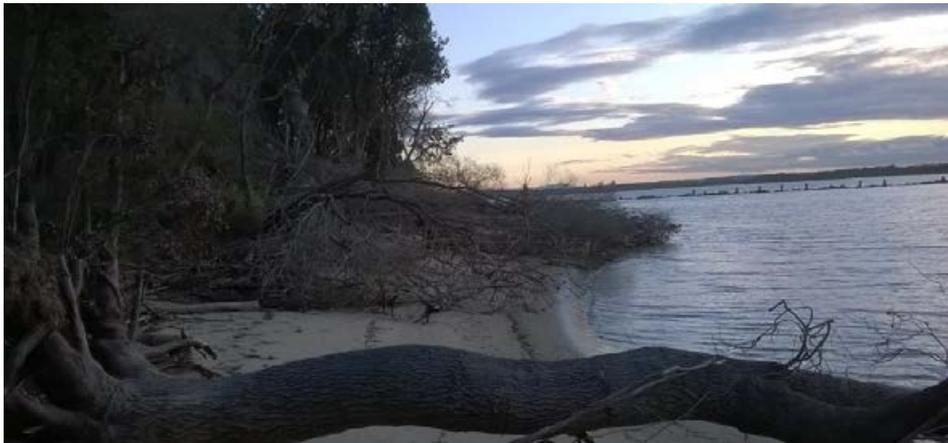
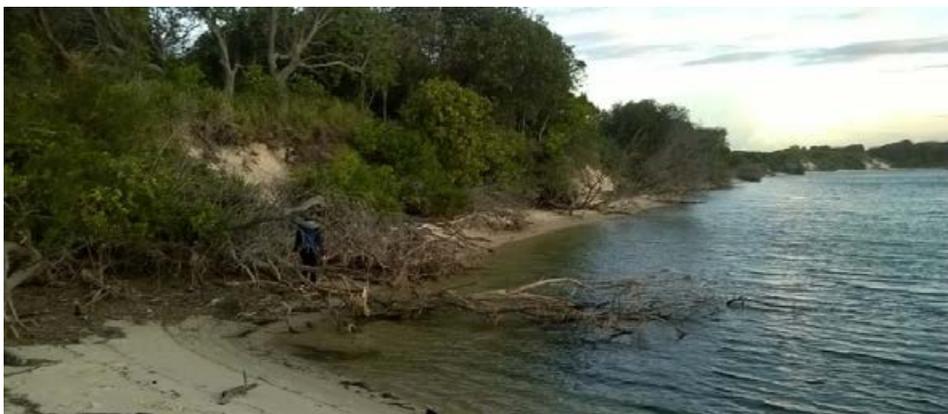
Upstream of the entrance, the inner side of the sand spit had also been devastated by the changes that occurred in the location of the entrance to the river (Figures 34 & 35). This is evidenced by the number of trees fallen into the river as we made our way back to Manning Point. Along the river side of the sand spit, significant erosion had occurred. Beyond the upstream limit of the southern barrier bank, large trees fallen into the river made moving along the foreshore difficult even at low tide.

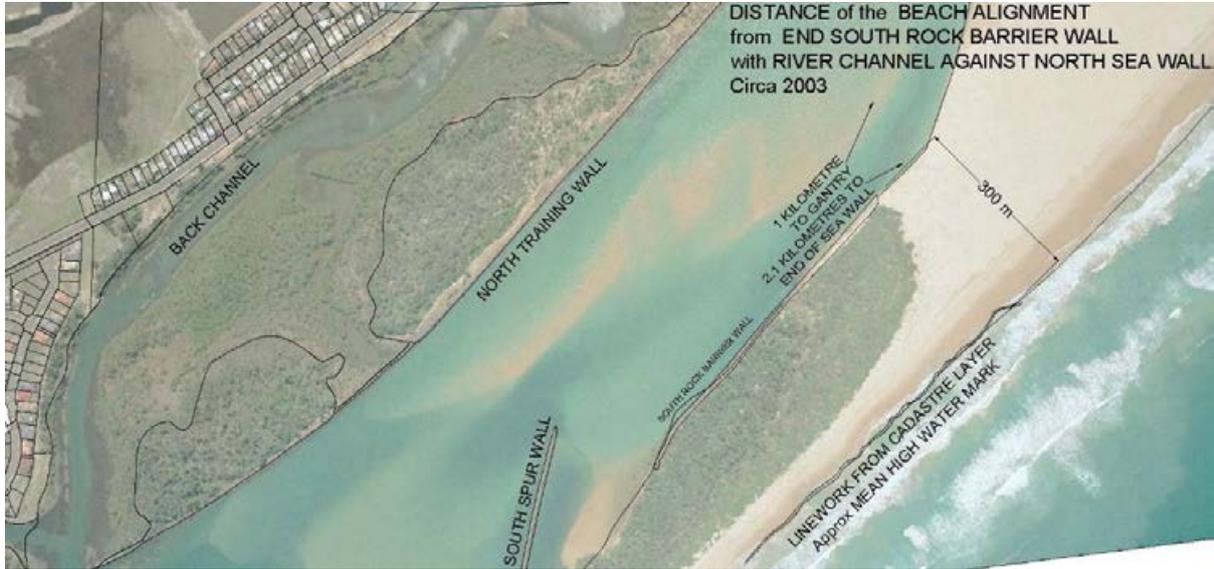
Figure 36: Beach near south barrier bank rocks, ca. 2003.

This photographic record over 3 years from 2012 to 2015 shows what happened when the river shifted away from the northern sea wall around 2009/2011 and migrated south. At the southern extent of this shift, it has come up against the northern end of the incomplete south barrier bank rock wall. When the river entrance channel is flowing against the northern sea wall, this remnant section of south barrier bank rocks is about 300 m west of the beach alignment (Figure 36).

- When the river entrance shifts to the south, it interacts with the unfinished south barrier bank rocks (see Figures 23-33).
- This interaction causes the beach alignment to shift westward 300 m to the northern tip of the incomplete south barrier bank rocks (see Figures 36 & 37).

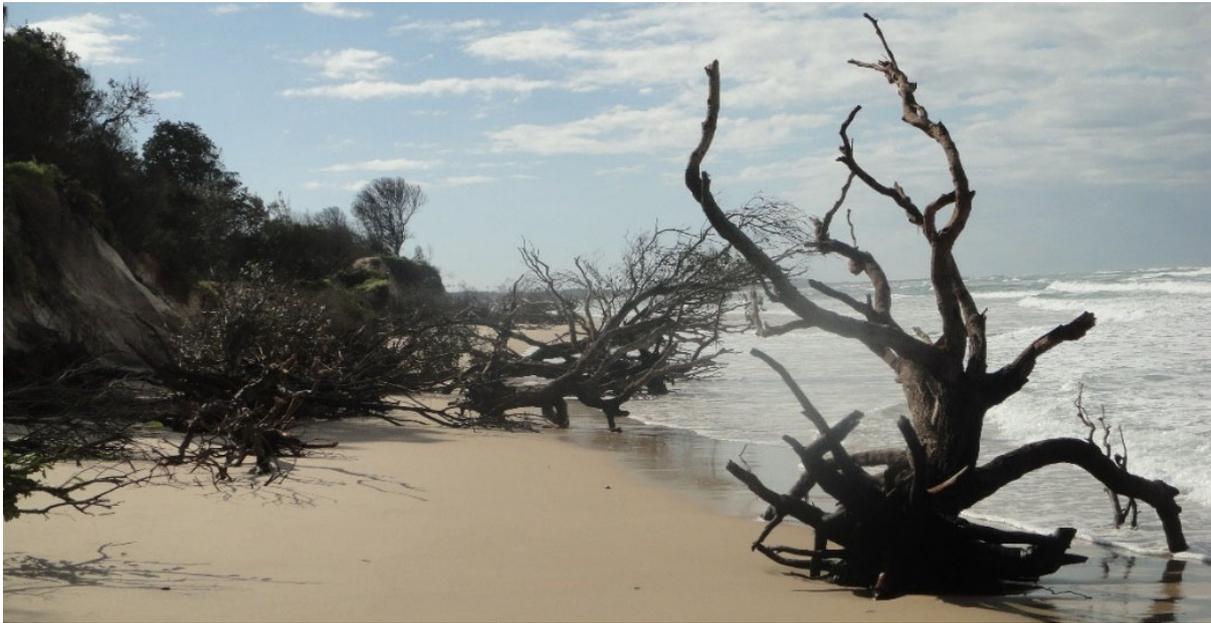
Figure 42: Coastal littoral rainforest trees dropping onto the beach, September 2012.

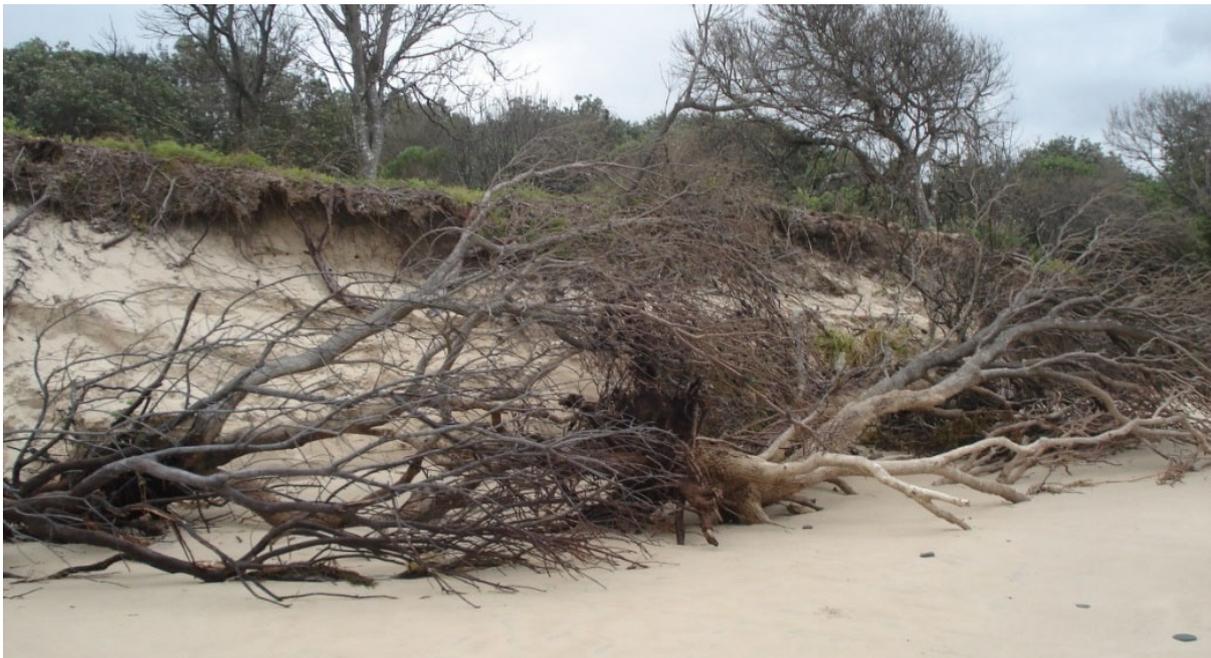
Figure 43: Trees suffering from exposure to the prevailing winds, May 2013.

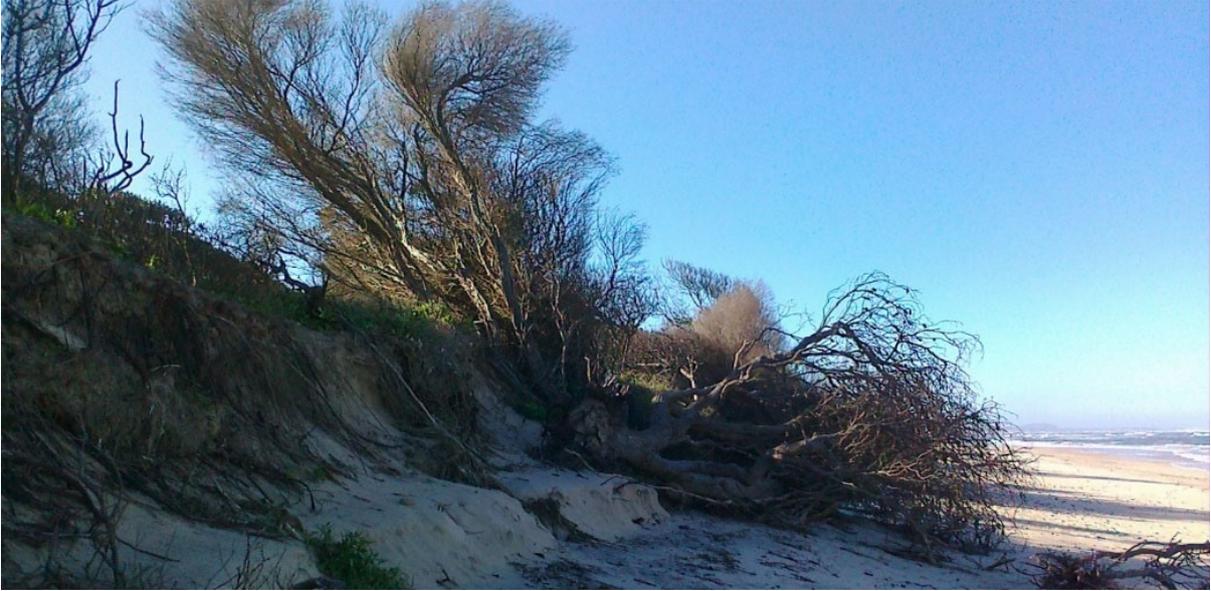
Figure 44: Trees suffering from exposure to the prevailing winds, July 2013.

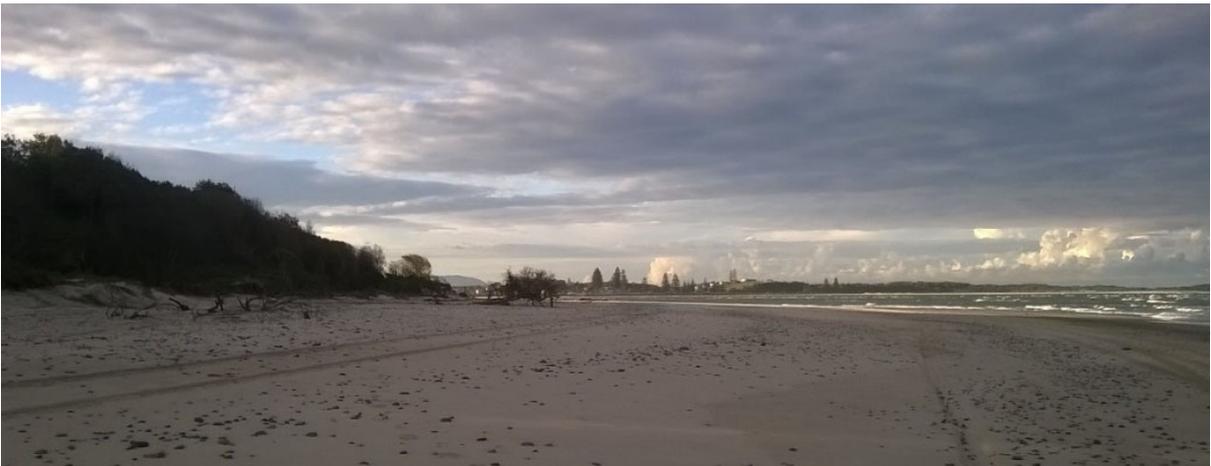
By 2015, large sections of the frontal dunes were gone. In Figure 45, the tall trees and water tank of Harrington village can be seen across the river entrance to the sea.

Figure 45: Tall trees and water tank of Harrington village across the river entrance, June 2015.

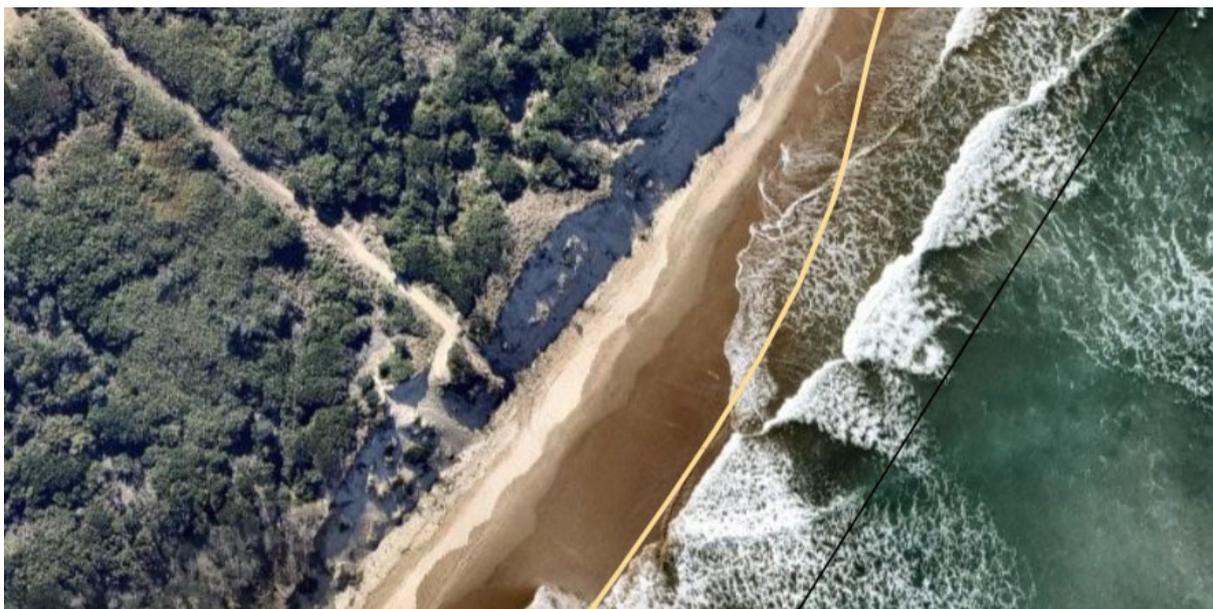
Figure 49: Second corner beach access and viewing platform disappeared (Nearmap image, 2015).

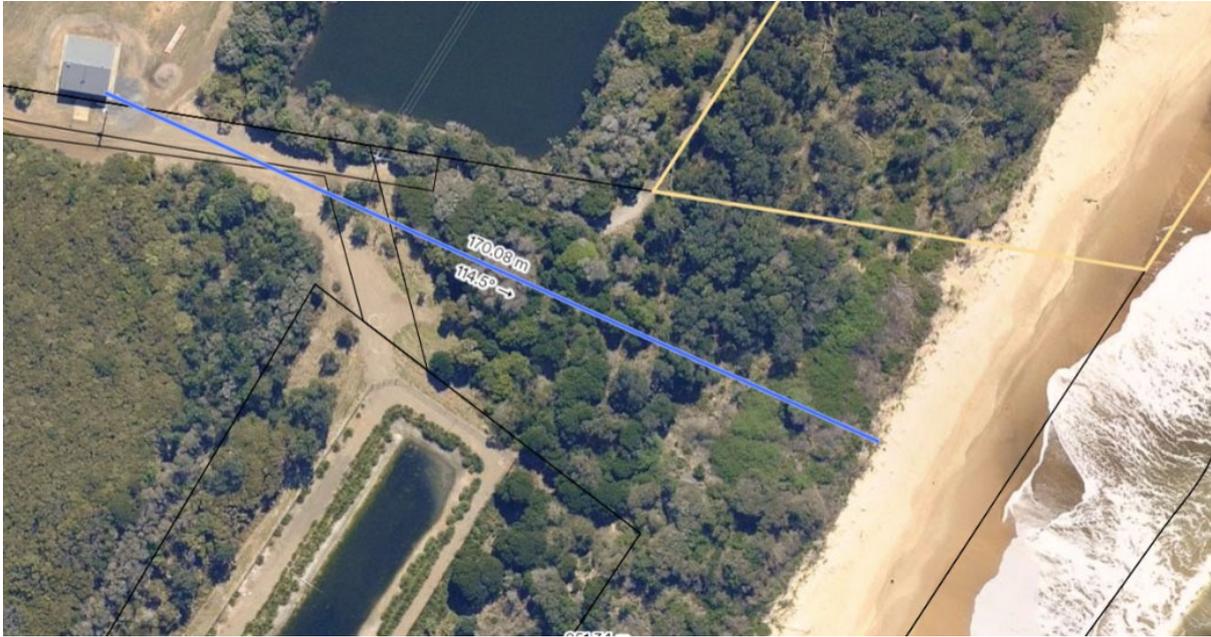
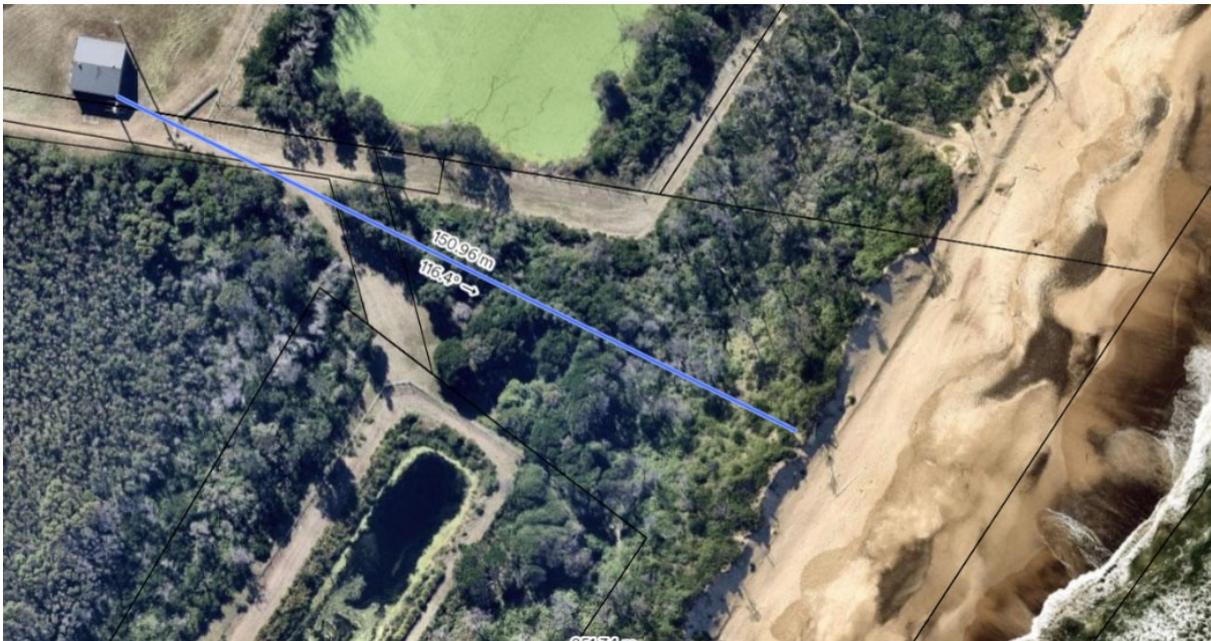
Between the villages of Old Bar and Wallabi Point, there is a disused sand quarry that now contains the Old Bar Waste Water Treatment Plant (WWTP) sand infiltration ponds. Between September 2011 and May 2022, the distance from the pump house to the edge of the dune scarp reduced from about 170 m to about 151 m, i.e. by almost 20 m (Figures 52 & 53).

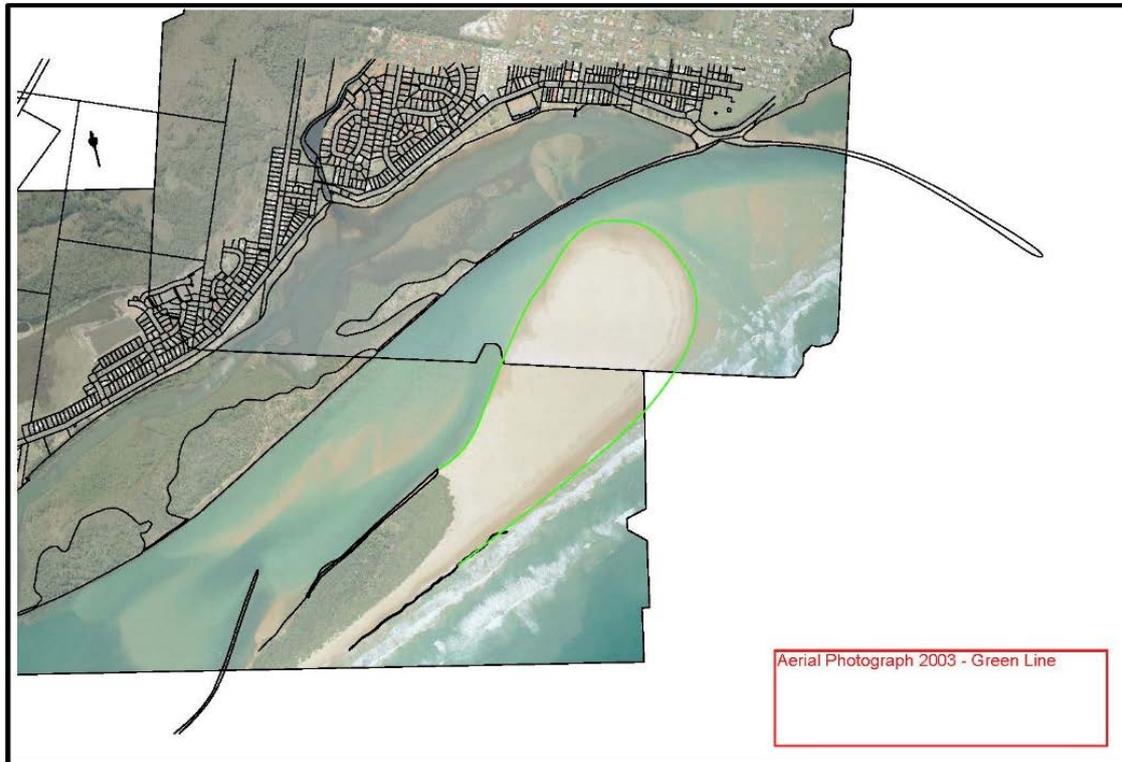
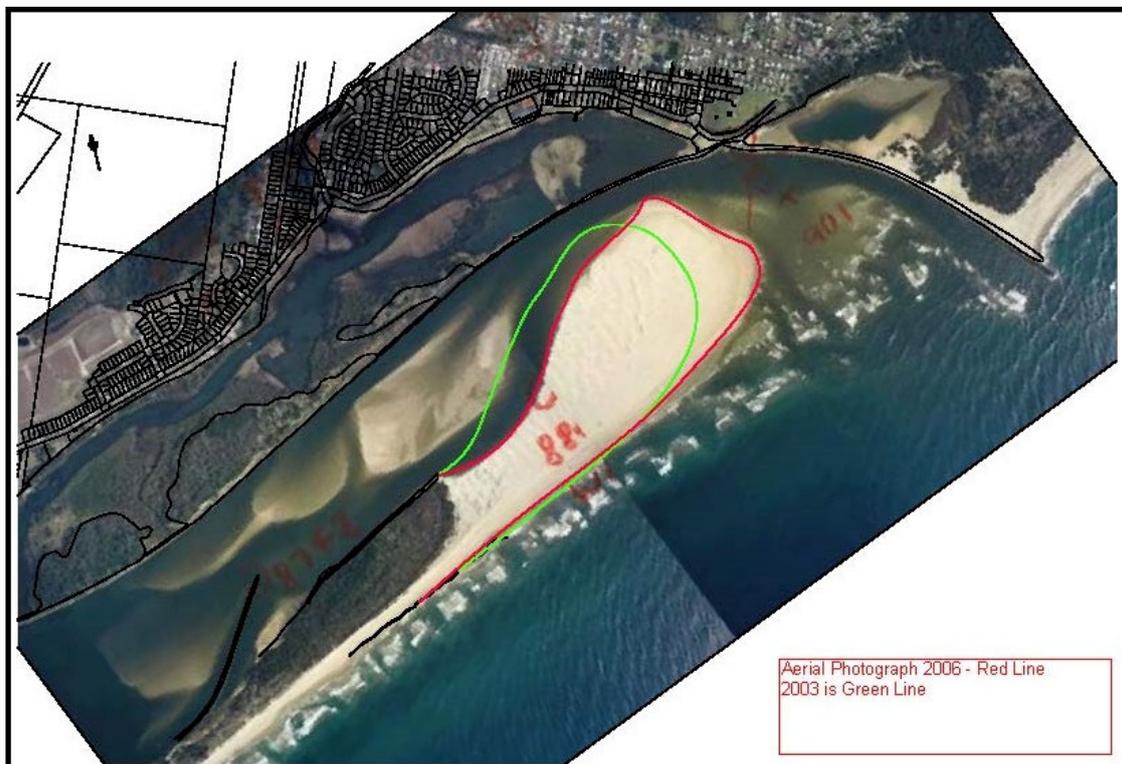
In Figures 59 & 60, there is a build-up of sand in front of the gantry. At the bottom of the tide, the jet of water coming out of the gantry is potentially blocking the last of the river's outgoing tide. This minor blockage over several tidal cycles has the potential to cause the upstream channel to meander. Between 2003 and 2006, the upstream channel meandered about 100 m.

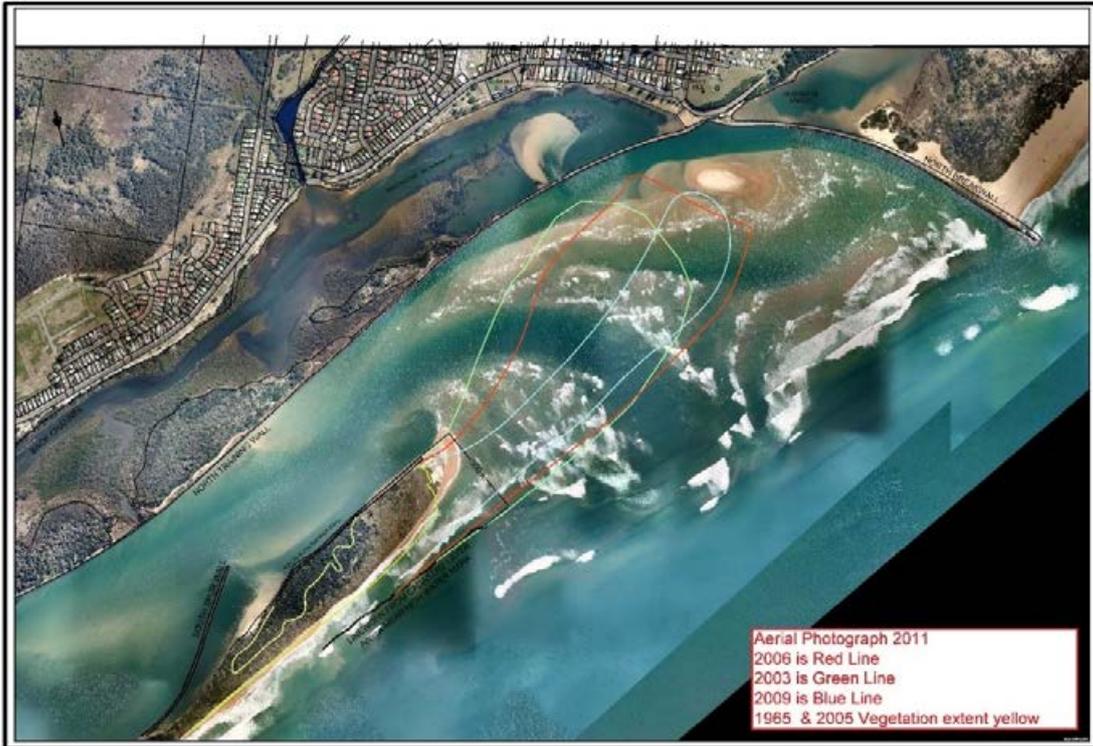
Figure 62: Aerial image (Nearmap, September 2011) overlaid on the cadastre and the sand bank outlined.

A major flood occurred in June 2011, not long before the image in Figure 62 was taken. It is unknown whether the river had broken through the beach before this time. One might postulate that the reduced channel by the north wall and reduced width of the southern sand spit has allowed the river to break through the sand spit and migrate radically south. The river entrance is flowing through the entire area between the northern tip of the south barrier bank rocks and the north break wall, i.e. a distance of 2.1 km.
