WASTE MANAGEMENT TRANSFER STATION

KATOOMBA

Graeme Paterson

Senior Surveyor
Blue Mountains City Council

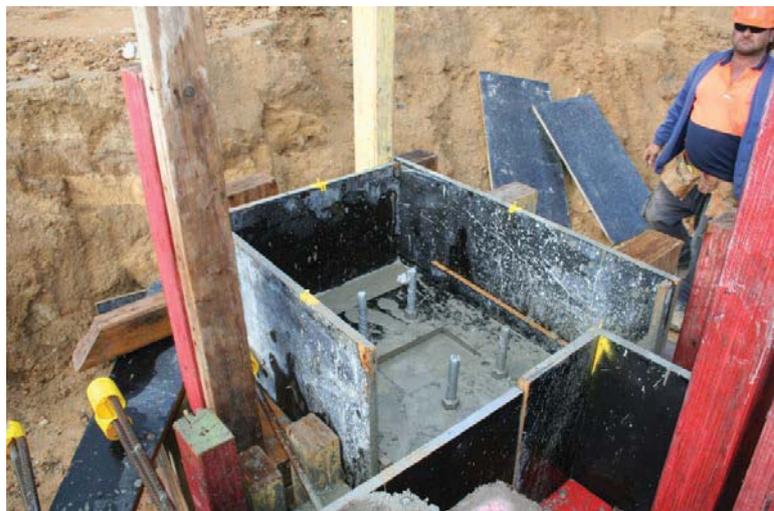
Retaining Walls – Most of retaining walls were fairly straight forward and only involved set-out marks on the footings. However, the concrete retaining wall at the Waste Drop-off Area (which was up to 3 metres high) presented particular difficulty, as the wall was to be built with the holding-down bolts for large steel shelters to be connected to the steel reinforcing in the wall and concreted insitu. These steel frames were pre-made and the tolerance for the holding-down bolts was minimal. The initial set-outs for the wall formwork were undertaken and the bolts then had to be set-out in space up to 3m high above the footing. The set-outs were done by placing 4 offset nails in the formwork cladding for the wall so that the centre of each of the set of 4 holding-down bolts could be established in space by direct stringing between marks. Templates for the set of holding-down bolts were then made and this was set-over the centre mark and fixed in place. Checks were made while the concrete was being poured to ensure that there was no movement on the bolts.

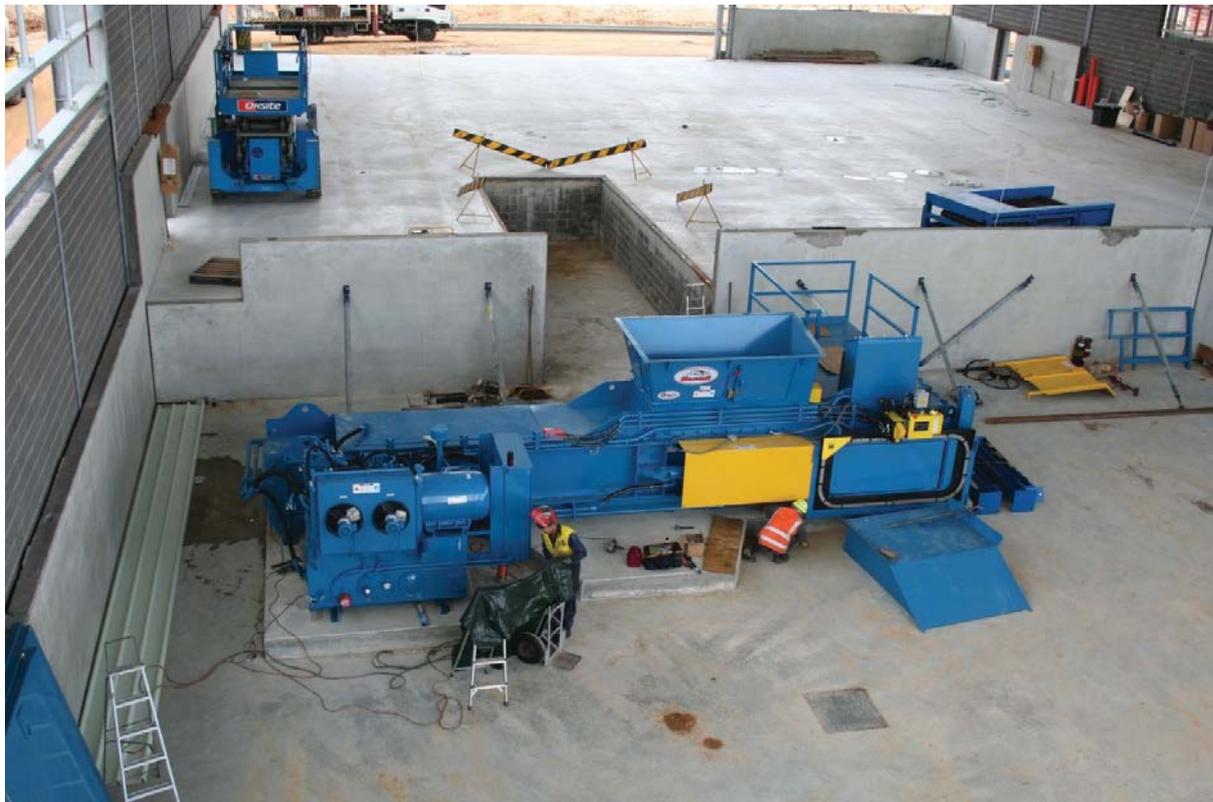
The set-out for the major equipment which crushed the garbage and baled it into blocks, also needed great care. It had to be set-out precisely (again) to ensure that it fitted snugly over the holding bolts and was welded to preset steel plates in the concrete slab foundations.

Baling and Waste Transfer Building – This was the major building constructed in the project and was designed around a 5 metre grid system to which all building design dimensions were related. These grids were marked on site and regularly checked for stability and accuracy. Most building set-outs were undertaken from the grid marks excepting, in particular, the holding-down bolts for the major structural columns. These were also poured insitu in the footings (again a quoted minimal tolerance) and were done in a similar fashion to the retaining wall using offset marks and templates. These were also accurately leveled so the column base plates were all set to the correct design level when placed over the bolts by crane. All the columns were placed by BBC method.

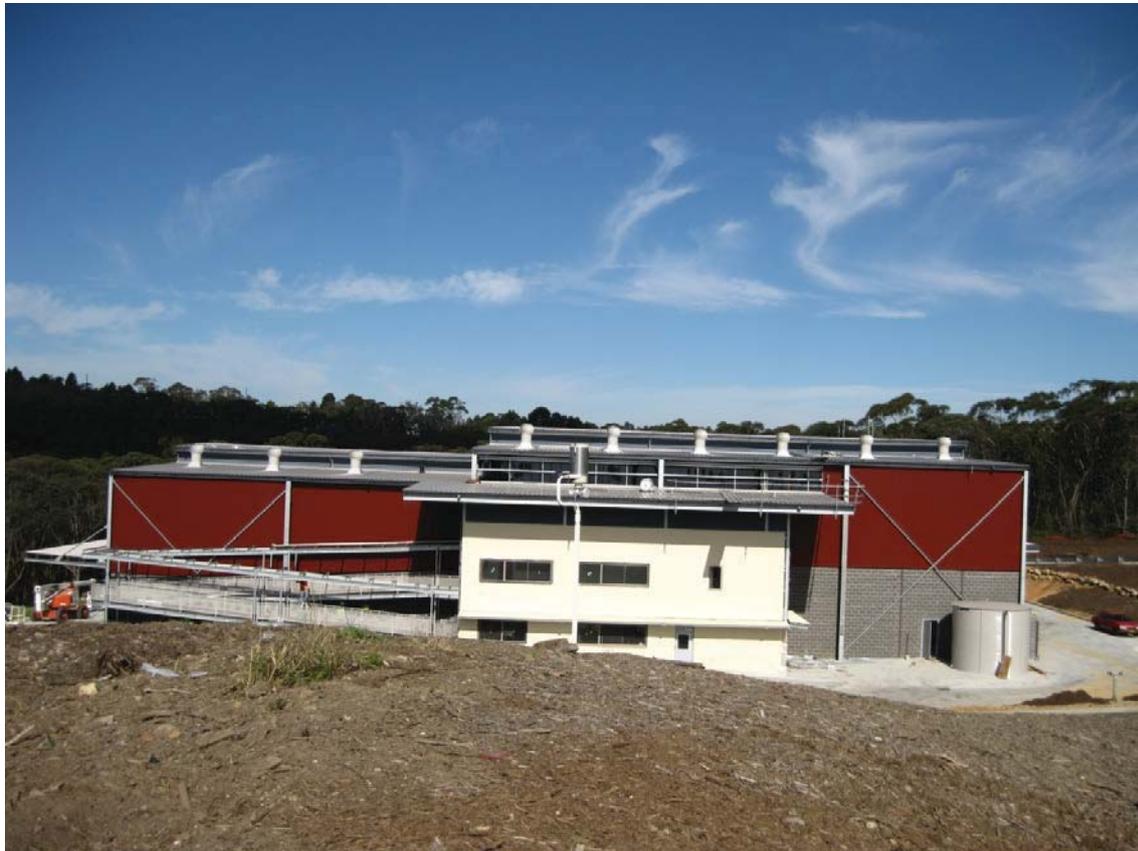
Disabled Ramp – access to the external ramp to the training room and offices in the building did not comply with the standards for disabled access. This needed some re-engineering including removal of part of the existing slab and re laying to different levels.
