# Cadastral Survey for the Sea Cliff Bridge on Lawrence Hargrave Drive by the Roads and Maritime Services

*This paper describes the cadastral survey carried out by the Roads and Maritime Services (RMS) to define the new road boundaries to accommodate the Sea Cliff Bridge on Lawrence Hargrave Drive near Clifton, NSW. The survey had to contend with inhospitable terrain and the instability of the geological structure of the Illawarra Escarpment. It is shown how the application of traditional survey techniques, coupled with modern technology, under these difficult conditions, has produced a very comprehensive and rigorous cadastral survey. The paper describes how marks that were over 100 years old were located along the ocean rock shelf, as well as locating rare stone cubes placed as monuments along the old road alignment. The political urgency of reopening the road as quickly as possible meant that design of the property boundaries was left until after completion of the bridge. This required the survey team to liaise with land owners and other stakeholders to determine the optimal final boundaries and extent of the survey. Complicating this was the need to accommodate a bridge suspen

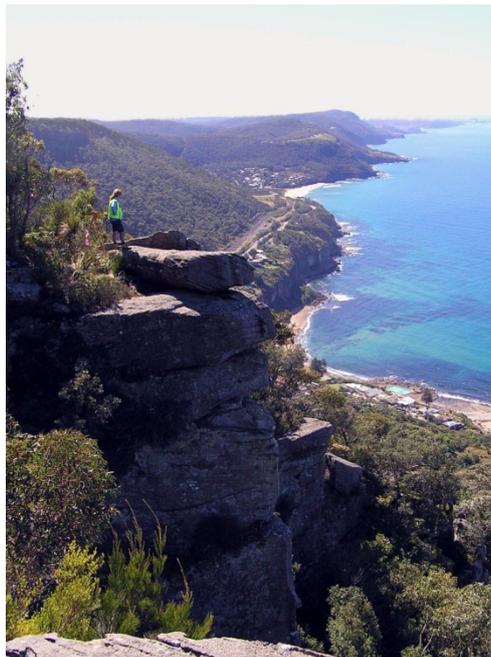
Figure 1: View of the coastline from the top of the escarpment.

The high battlements of the escarpment and the vast openness of the Tasman Sea offer a vista of some of the most spectacular coastline in NSW for motorists (Figure 1). However, the geotechnical structure of the escarpment, steep cliff faces, thick vegetation covering the escarpment and the pounding sea make this area one of the most difficult for road/bridge construction and associated survey work.

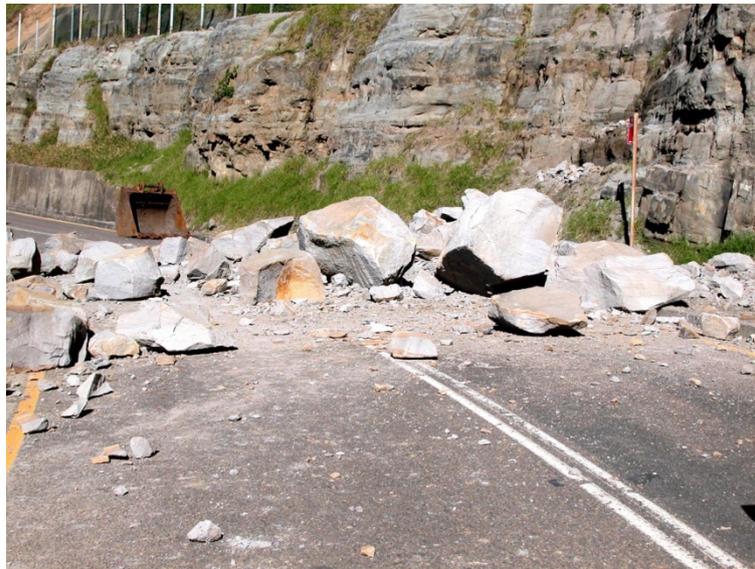
Figure 2: Typical rock fall during 2003.

The survey team's first visit to the site was just prior to the bridge's opening in December 2005. This enabled them to consult with construction personnel to understand OHS risks associated with the site and develop a Safe Work Method Statement (SWMS) specific to the cadastral survey. The Safety Management Plan for construction identified the risk of rocks falling from the escarpment onto the old road formation as high and recommended avoiding work in that area where possible but if necessary then a lookout was required. Figure 2 shows a typical rock fall that led to the closure of the road in August 2003 and was still possible during the time of the survey.

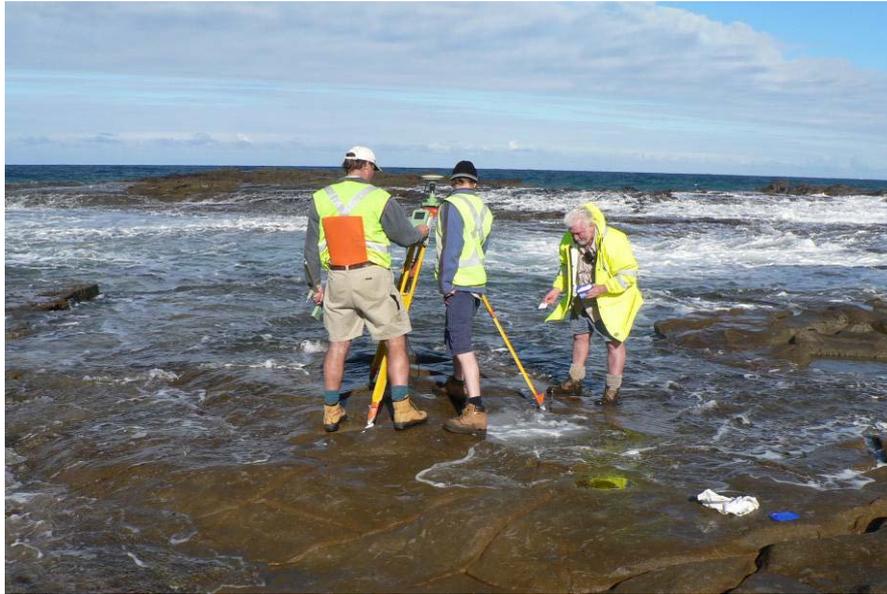
Figure 3: GNSS position fixing of SS 141552.

However, as shown on DP 1137408, this mark is on the seaward side of mean high water but is nevertheless frequently uncovered. Therefore survey work occupying the mark had to be planned in advance, including consultation with the RMS Survey Manager to provide extra staff for OHS compliance. It also needed optimum predictions for rain, tide, wind direction

and strength, wave direction and height and, on one occasion, satellite availability for GNSS observations to ensure successful completion of survey tasks (Figure 3).

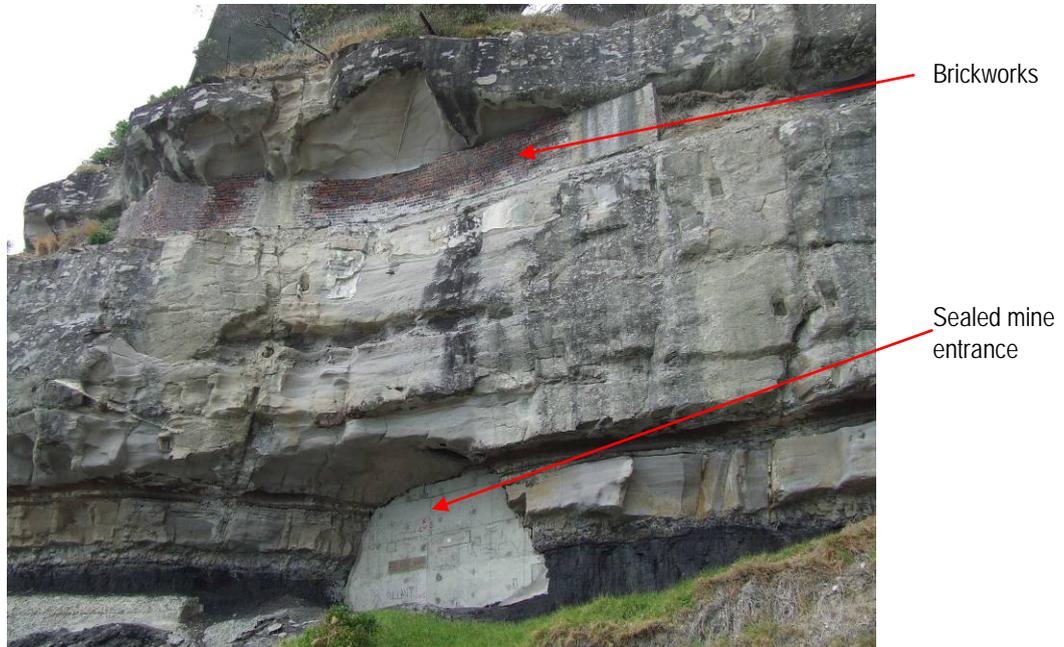
Figure 4: Sensitive heritage items.

The REF describes the boiler and the brickwork as having high significance. Figure 4 shows the sealed entrance to the mine and the brickworks.

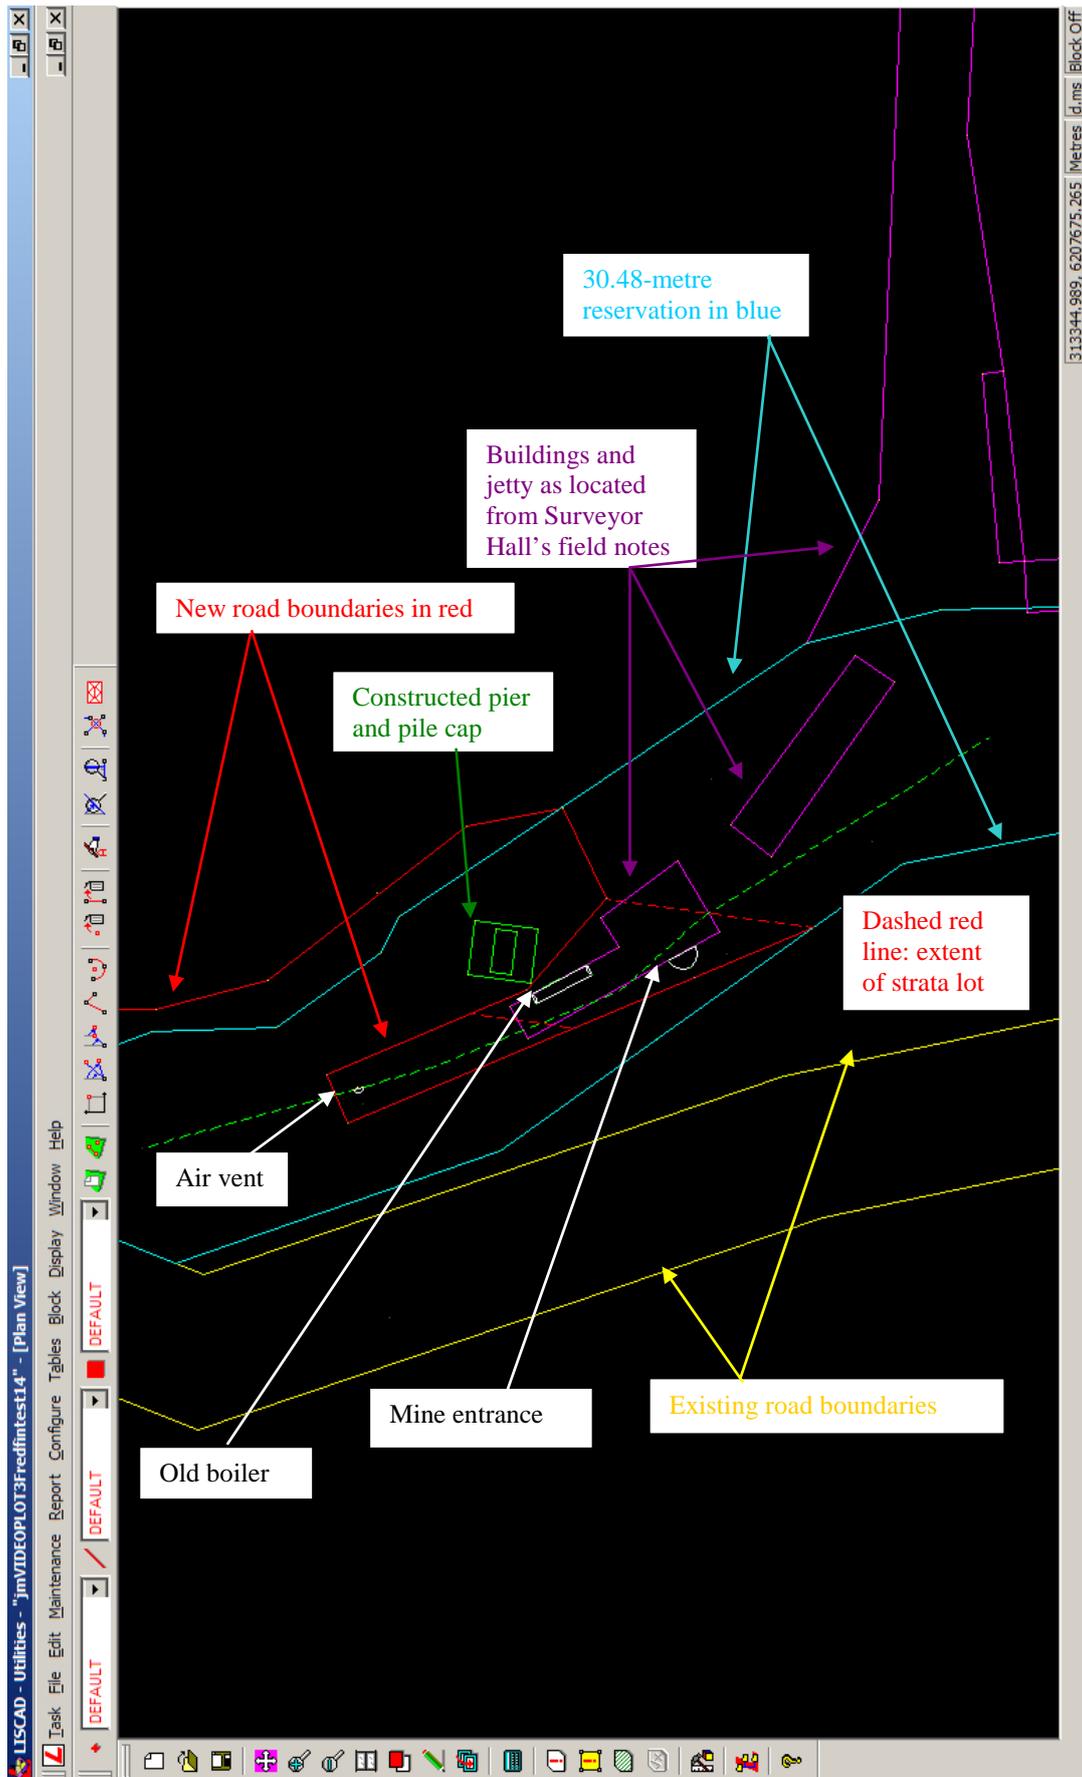
Figure 5: LISCAD screen dump of heritage items.

The significance of the old mine boiler was highlighted at the start of the project and caused a change in the bridge design when it became clear that a bridge pier was to be constructed over it. The bridge pier shown green in Figure 5 is in the final constructed position, not in the position originally intended.

The boundary of lot 6 north-west of lot 18 had to pass between the pier and the boiler to ensure that the pier is located in lot 19 (to be dedicated as road) and the boiler remained in lot 6. The two green rectangles shown in Figure 5 are the outlines of the pile cap and the pier itself.

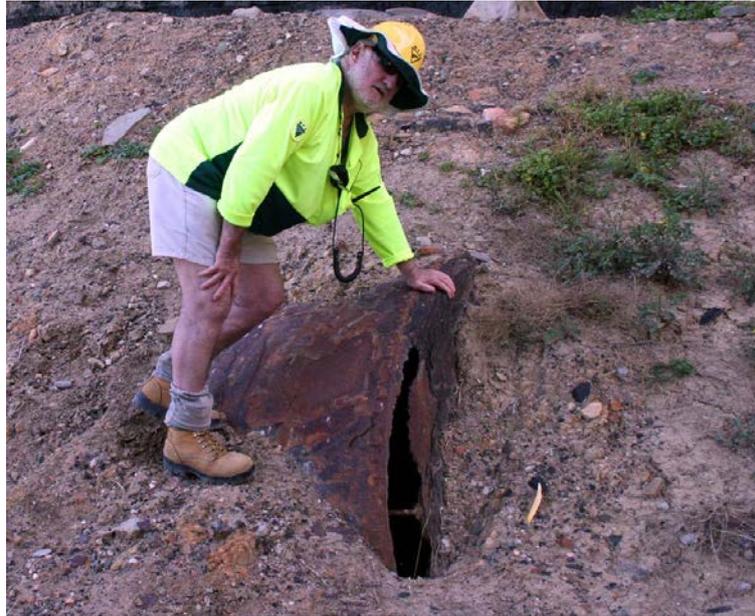
Figure 6: Land Surveyor Stephen Bennett with the exposed boiler.

The REF describes the boiler as 4 metres long and 0.6 metres in diameter (although Figure 6 suggests that it is a 0.6-metre radius, not diameter), consisting of seven cylindrical hoops riveted together.

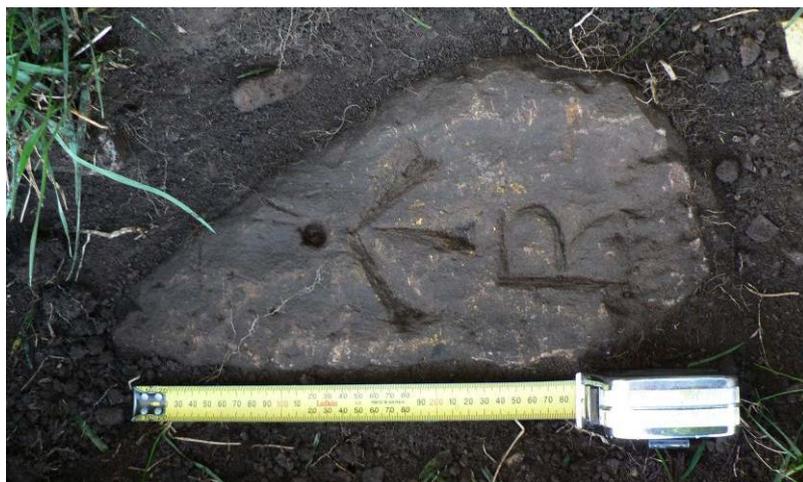
Figure 7: One of the stone cube monuments placed by Surveyor Hall.

A feature of the road survey was the placement of stone cubes with a drill hole and broad arrow to mark angles in the road (Figure 7). Surveyor Hall also carried out a survey in 1909 to create a right-of-way to the Clifton School and also placed stone cubes with a drill hole and broad arrow for that survey (see DP 935466). The survey team located some of the stone cubes to refix the road boundary, one of which was buried 600 millimetres.

Surveyor Hall's use of the stone cubes found by the survey team as survey monuments is unusual if not unique. A literature search failed to provide extra background information about the stones.

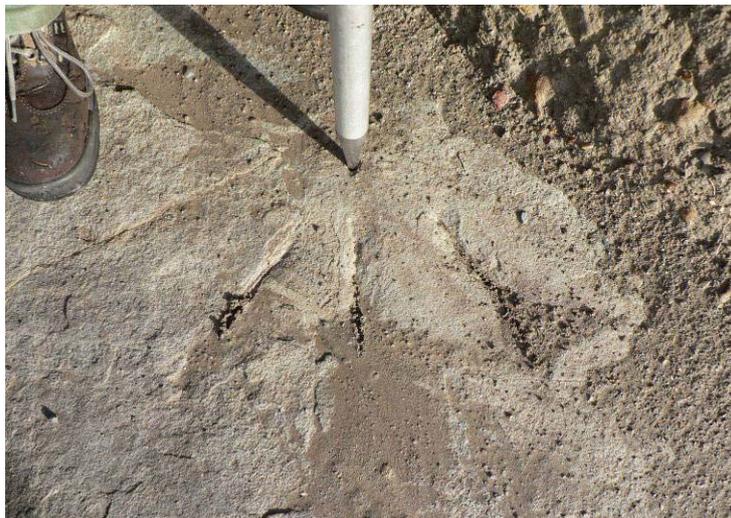
Figure 8: One of the 1883 rock marks found at the northern end.

Two rock marks shown as found by the road survey (plan 3045-3000) were found at the northern end of the survey (Figure 8). However, plan 3045-3000 did not show any reference to the origin of these marks. This required further investigation to establish their origin before they could be shown on the final Deposited Plan for this survey. A search located a road survey from Blue Gum Forest to Coalcliff carried out by Surveyor John Richmond in 1883 shown in plan 1778A-1603. This survey was a re-survey of that section of road that was originally surveyed in 1863. In almost 50 years of cadastral surveying, these are the oldest marks sighted by the co-author of this paper. Adoption of the two rock marks strengthened the boundary fix of Lawrence Hargrave Drive (see sheet 4 of DP 1137408 in the appendix).

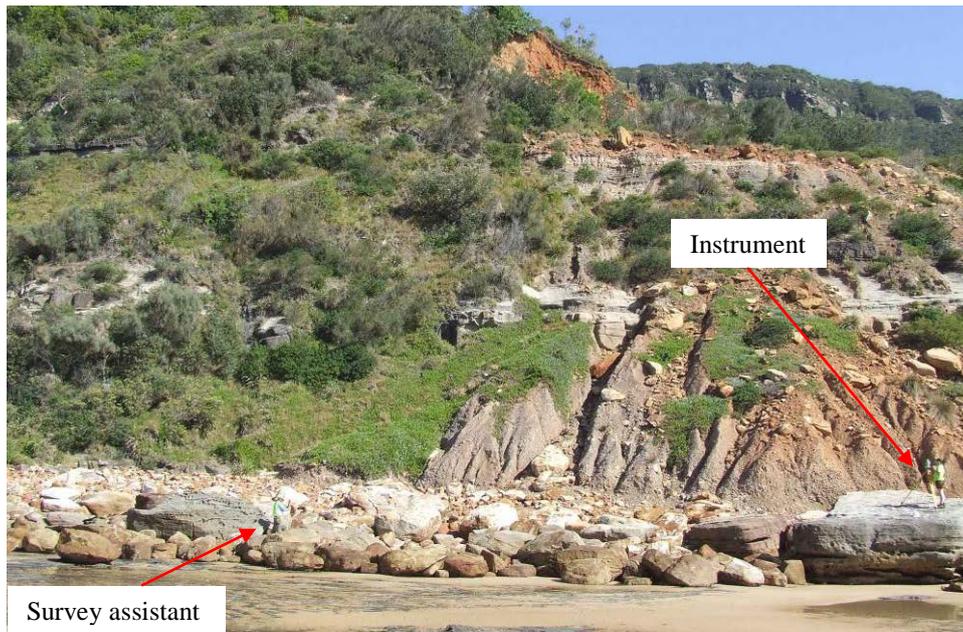
Figure 9: Searching for Surveyor Hall's rock mark.

The probability of finding the rock mark at the eastern end of the southern boundary of the 30.48-metre reserve at first appeared very small (Figure 9). The amount of slips on the side of the slope and the quantity of rocks on the rock shelf below suggested that the mark was, at least, inaccessible. However, as shown in Figure 10, the mark was located and found to be in good agreement with other traverse marks found from 3045-3000. Six traverse stations from 3045-3000 were found, as shown on sheets 1, 3 and 4 of DP 1137408, which enabled reinstatement of 3045-3000.

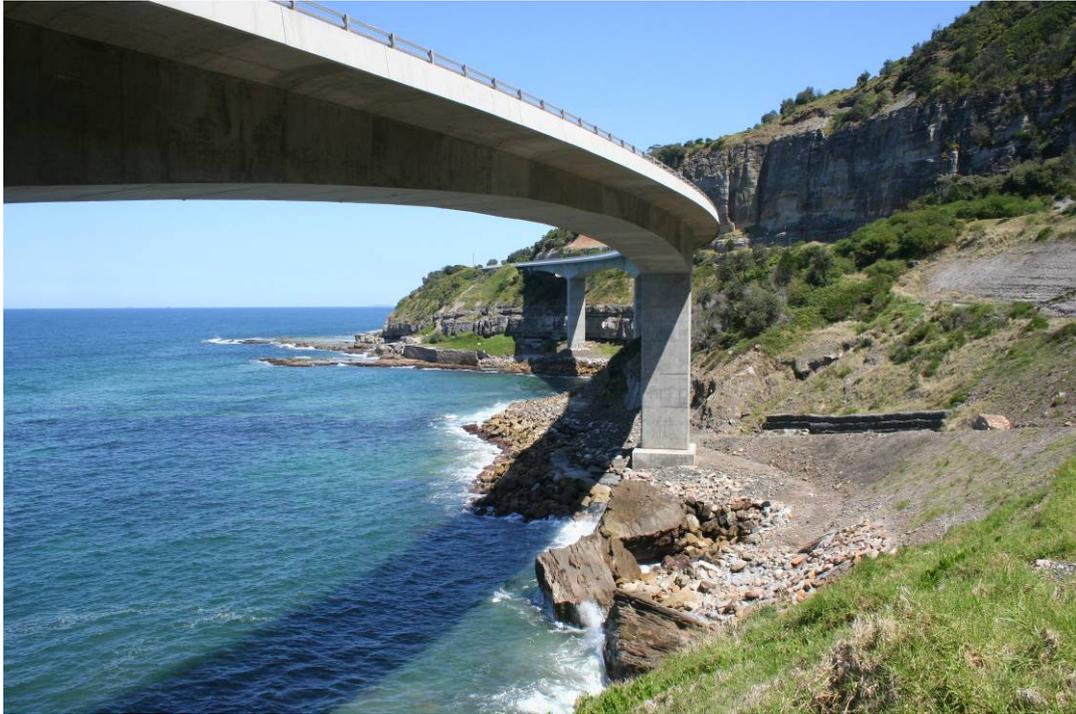
Figure 11: Pier constructed on land reclaimed from the sea bed.

Reclamation of some of the sea bed was carried out to allow construction of the piers on compacted land raised above sea level and for access tracks for construction of the piers. Figure 11 shows one of the piers constructed on compacted fill placed on the reclaimed sea bed.

The boundary of the reclamation was defined where the toe of the batter of the imported material forming the platform for the piers met the sea bed.
