Game of Stones... The Big Stone Alignment Posts of Ryde

Fred de Belin

City of Ryde Council

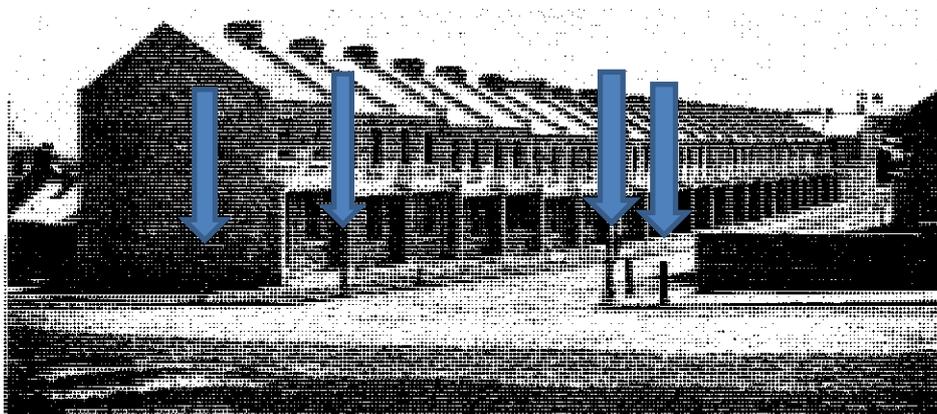
Figure 1: Timber alignment posts shown in an 1871 photograph of Buckingham Street, Sydney.

In 1833, legislation was introduced requiring the Surveyor General “to set out the breadth of the carriageways and footways in the town and cause the footways to be marked by posts at the corners and intersections” (Marshall, 2006). Consequently, alignment posts are survey marks (monuments) placed at intersections and bends in the roadways to indicate the kerb lines. The first alignment posts were 6 inch (150 mm) square, dressed hardwood timber posts and appeared in Sydney City from 1836 when 400 posts were ordered and placed (Figure 1).

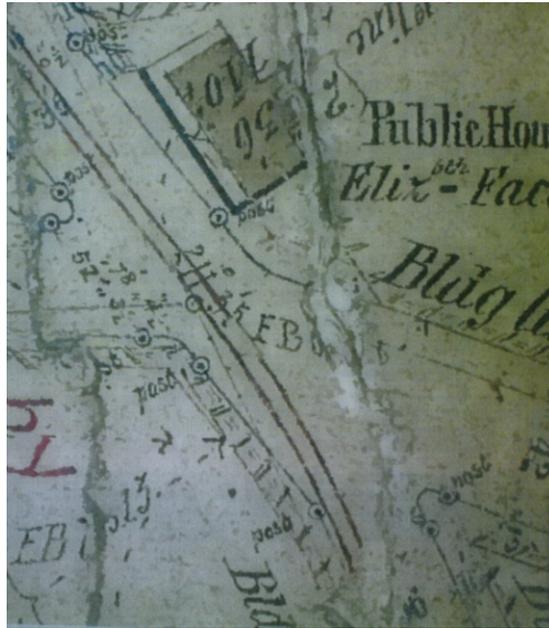
Figure 2: Part of alignment plan by Mr Surveyor George C. Hedgeland dated 1875, showing placement of timber posts at Belmore Street, Ryde.

The Council of the Municipality of Ryde was similarly placing timber alignment posts in 1875 (Figure 2).

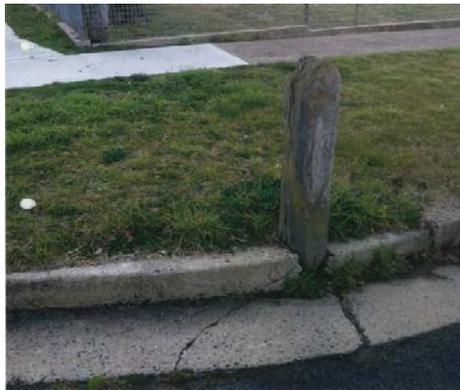
Figure 3: Typical timber alignment post – photo taken at Blayney, NSW in 2013.

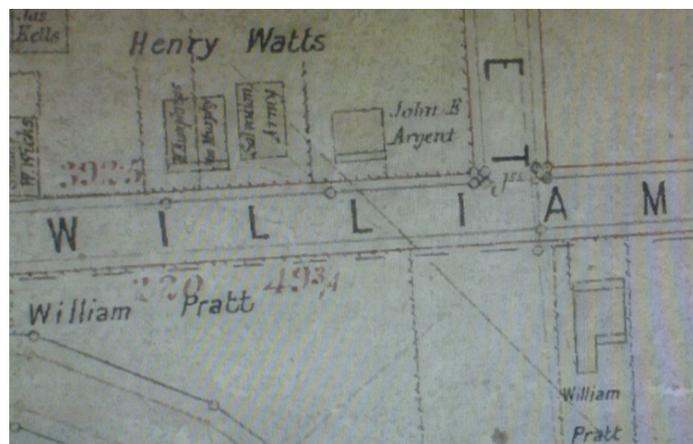
Figure 4: Part of an alignment plan in 1885, showing placement of stone alignment posts at a street intersection.

At a Council meeting on 19 September 1884, Council received a letter from “*surveyor enclosing plans of stone alignment posts*” and at the next meeting on 17 October 1884 approved payment for “*two alignment posts (specimen) 1 pound 0 shillings*”. At a Council meeting on 23 December 1884, Council proposed to accept “*the tender of P. McCarthy for furnishing 100 alignment posts at 5 shillings and 9 pence each*”. At a Council meeting on 23 January 1885, Council then approved the payment to “*P. McCarthy 28 pounds 15 shillings for 100 alignment posts*” (and in May 1885 to “*J. Hicks for providing 55 alignment posts at 5 shillings and 5 pence each*”). At the same meeting in January, a letter was received from the surveyor “*pointing out that some of the alignment posts supplied were not dressed square*”. Figure 4 shows part of an alignment plan with placed alignment post indicated, while Figure 5 shows a photograph of the same intersection.

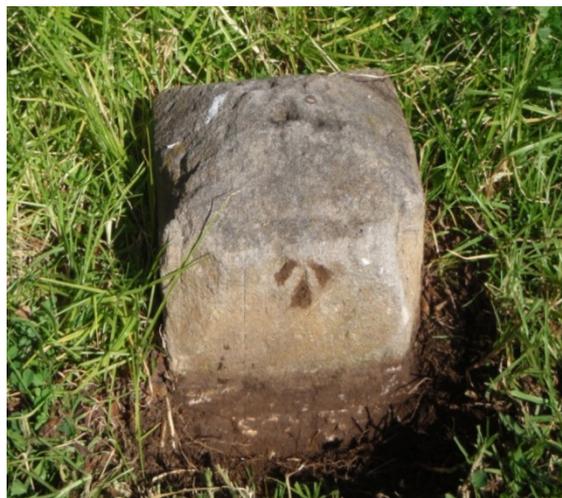
Figure 6: Stone 2, on North Road, Eastwood, showing the square dressed faces and weathered domed top. The stone has a broad arrow cut into one face, indicating that it was originally placed on a bend in the kerb line. This stone is in its original position.

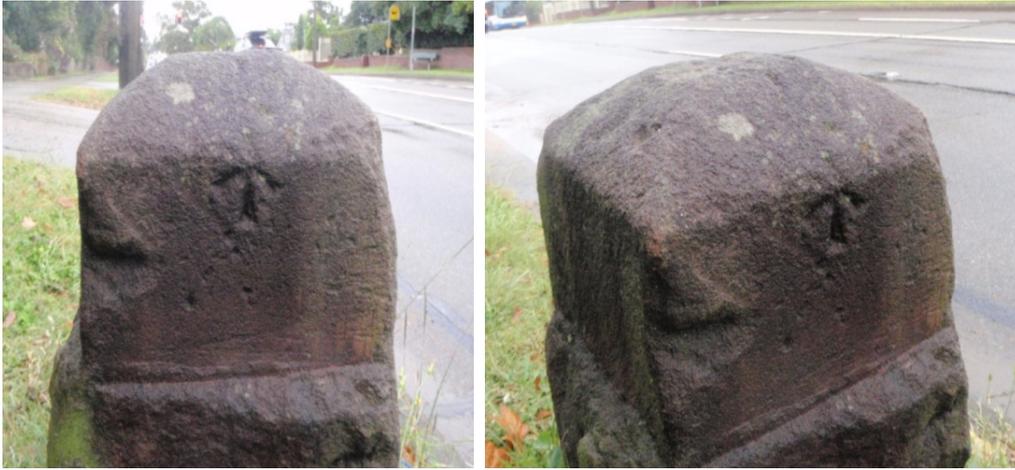
Figure 7: Stone 3, on Blaxland Road, Eastwood, showing the square dressed faces, domed top and rough-hewn base. The stone has a broad arrow cut into one face, indicating that it was originally placed on a bend or crest in the kerb line. The orientation of the broad-arrowed face indicates that the stone is not in its original position but has been moved and rotated.

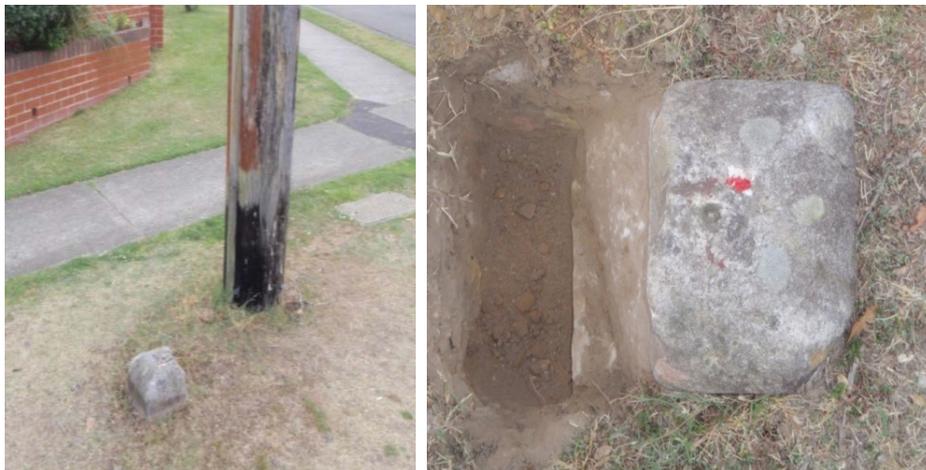
Figure 8: Stone 6, on Pittwater Road, North Ryde, showing the square dressed faces and domed top. The stone has had one face removed, but a shallow excavation reveals the true extent of the remainder of the stone. This stone is in its original position.

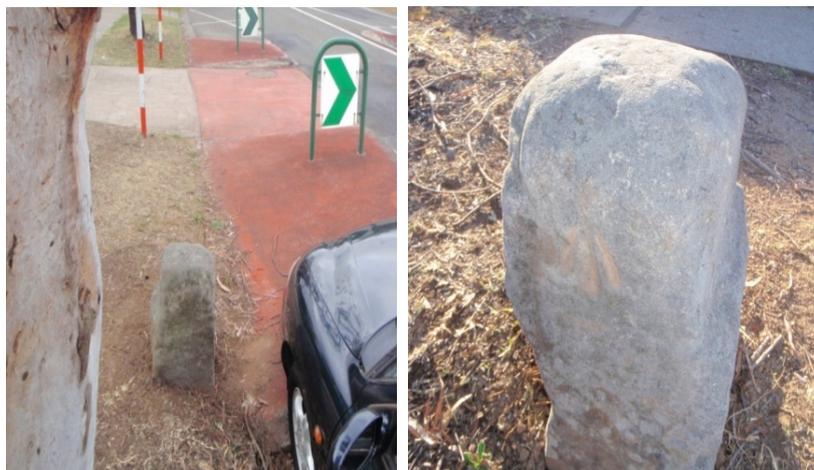
Figure 9: Stone 7, on Badajoz Road, Ryde, showing the square dressed faces, weathered domed top and rough-hewn base. The stone has a broad arrow cut into one face, indicating that it was originally placed on a crest in the kerb line. This stone is in its original position.

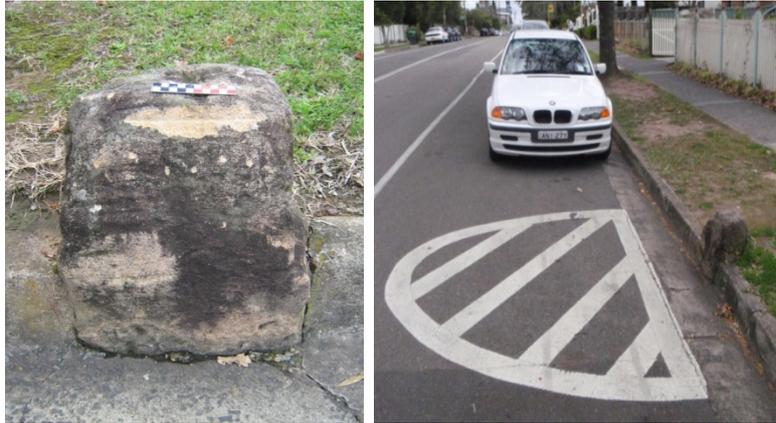
Figure 10: Stone 8, on Parkes Street, Ryde, showing the square dressed faces, weathered and damaged domed top and part of the rough-hewn base. The stone shows damage from vehicle scrapes, however painted line markings on the roadway have since helped to preserve the stone from further car strikes. This stone is in its original position.

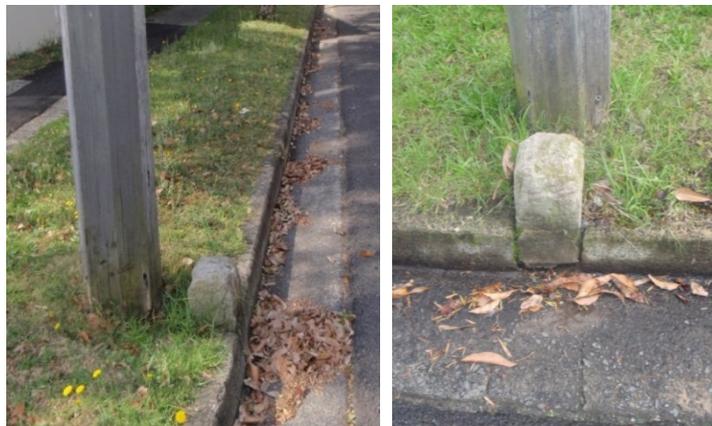
Figure 11: Stone 5, on Pittwater Road, Gladesville, showing the square dressed faces, weathered domed top and a startling revelation. This stone post is only 230 mm by 230 mm square (the sole stone post found in Ryde to date being of a smaller size). This stone is in its original position.

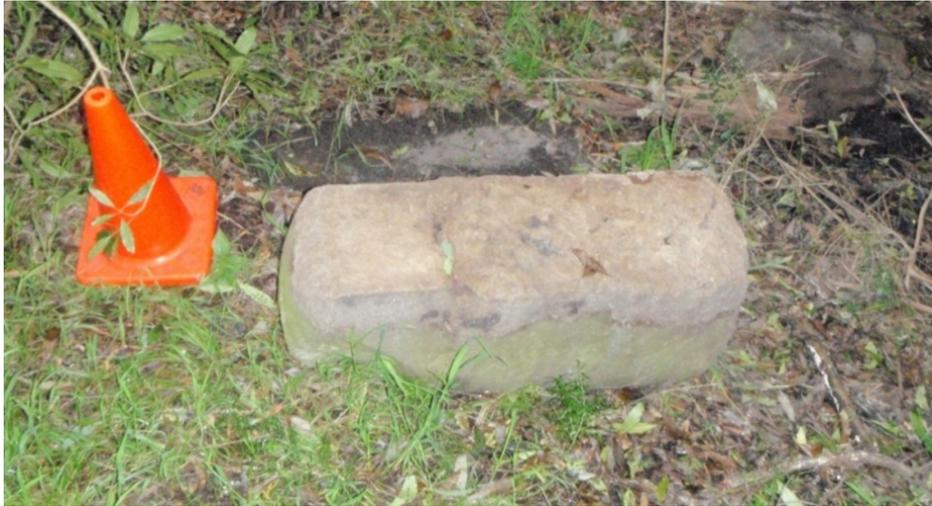
Figure 12: Stone 17, in Kitty's Creek bushland, East Ryde.

Then a moment of magic! Four stone posts were found in bushland at the site of an 1882 road intersection, waiting to be placed on alignment under the supervision of a Lands Department surveyor. The road is still unformed. This stone, which was never set into position, is in excellent condition (Figure 12) but does not fit the criteria to be heritage-listed. It provides the classic shape and dimensions of the big stone alignment posts of Ryde (Figure 13). This stone post, which has been donated to Land and Property Information (LPI) in Bathurst for inclusion in their survey mark museum, was retrieved from the idyllic bushland setting. One other identical stone post, to be used by the City of Ryde, was also retrieved at the same time. The two other stone posts were left in situ.

This was the first time Council's survey team was able to see several entire stones. The dimensions of each stone were identical. They were a massive weight, upwards of 240 kg each – estimated by using house brick volume and weight, but verified by a stonemason who quoted 2.6 tonnes per cubic metre as the norm for this type of sandstone. None of the four stones showed any broad arrow marking. The four stones had been laying there in the open for 128 years!

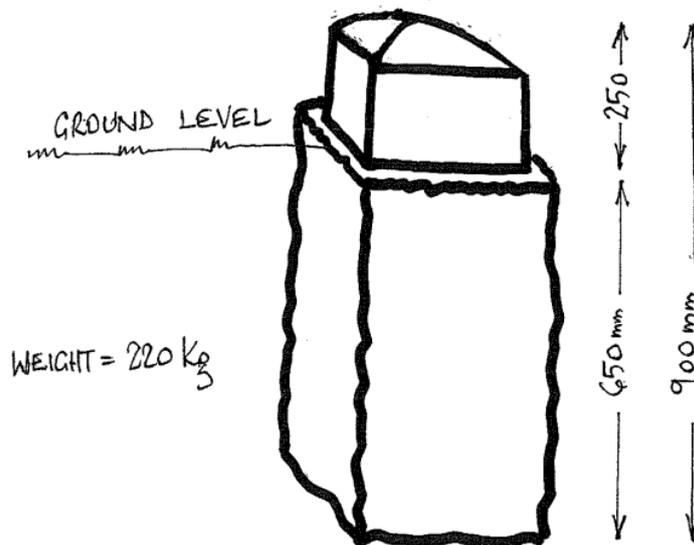
Domed top with dressed faces 300 mm x 300 mm.

Rough-hewn base 350 mm x 350 mm variable.

Figure 13: Classic shape and dimensions of the big stone alignment posts of Ryde.

As mentioned earlier, alignment posts are survey marks placed at intersections and bends to define the boundaries of roads, with one dressed face being aligned with the kerb line. When a stone alignment post was used to define a bend or crest in the road then a broad arrow mark was cut into one dressed face to indicate the bend in the kerb line. Why four dressed faces if only one is needed? The dressed top of the stone post stands above ground level and is therefore visible, so it may have been a matter of aesthetics.

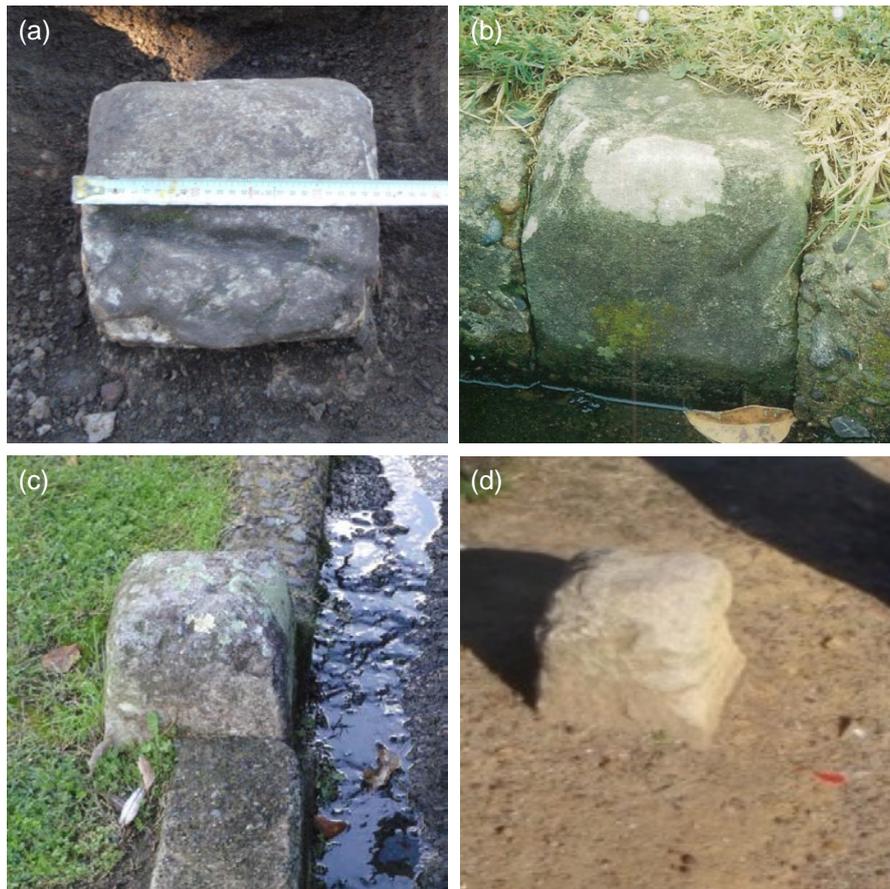
Figure 14: Alignment posts of (a) Hornsby, (b) Stockton, (c) Hunters Hill and (d) Parramatta.

At this point the Ryde Council survey team became interested in how much bigger these stone posts are when compared to the stone alignment posts found in other metropolitan locations (Figure 14). Although stones were used for alignment posts in these diverse districts, their size is much smaller: 230 mm x 230 mm square dressed faces. This results in the weight of the stone being half that of the big stones of Ryde. Could this have been a contributing factor in the downsizing? It would be interesting to find out if these smaller stones were, in fact, placed after 1885.

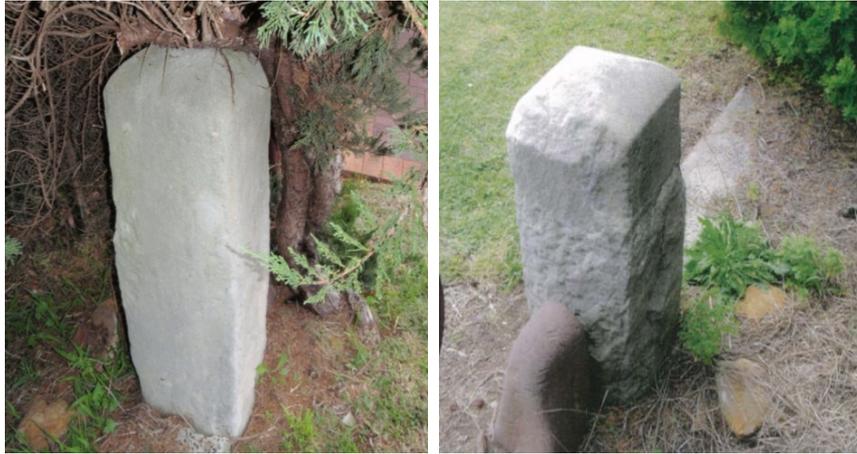
Figure 15: Stone 14, on Bridge Road, Ryde, showing a complete stone post which has been relocated sometime in the past and preserved to be used as a property corner post. This stone post cannot be heritage-listed as it stands on private property.

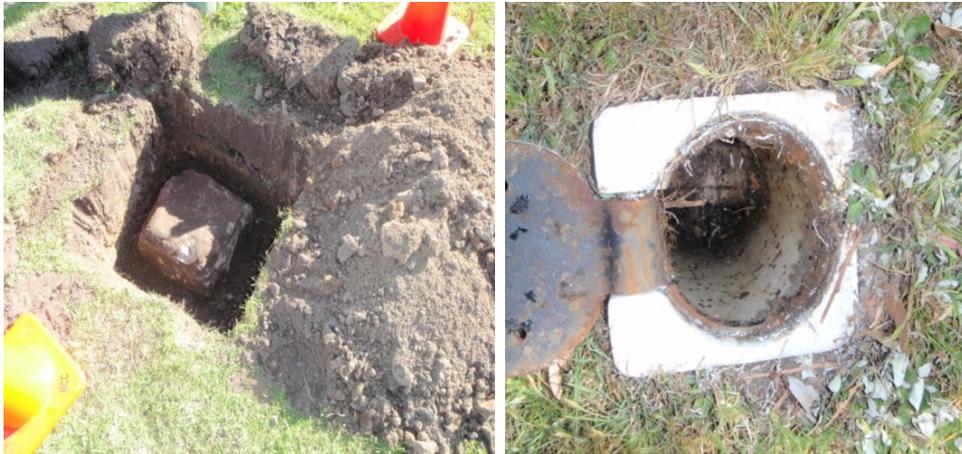
Figure 16: Stone 11, on Quarry Road, Ryde, showing that the domed top and dressed faces have been removed while the rough-hewn base still remains. Road works have raised the ground surface level, so a metal cover box enables access to the stone. Note that the survey mark (i.e. the dressed face) is gone, however comparative measurements, on all stones discovered so far suggest that an offset of 30 mm or 35 mm from the rough-hewn base closely approximates the position of the original dressed face. This stone is in its original position.

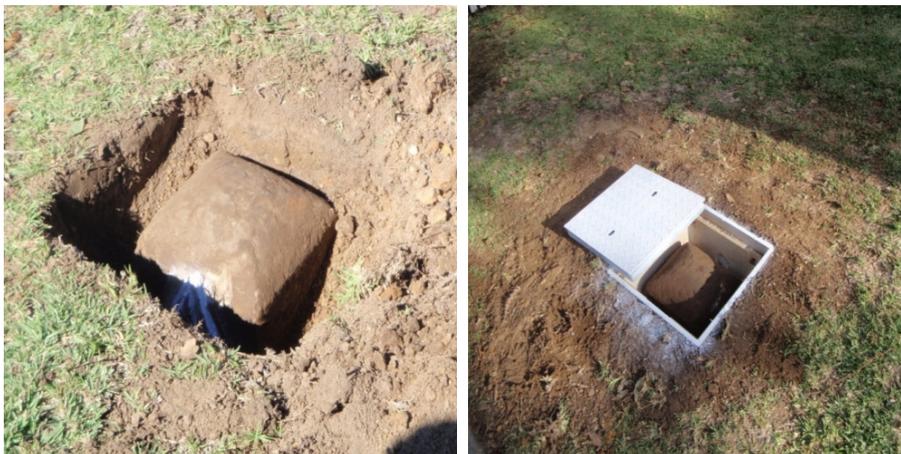
Figure 17: Stone 31, on Wolfe Road, East Ryde, showing domed top and 30 cm dressed faces. The stone has a broad arrow facing the road, indicating that it was originally placed on a crest in the kerb line. The stone has been buried for many years and now resides under an improvised metal cover. This stone is in its original position and in perfect condition.

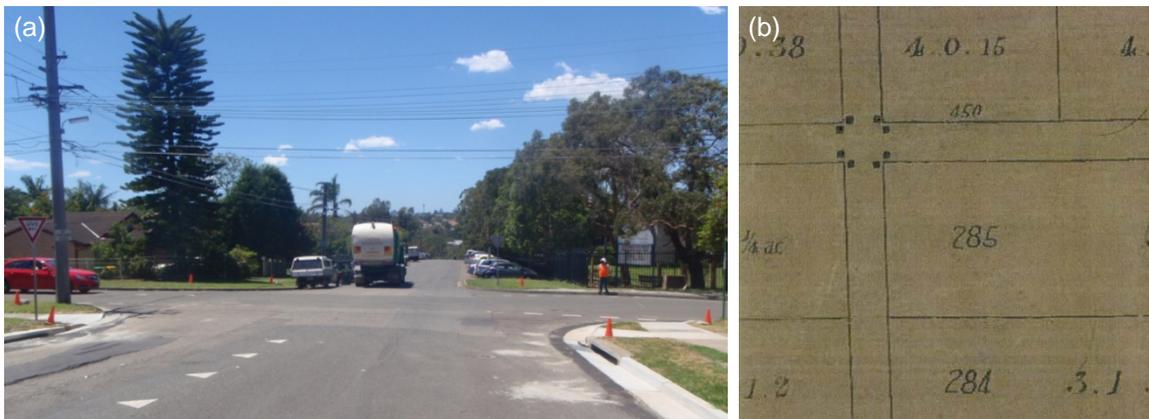
Figure 18: (a) Orange cones indicating the location of each of the stone alignment posts, and (b) part of an 1885 tracing showing the alignment survey at the intersection.

However, the Ryde Council survey team's best attempt at preservation has occurred at the Forrest Road / Malvina Street intersection (Figure 18). Here, seven of the original eight stones were found in place. It is intended that this intersection be maintained as a heritage site.

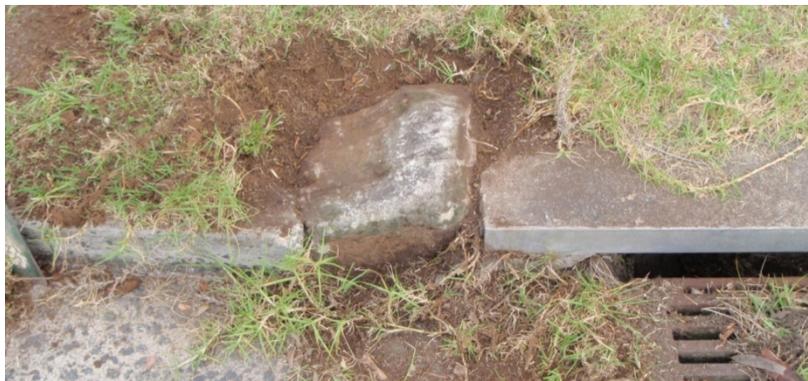
Figure 19: Damaged remainder of an 1885 stone alignment post on the Forrest Rd / Malvina St intersection.

During 2013, major road works were planned for Forrest Road. The works included replacing the existing concrete kerb and gutter on each side of the road. The damaged remainder of an 1885 stone alignment post was visible on the southern side of the intersection and had been incorporated into the old kerb (Figure 19). It was decided to replace this stone with one retrieved from Kitty's Creek bushland in order to have a full sized alignment post, with dressed faces, to enhance the intersection as a heritage site (Figure 20). It was, after all, a stone from the original 1885 alignment survey!

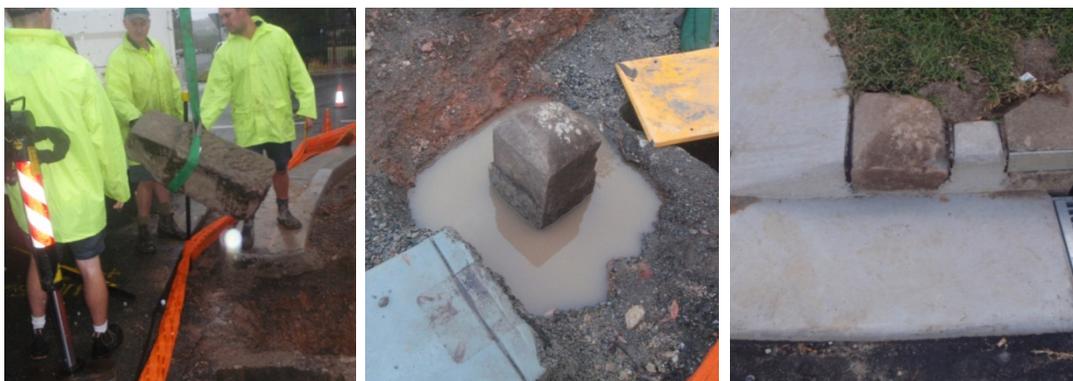
Figure 20: Setting of the replacement stone alignment post, which is now incorporated into the new kerb.

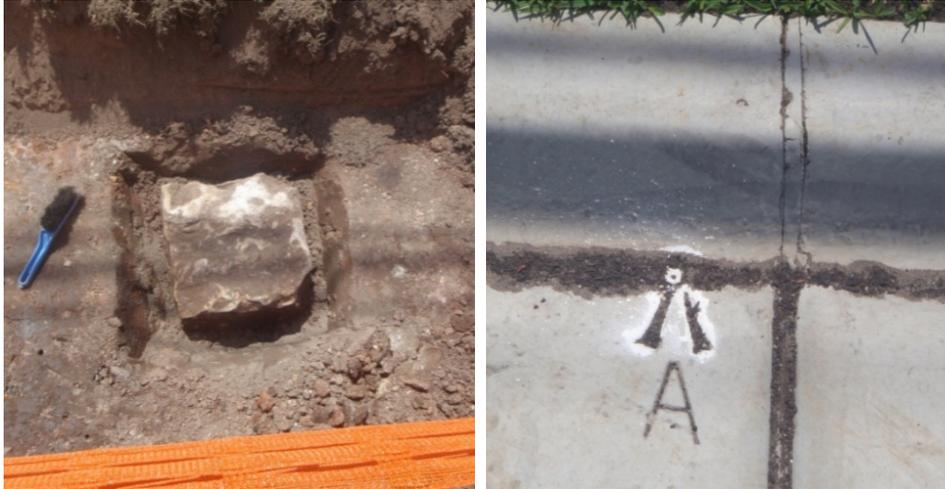
Figure 21: Remnant base of an original stone alignment post and distinctive survey mark placed above in the new concrete gutter.

At the other end of Forrest Road, removal of the old kerb had already exposed the base of an original stone alignment post. The dressed top had been removed by the previous construction. This remnant was left in place and re-hidden beneath the new kerb. However, a distinctive survey mark was placed above in the new concrete gutter by the Ryde Council survey team to indicate the position of the road alignment (Figure 21).

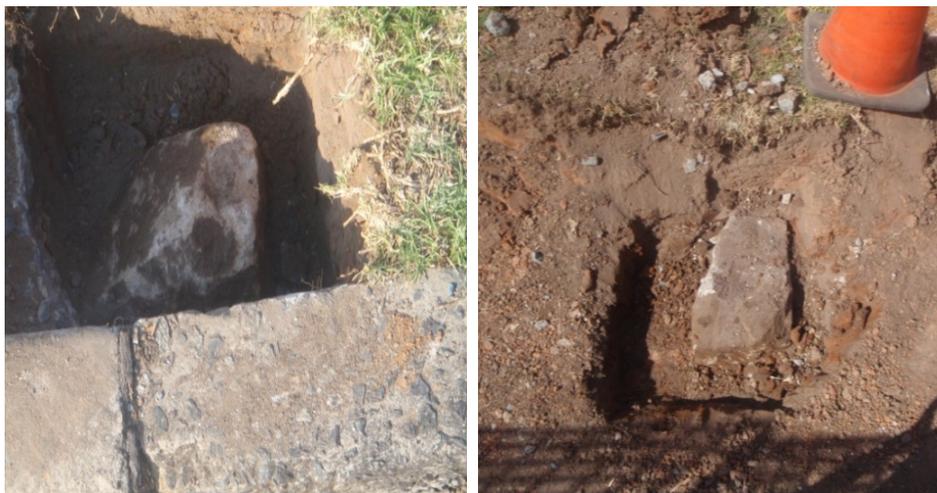
Figure 22: Badly damaged alignment post remains on the northern side of Forrest Road.

No stone was visible on the northern side of the Forrest Road intersection, and it was unknown if any part of that stone alignment post remained beneath the old kerb. A dig exposed stone remains, although badly damaged by previous drainage works (Figure 22).

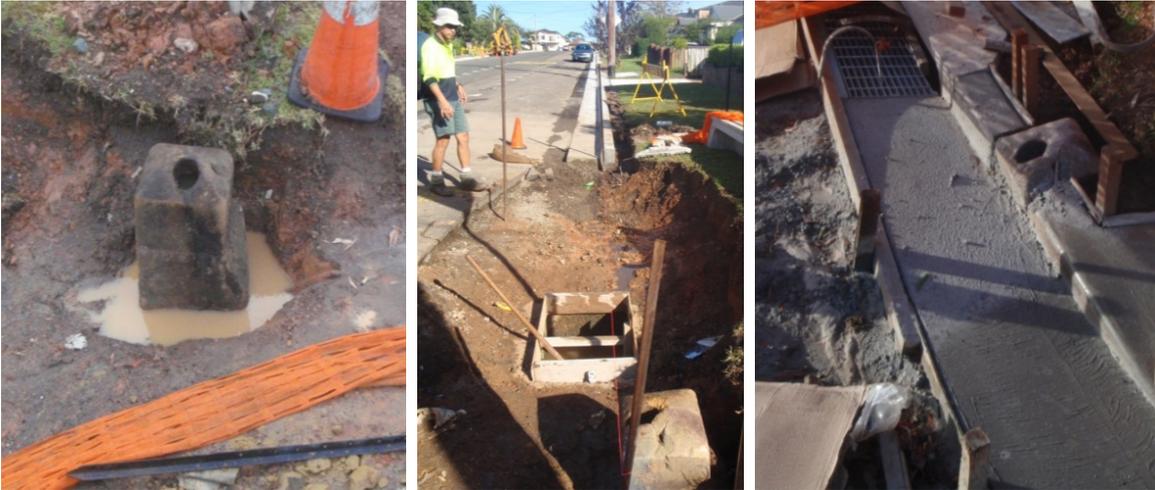
Figure 23: Construction of the new kerb and gutter, incorporating the replacement stone alignment post.

There was so little left of this stone that it was decided to re-instate another. One other previously retrieved stone alignment post was available from the 1885 survey (stone 28), which has a substantial part of its base removed and a large post-hole drilled into its domed top. Construction of the new kerb and gutter incorporated the replacement stone alignment post (Figure 23). So yes, the new concrete kerb is laid on the kerb line! A patch-up job to fill the hole to restore the domed top is currently underway.

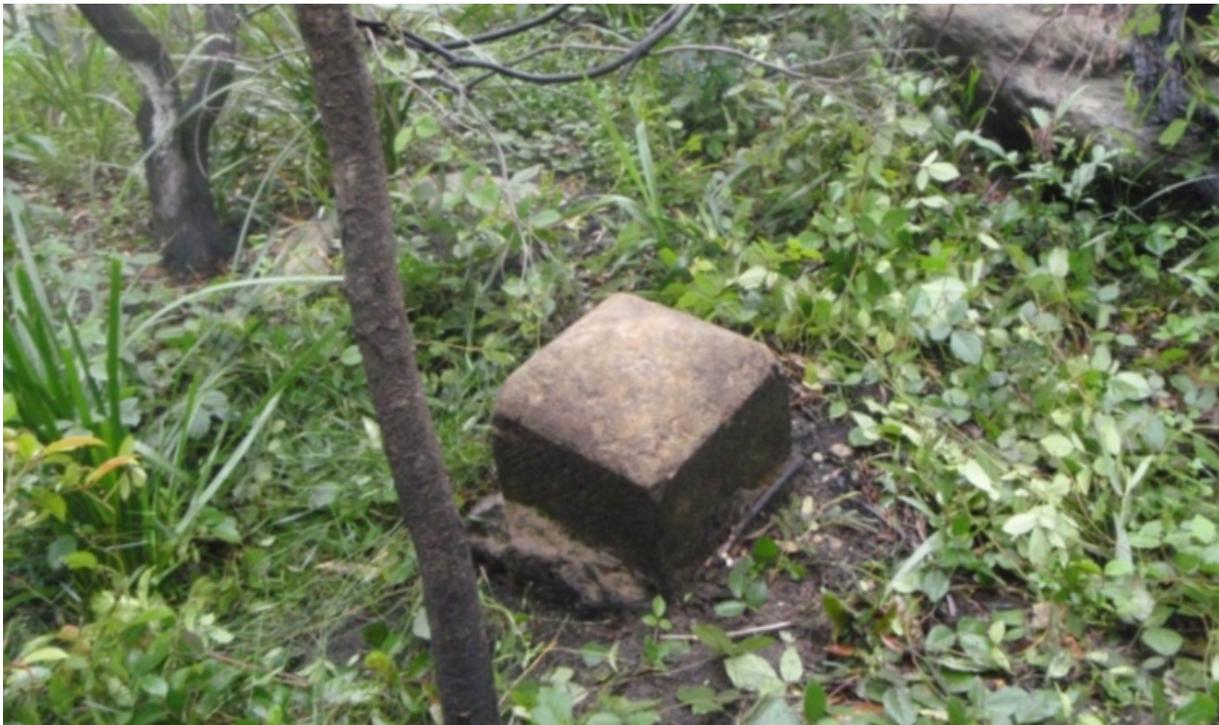
Figure 24: Stone 34, on Pittwater Road, North Ryde, showing remarkable preservation after so many years.
This stone is in its original position.

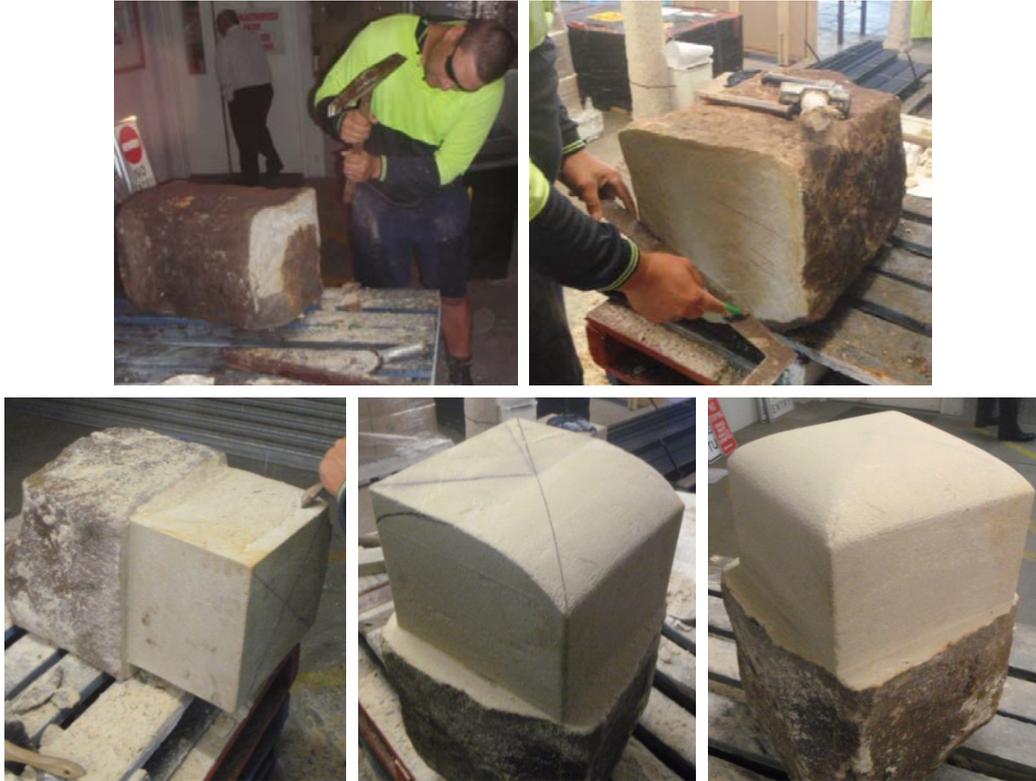
Figure 25: Dressing of a stone alignment post using traditional methods and hand tools. Firstly, an even surface from which to measure is created. Then the four squared faces are chiselled and the domed top is created.

What to do with the damaged stone alignment post retrieved from the southern intersection? It was removed with the mad idea to re-dress one end of it into a domed top with four squared faces. Ryde Council has a stonemason by happenstance, who agreed to give it a go, using basic hand tools. Just how difficult would it be to replicate the work of the 1885 artisans? The exercise of recreating a dressed stone post took the stonemason about one day (Figure 25). As yet, no plans have been made to use this stone at any site.

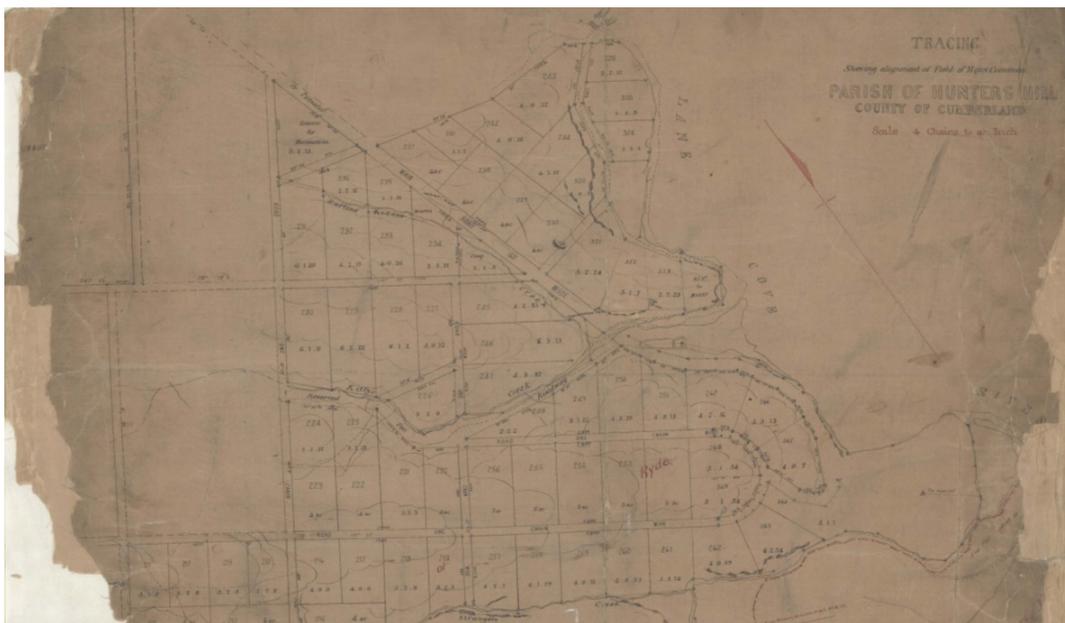
Figure 26: Part of his 1885 tracing showing alignment of roads in Field of Mars Common.

And just who was that Lands Department staff surveyor who, so many years ago, recommended that stone alignment posts be used in Ryde, and that they should be so big? He was registered in 1880. In 1881-82 he undertook Crown Land subdivision work at Ryde, followed in 1885 by numerous alignment surveys in the same area (Figure 26).
