PROCEEDINGS OF THE
APAS2015 CONFERENCE

16-18 MARCH 2015

PRESENTED BY THE ASSOCIATION OF PUBLIC AUTHORITY SURVEYORS

20th Annual Conference, Association of Public Authority Surveyors (NSW) Inc.
(incorporating 90th Annual Conference, NSW Staff Surveyors Association Inc.)

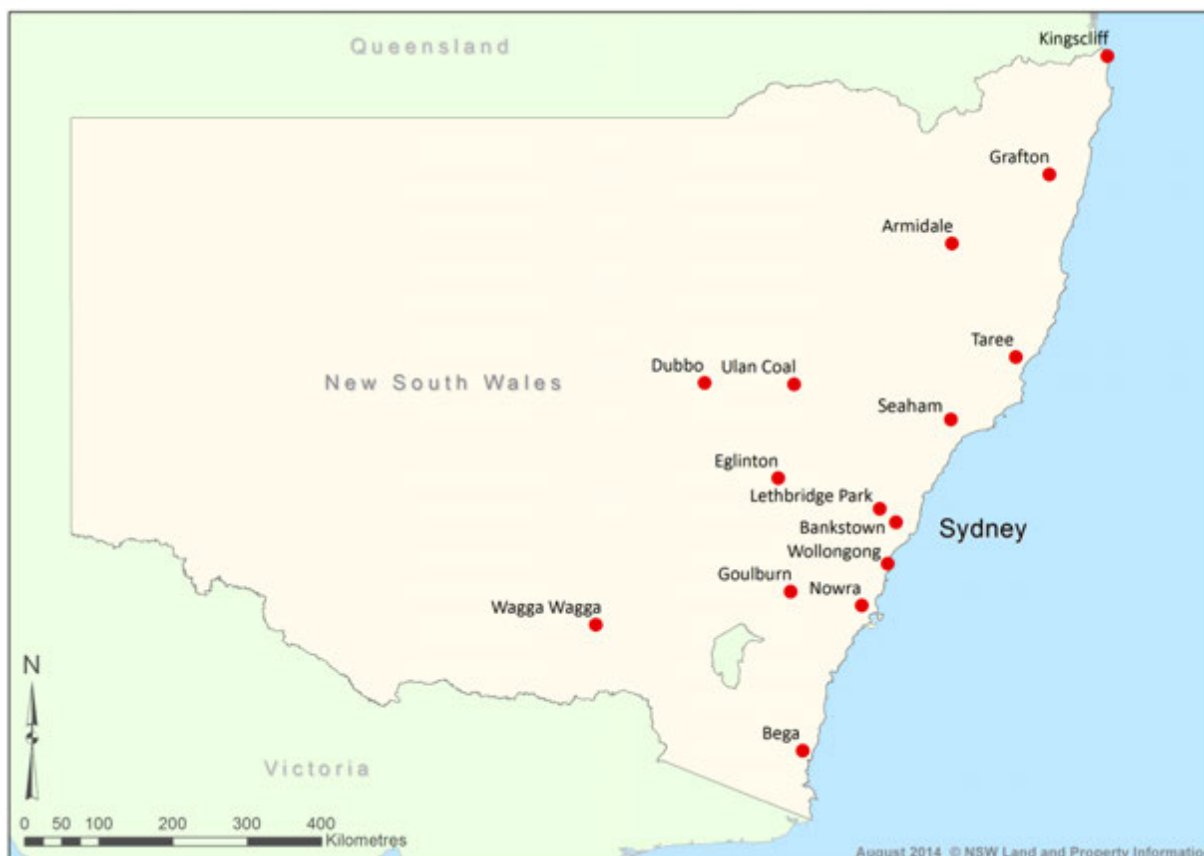
Figure 1: Location of current EDM baselines in New South Wales.

All EDM baselines in NSW (current and those under construction) follow the Heerbrugg design (also known as Schwendener design), which features an almost equal distribution of the distances measured in all combinations over the baseline length as well as over the unit length of the EDM instrument and permits the detection of all distance-dependent errors, including cyclic errors (e.g. Schwendener, 1972; Rüeger, 1996).

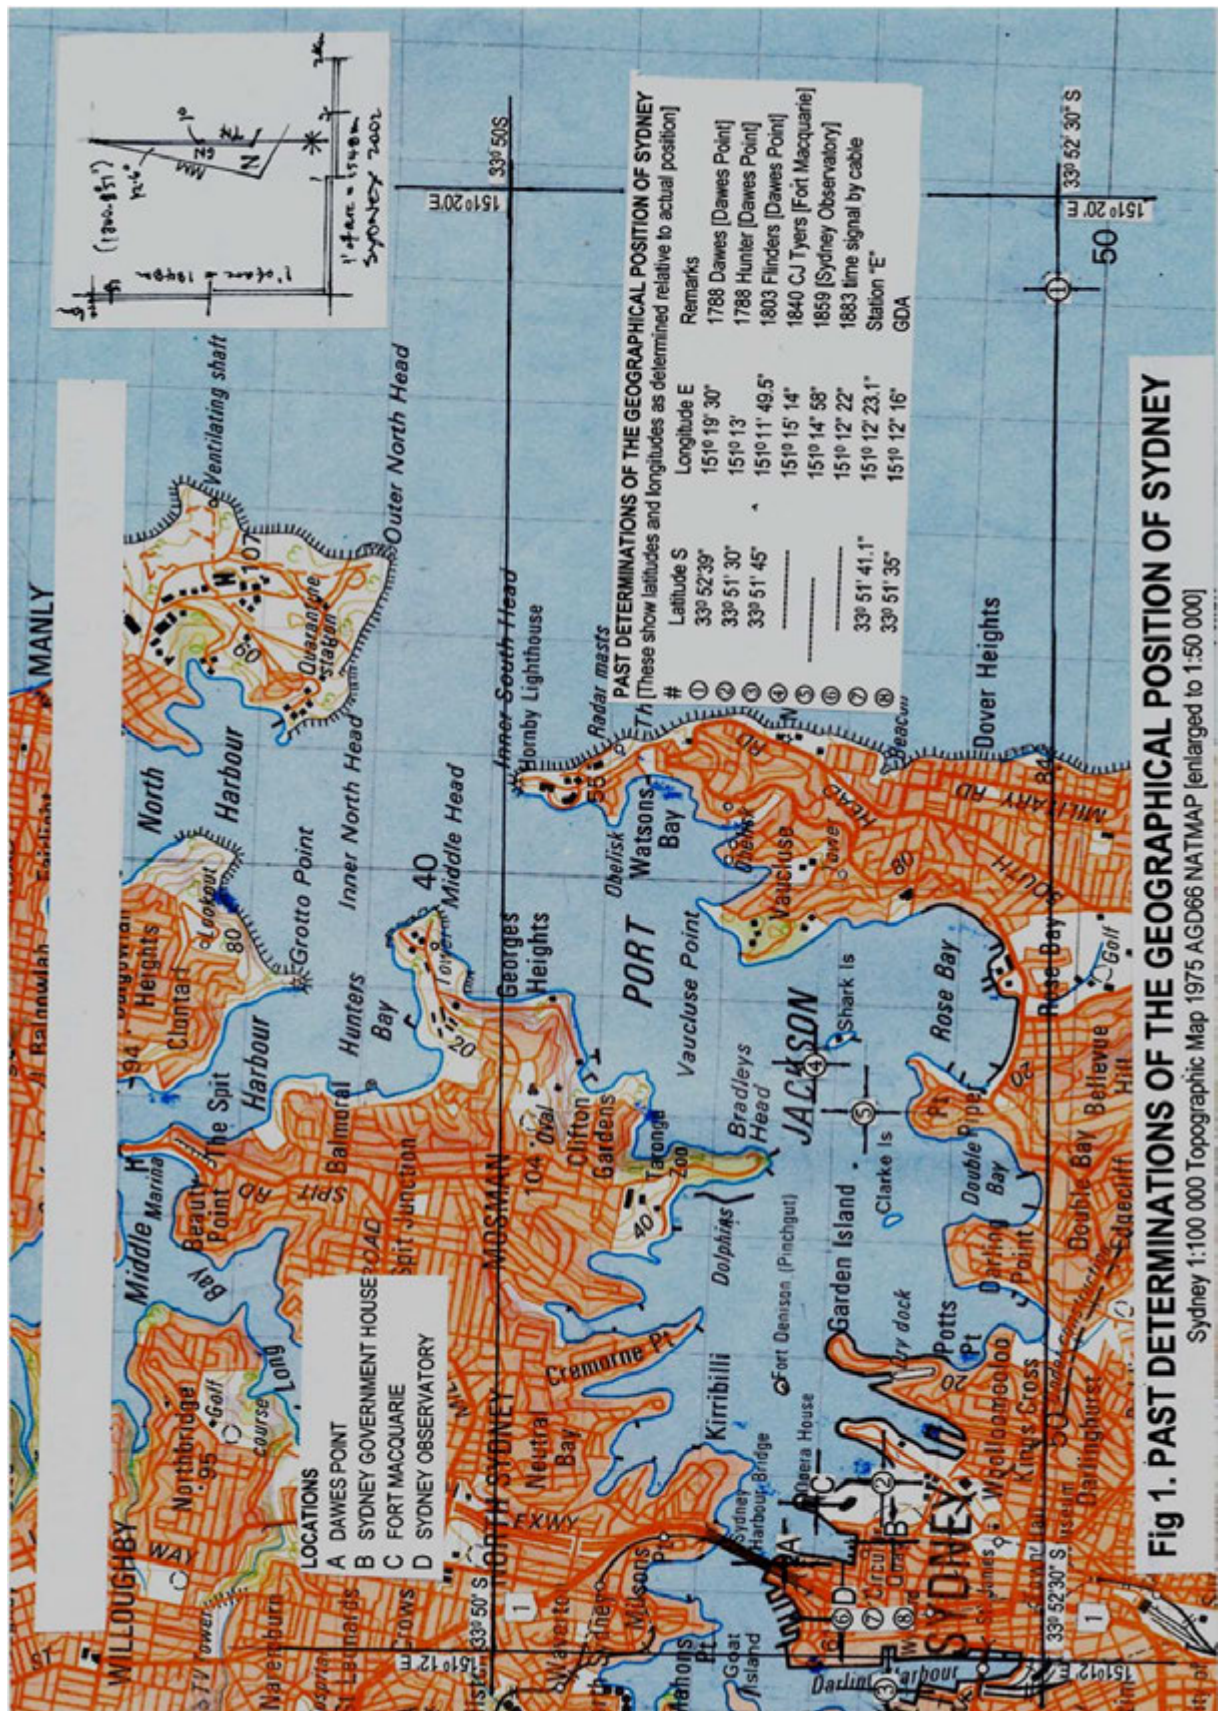
Figure 1: Past determinations of the geographical position of Sydney.

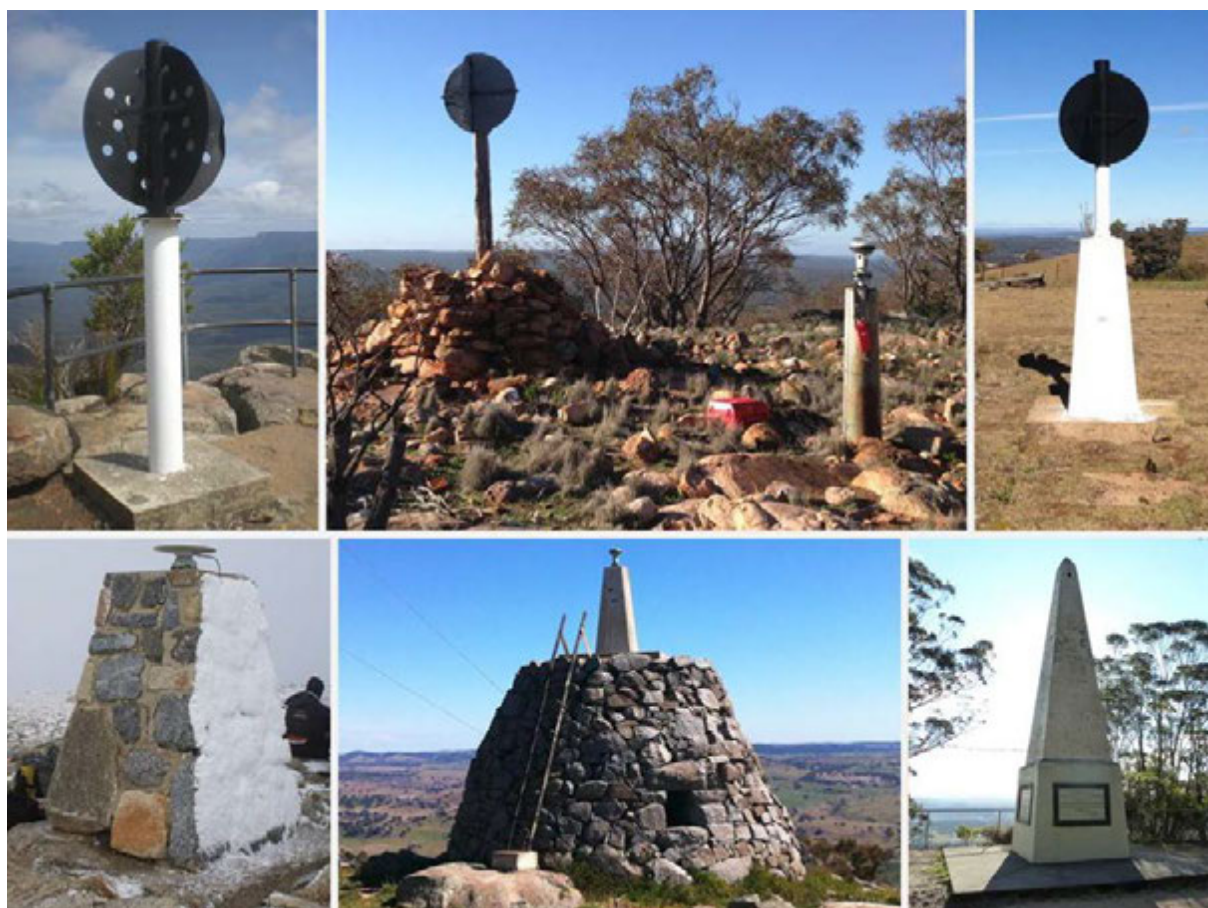
Figure 1: Trig station monuments in NSW. Clockwise from top left: Steel pillar, cairn and astro pillar, concrete pillar, obelisk, concrete pillar on grand cairn, and stonework veneer on concrete pillar.

come in a variety of forms and structures and usually consist of a primary monument or standpoint surrounded by witness or eccentric marks. The primary monument can take on a multitude of forms, ranging from survey pillars (concrete or steel) to plugs in stone underneath rock cairns or in rare cases galvanised iron pipes or stainless steel rods in soil. It should be noted that all CORSnet-NSW stations are also trig stations – these are known as ‘active’ trigs. Figure 1 illustrates the large variety of traditional trig station monuments in the NSW survey control network. Sometimes these marks have very high historical significance and are usually located in very prominent locations. Lighthouses, church spires, radio masts and tall towers are other forms of trig stations that are sometimes encountered.

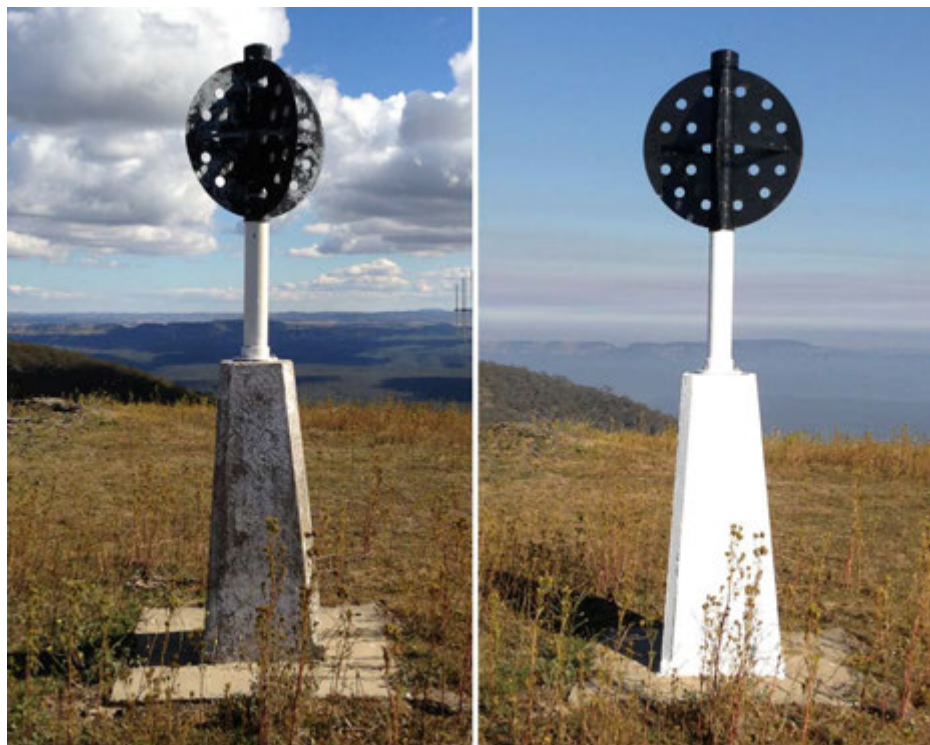
Figure 5: TS1730 Cumber before and after trig maintenance.

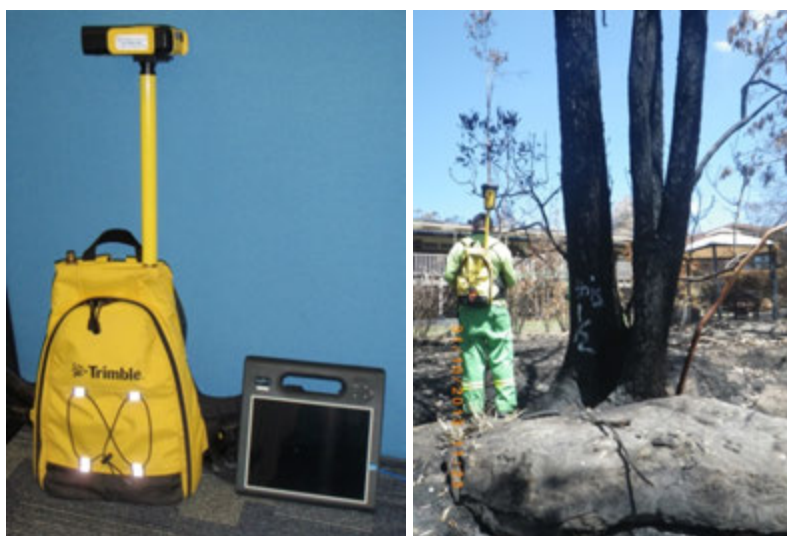
Figure 5: Survey equipment (left) and survey with external antenna (right).

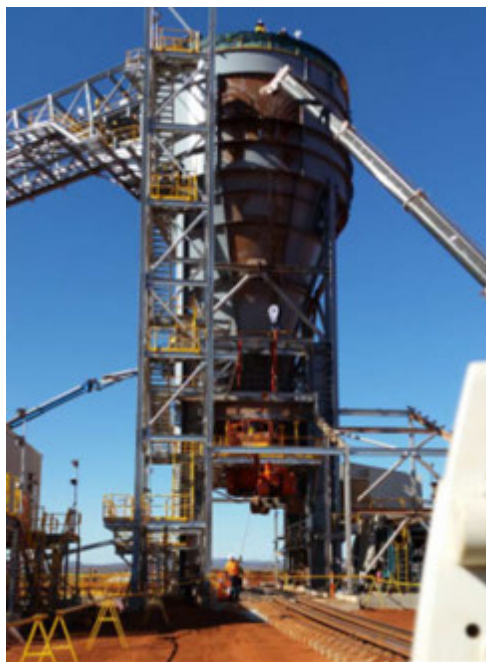
Figure 1: Train load out structure.

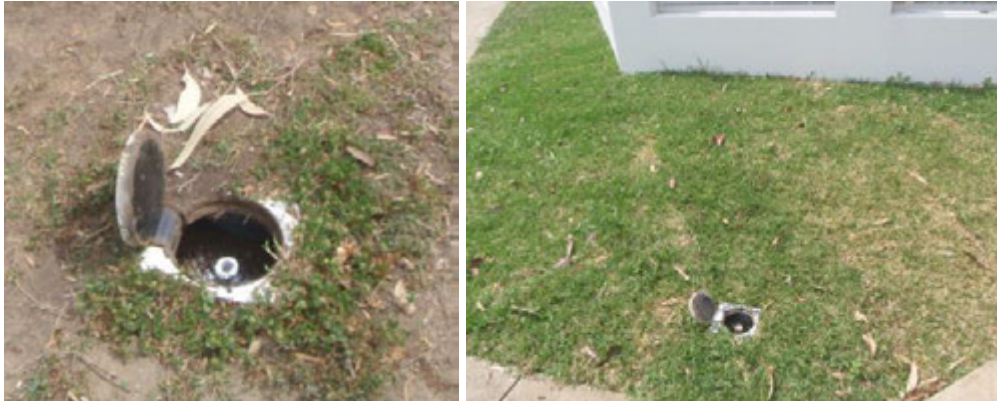
Figure 7: GI pipes found at two intersections: Beaumont Ave, Denistone and Moira St, Denistone West.

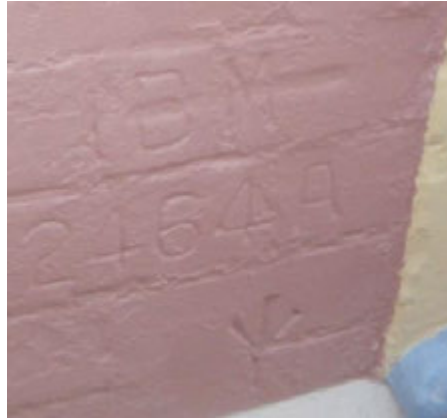
Figure 17: Very old Survey Bench Mark in face of a heritage building in Parramatta.

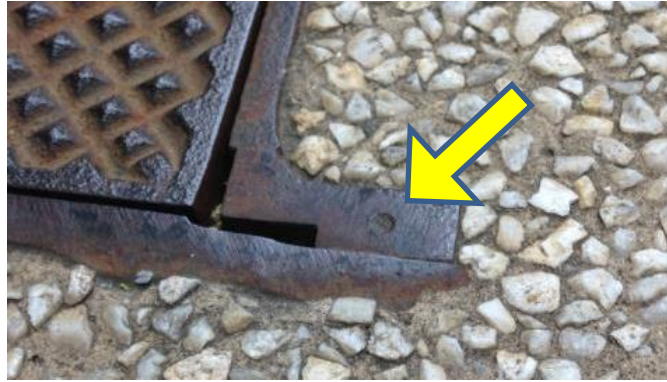
Figure 23: Drill hole found placed in lid frame at UNSW.

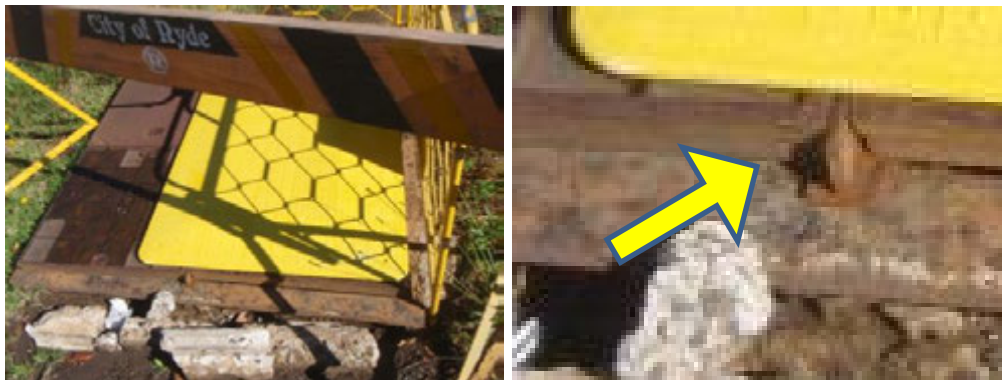
Figure 24: Telco pit with major damage, including missing concrete and metal frame.
