# Forensic Fencing... The Dark Art of Re-Defining an Old DP (or the Problem with Using Just the Street to Fix the Street)

**Fred de Belin**

City of Ryde Council

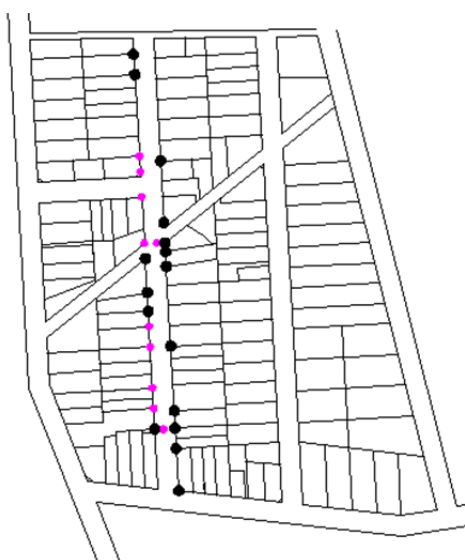
Figure 4: Survey reference marks in Grand Avenue, as placed (dots) and as found (black dots).

Who is going to pass up two beautiful reference marks, either side of the job (Figure 4), or investigate the definition on which they were placed, or determine whether they were even placed correctly? Registered plans from the LPI are gospel, right?

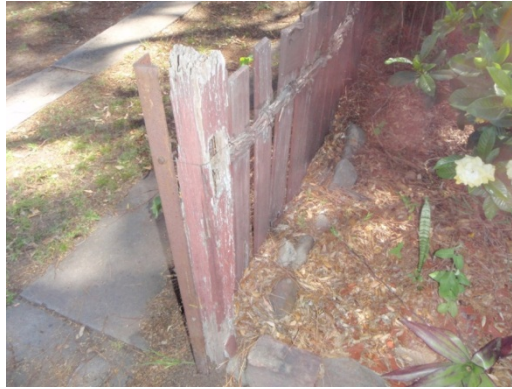
Figure 5: Old and disintegrating timber fence with palings retained and preserved by wire ties.

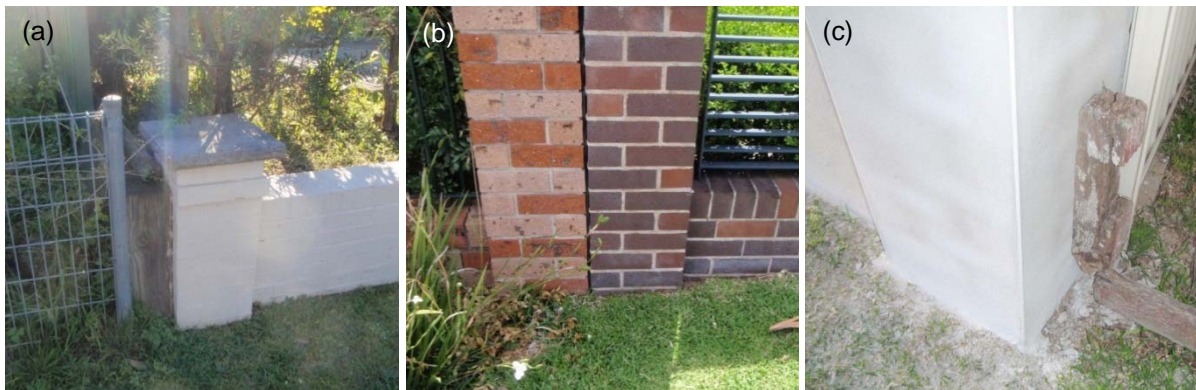
Figure 6: (a) Timber fence with brick pier abutting, (b) brick piers abutting at a side boundary, and (c) old post retained as new front and side fences are erected.

Which point best defines or represents the fenced line? Is it the centreline of a fence, the face of a fence, or some other feature of the fence structure? A fence obviously has a thickness, depending on whether it is made of timber (Figure 6a), brick and masonry (Figure 6b), metal tray (Figure 6c), or any other material.

- New fencing ending at a very old post (Figure 6c).
- Evidence of a former post by such clues as paint silhouetting (Figure 7a).
- Fence rail slots in the back of brick piers.
- Edge of poured concrete (Figure 7b – note evidence of a previous brick pier, a previous fence post, a previous line of paling fence and the cut-off base of a metal post at ground level).

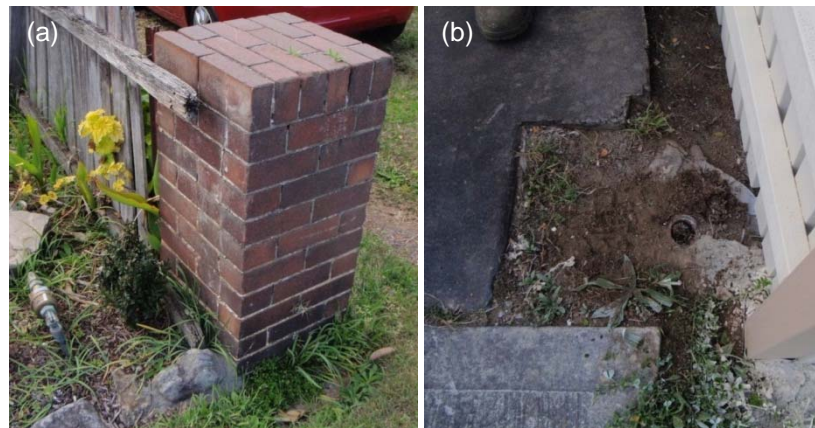
Figure 7: (a) Silhouette of removed timber post outlined on the brick pier by old paint, and (b) evidence of several previous fence structures.

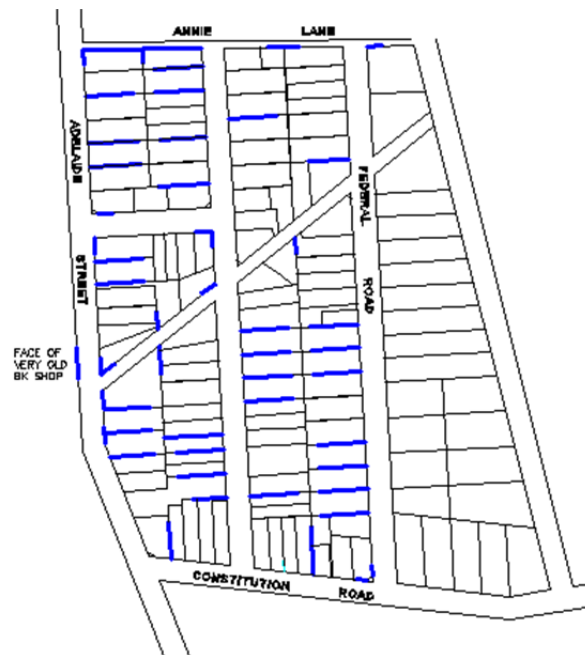
Figure 12: Additional occupations and fencing (within 50 mm) at street corners and bends.

Confirmation that a reliable boundary fix of the old DP 4516 (1905) had been achieved was apparent when the occupations at bends and intersections in surrounding streets were compared (Figure 12).

In Adelaide Street and Annie Lane, occupations stand within 50 mm of the street boundaries. Of particular note is that the 'face of very old brick shop' is only 10 mm off line. This face of the shop has been adopted by surveyors for decades as defining the boundary of Adelaide Street! The resultant bearing for Grand Avenue, after investigating the relevant side fencing occupations, is 6°27'55". This compares to 6°26'05" in DP 1210616 (2015).

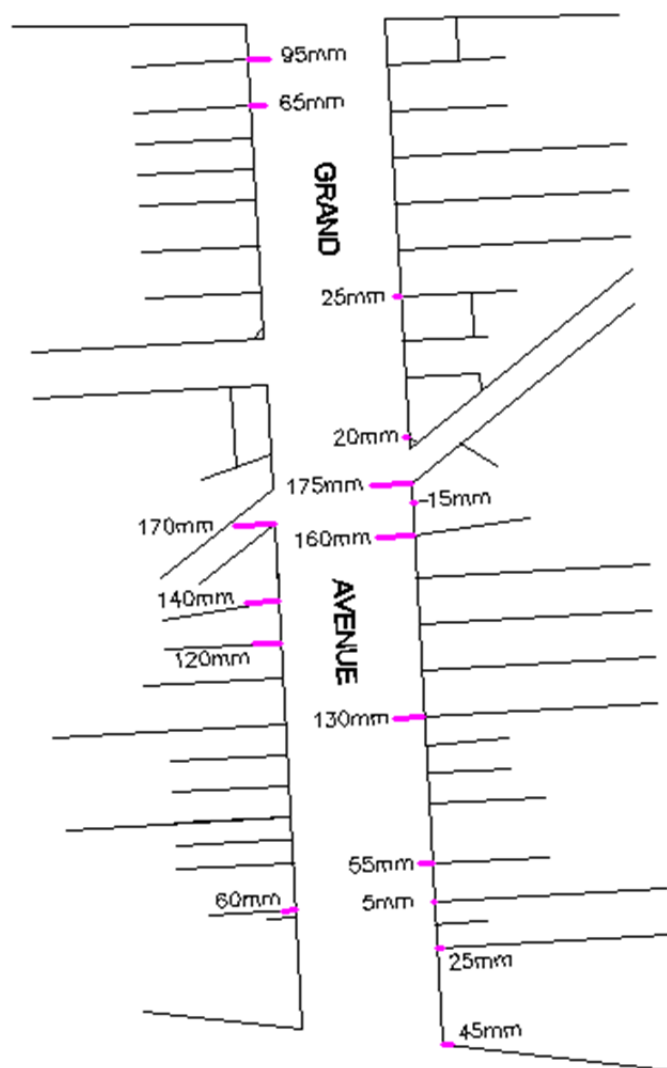
Figure 13: Street boundary fix by reference marks (pink) compared to street boundary using only side fencing.

A comparison between the street fix by side fencing and the street fix by reference mark is shown in Figure 13. The differences show where the reference mark street fix is in relation to the re-defined old DP boundary.
