## Railway Underbridge Renewal at Granville

Ian Jones

Sydney Trains

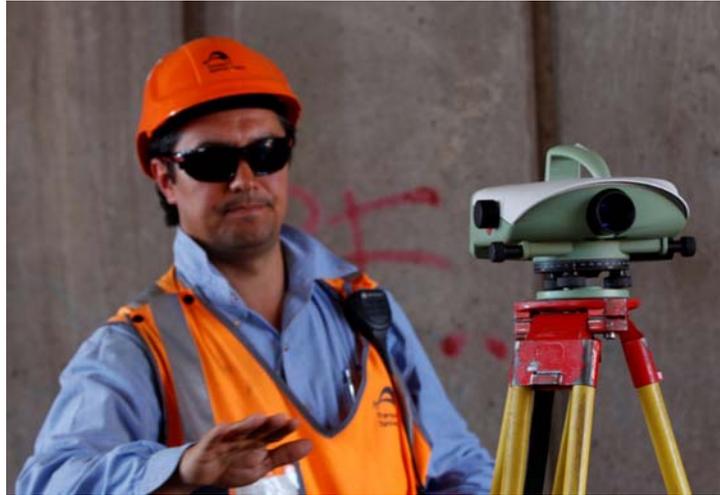
The construction of the rails for the jacking mechanism started in the early hours of Boxing Day, and the survey teams successfully worked closely with the contractors to ensure the jacking mechanism was positioned to the required tolerances (Figure 3). After the existing girders were stripped down and removed and the abutments exposed (Figure 4), the surveyors were involved in marking out bearer plate locations, core holes and the beam locations in both the horizontal and vertical dimension, ready for the new girders to be brought in.

Figure 3: Mark that!

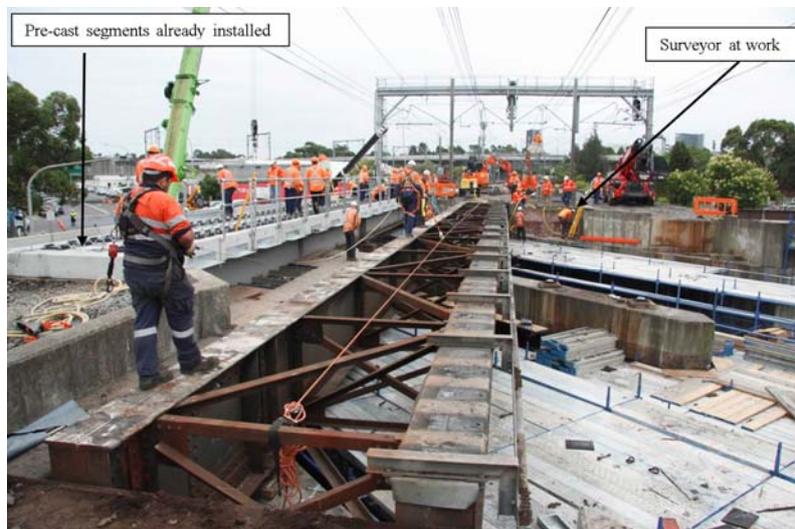
Figure 4: Removing the old girders.
