Rural Cadastral Survey of Crown Land for Aboriginal Land Grant under the Aboriginal Land Rights Act

Anthony Oliver

Registered Land Surveyor, ADW Johnson Pty Ltd

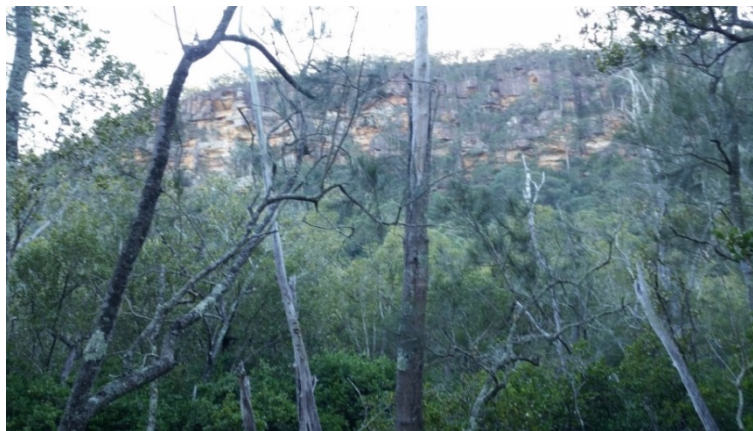
Figure 2: View of the escarpment along the northern boundary of lot 14, from Hawkesbury River bank.

Terrain: The region is mountainous and there are several areas where there are significant cliff escarpments (100 m or higher) combined with smaller drop offs, often not visible due to the thick vegetation. Consequently, it was necessary for all personnel to be well aware of their surroundings, maintaining a safe working distance from cliff faces and drop offs, whilst ensuring fatigue is managed to avoid heightened risk due to a lack of awareness (Figures 2 & 3).

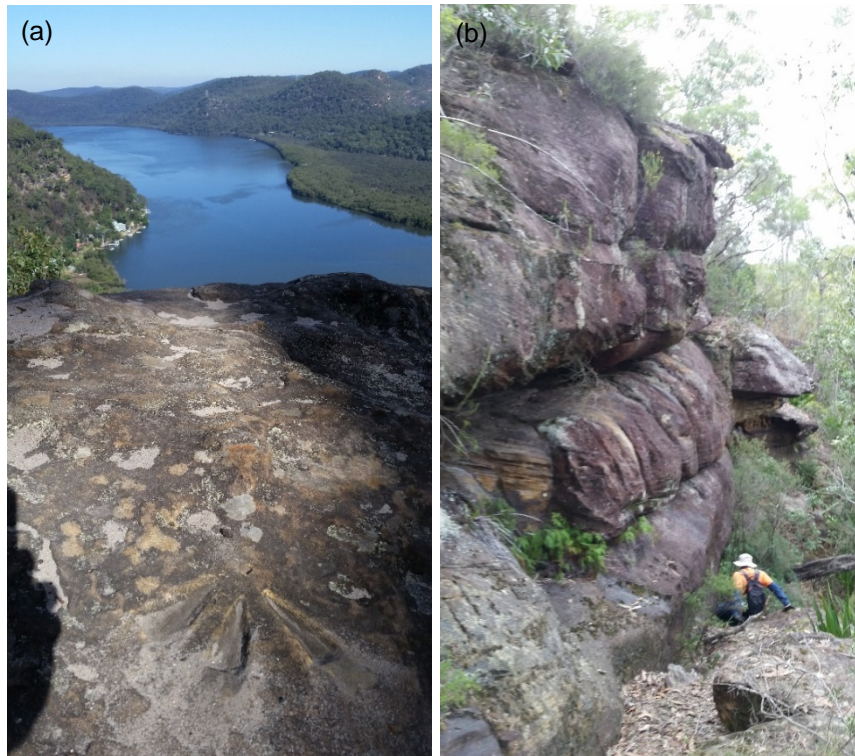
Figure 3: (a) View from the southernmost corner of lot 10 south to Marlow and the Hawkesbury River, and (b) access to TS4746 Mount White.

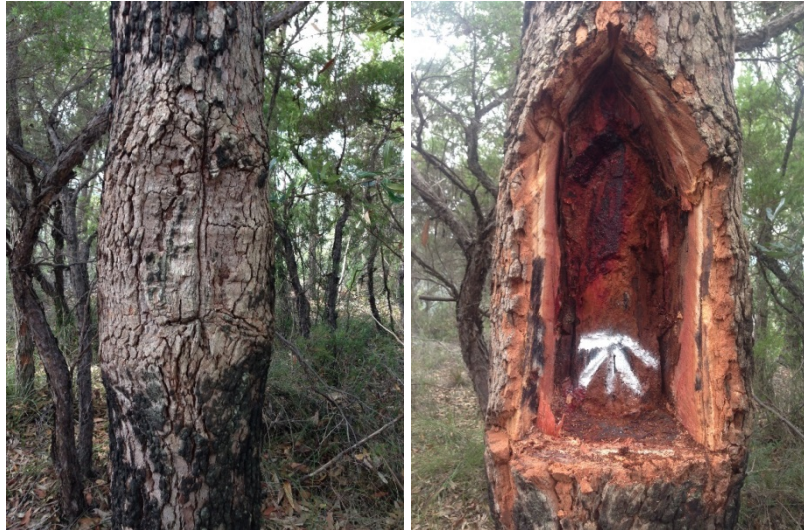
Figure 4: Opening a shield (before and after).

Chainsaw use: As this is a rural survey, many of the marks and reference marks were trees, particularly in the northern and western sector of the project. In accordance with the Surveying and Spatial Information Regulation, it is also necessary to clear and blaze the boundary lines in the course of completing the survey. Consequently, it was determined that chainsaw use would be a regular requirement during the course of the survey to expose reference tree shields (Figure 4) and also increase the speed with which boundaries could be cleared and blazed.

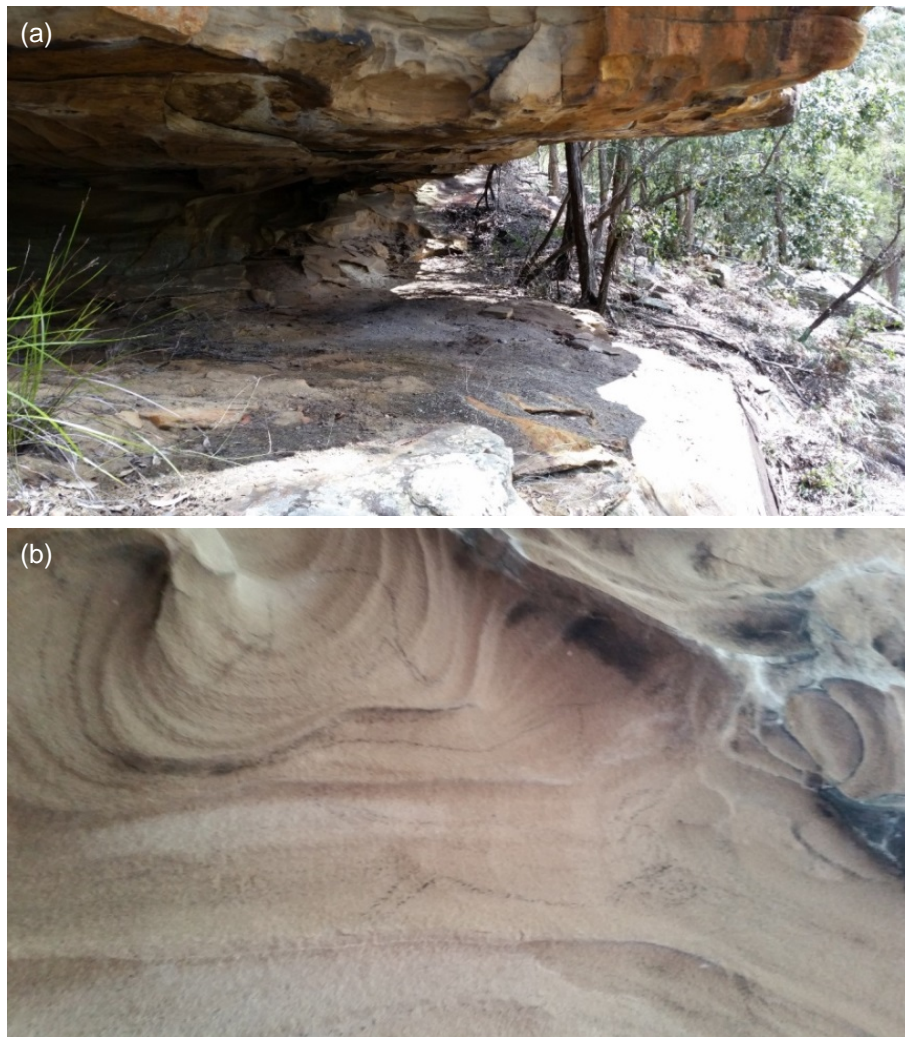
Figure 7: (a) Cave containing Aboriginal drawings, and (b) charcoal drawings within the cave.

Whilst heritage items were speculated to have been identified and avoided throughout the course of the project, Aboriginal heritage was identified and reported at only one location, near the south-eastern corner of lot 6. This heritage was a cave which was located only metres from the corner (Figure 7). Once identified, the area was avoided and a report, location and photos sent to the NPWS and DLALC. Whilst it is not always possible for the untrained eye to be certain of the authenticity of potential artefacts encountered throughout the course of the survey, our awareness of the types of artefacts, combined with a policy of extreme caution and avoidance in all situations, minimised the risk of any impacts on Aboriginal heritage.

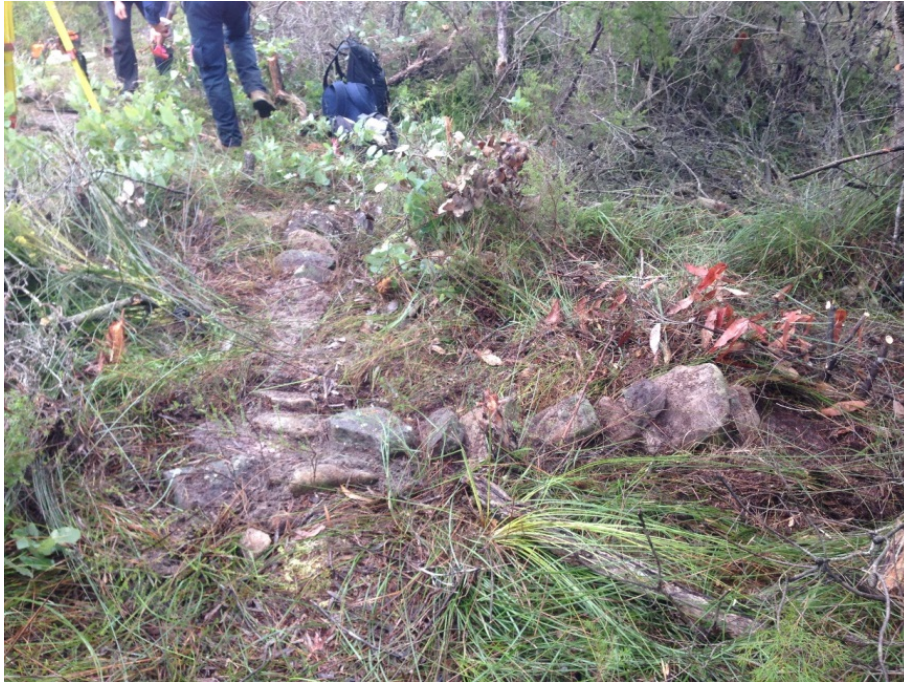
Figure 10: Corner A, c. 1910.

Having regard to Figure 9, during the course of the abuttal traverse, original marks were found at corners A, B and C. Corner A (Figure 10) had been placed in the course of the survey for portion 101 (N4505, circa 1910) whilst at corner B (Figure 11), the original corner mark is noted as found from Ph 55 (N3824, c. 1903) and the reference tree was created in N4505. Corner C (Figure 12) had been placed for the survey of Ph 83 (N1021, c. 1883). Distance A-B is per original (PO).

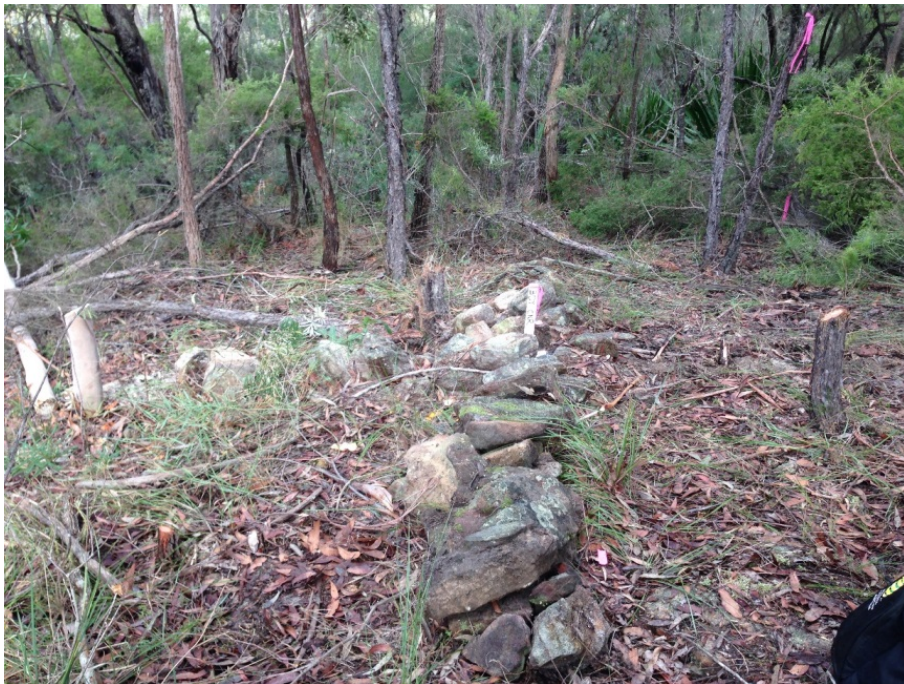
Figure 11: Corner B, c. 1903.

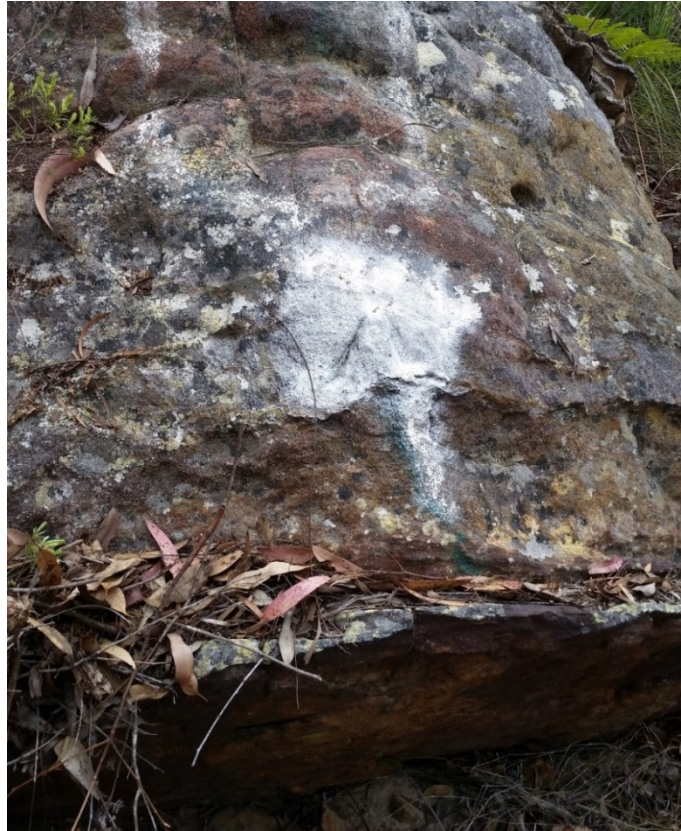
Figure 12: Corner C, c. 1883.

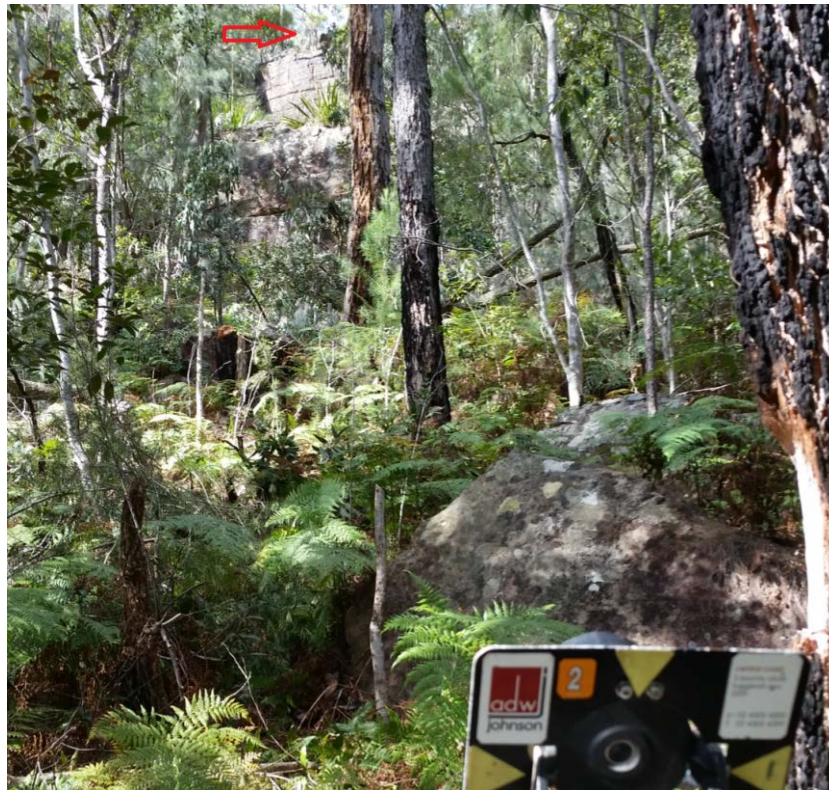
Figure 14: View looking east along the southern boundary of Ph 31. The south-east corner of this portion is near the red arrow.

It is also important to note the referencing of Truscott (1894) in Marshall (2002, p.13), which states *“...during the period 1830 to 1850, in surveys over rough broken ground there is little likelihood of old marks being found because often in portions with river frontages extending back to cliffs, the back lines were generally not run and if the back corners were not easily accessible marking was also omitted.”* Whilst this statement applies to surveys a decade prior to the subject portions, the geography (Figure 14) and methods of measurement are similar and good practice to consider.

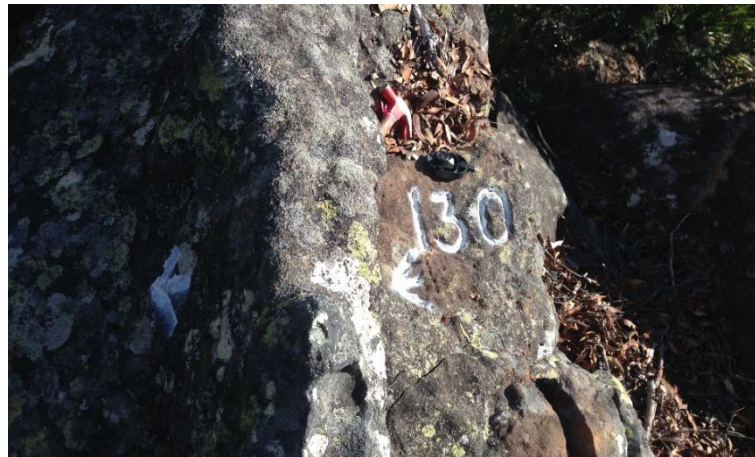
Figure 16: Reference mark C in N5944 (Ph 130), c. 1922. North is to the right as confirmed by the shadowing.

Figures 15 & 16 show a corner mark from Ph 130, being plan N5944. Despite the custom of chiselling the number at the corner mark, where possible, as shown in Figure 16, the portion number has been chiselled adjacent to the reference mark.

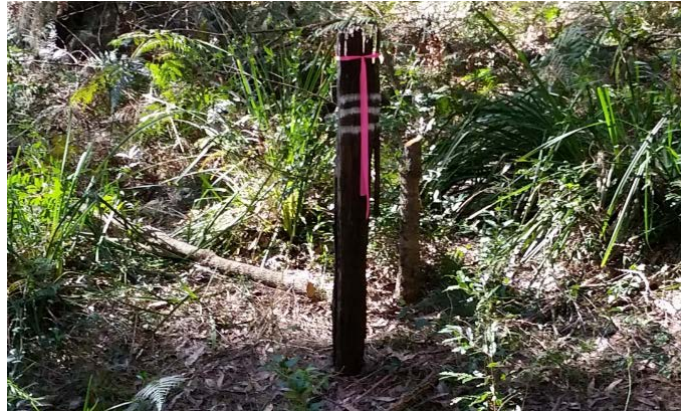
Figure 18: Very old fence post found in Ph 31 (on the reserve road boundary).

Calculations were extended using original dimensions from corners C to N. The traverse was extended along these calculated boundaries from C to L. At this point no marks had been found, including the reference mark near corner L which was found later. Given the age of the surveys and terrain, it was decided to proceed northwards in order to (1) search for other marks relating to portions 31 and 34 along the reserve roads and other boundaries, and (2) close the traverse to verify the accuracy of the control. Unfortunately, no marks were found and only a couple of very old fence posts were located within Ph 31 (Figure 18).

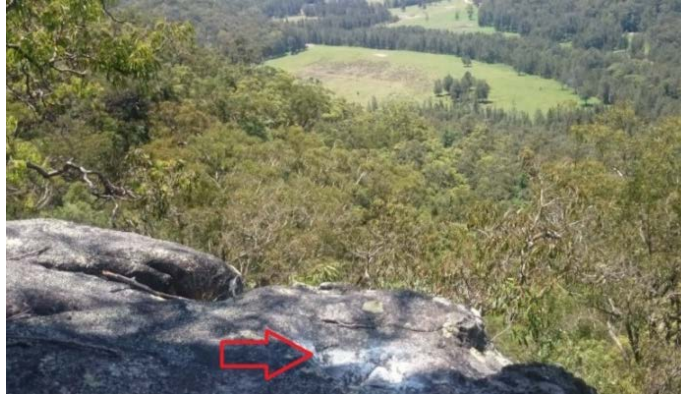
Figure 19: Corner N (“on high rock”) vide N1178 (Ph 82), c. 1886.

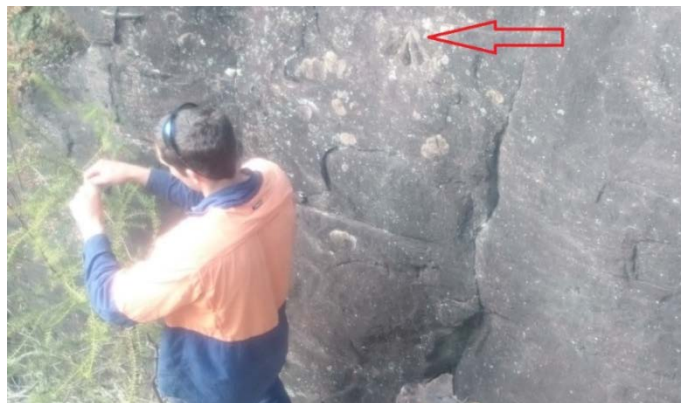
Figure 20: Reference mark adjacent to corner L vide N1177 (Ph 81), c. 1883.

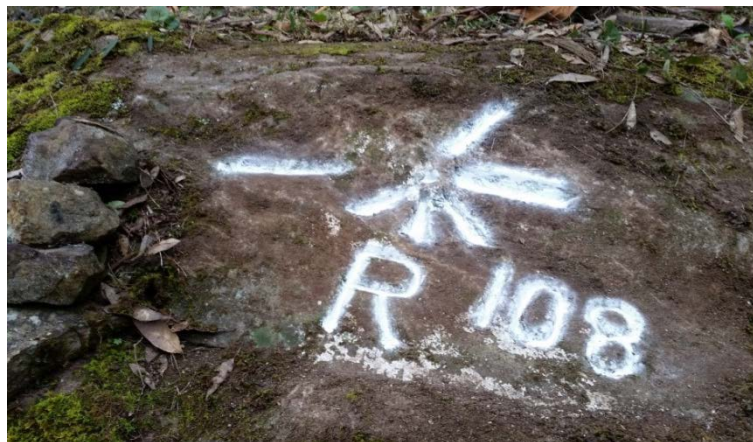
Figure 23: Rock mark on portion road.

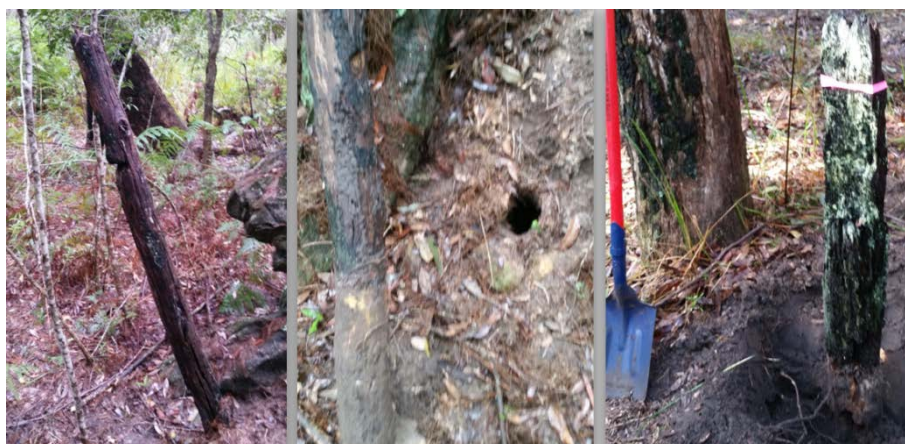
Figure 26: Sample of very old fence posts.

As noted earlier, fencing was also located throughout this survey and whilst it did not prove beneficial to the definition, it did exist in a position that indicated it was the same fencing shown in the road plan of 1887. Figure 25 includes an extract of part of R3432 showing fencing around a cultivated area of portion 31. Red dots on this extract indicate the approximate position of very old fence posts which were found as shown in the extracts from the Plan of Subdivision. Figure 26 shows a couple of these original posts (see also Figure 18).

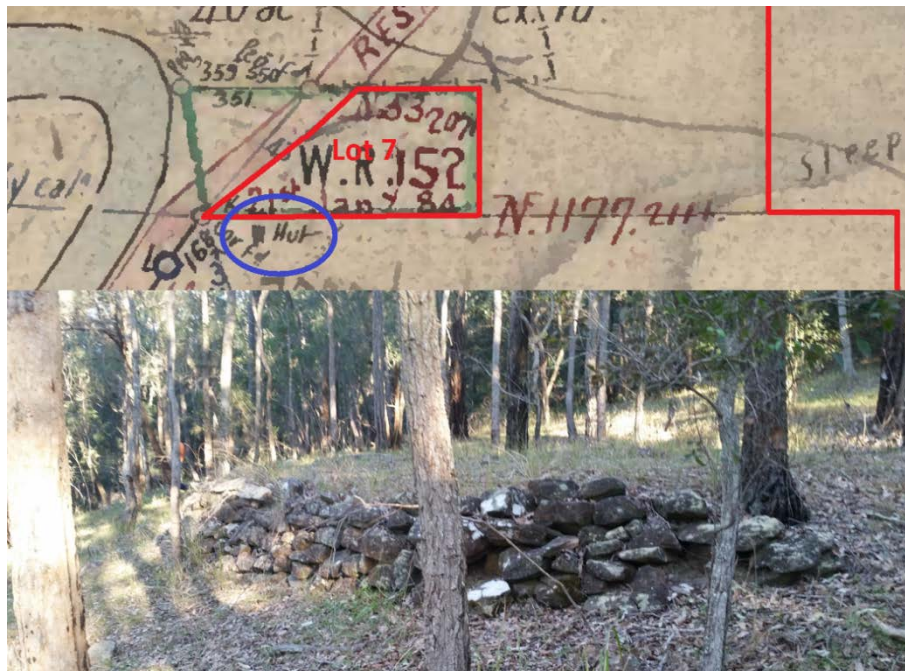
Figure 27: Retaining wall of local rock, possible site of hut in 1887.

Another item of note is the old hut as depicted upon portion 82 in R3432, an extract of which is shown in Figure 27. A retaining wall of local rock was found in this general vicinity as shown in Figure 27, and it may be that this was the location of the cottage in 1887.

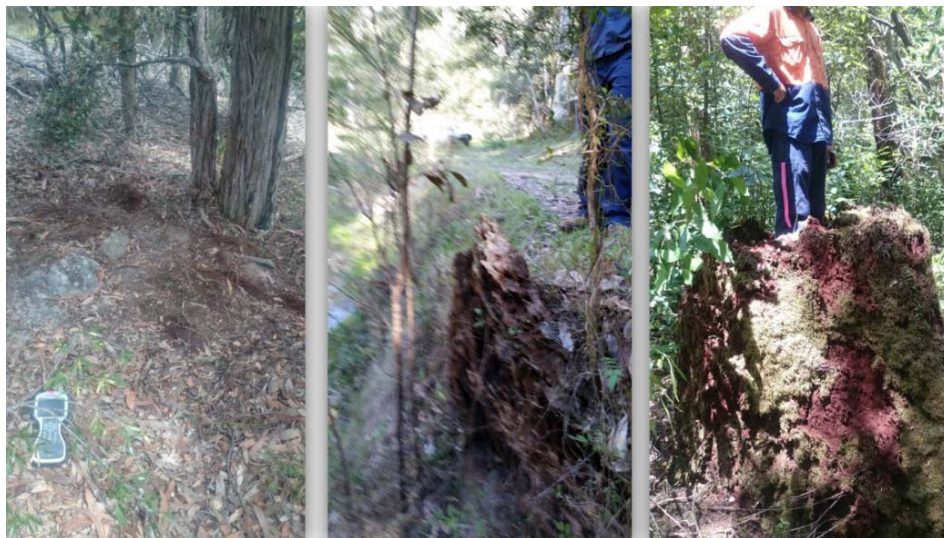
Figure 29: Remains of lockspit at corner Z, Mahogany stump at corner X, and reference stump at corner AC.

At this point, the survey approach returned to the abuttal boundary at corner R, having closed off the traverse loop at this point. The traverse pushed eastwards along the southern boundary of Ph 64 and then looped back through the cleared valley (via corner V) to corner W. Again no marks were found, and so the traverse extended around the valley down to corner X where a stump was found in the position calculated for this corner from N4072 (Ph 65) (Figure 29).

The traverse then returned to corner V and continued along the abuttal southwards to corner Y and then across the valleys to corner Z. At Z, lockspit remains were found which agreed well with the orientation and distance from the Mahogany stump at corner X (see Figure 29).
