Cornering the Cadastre

Fred de Belin

City of Ryde

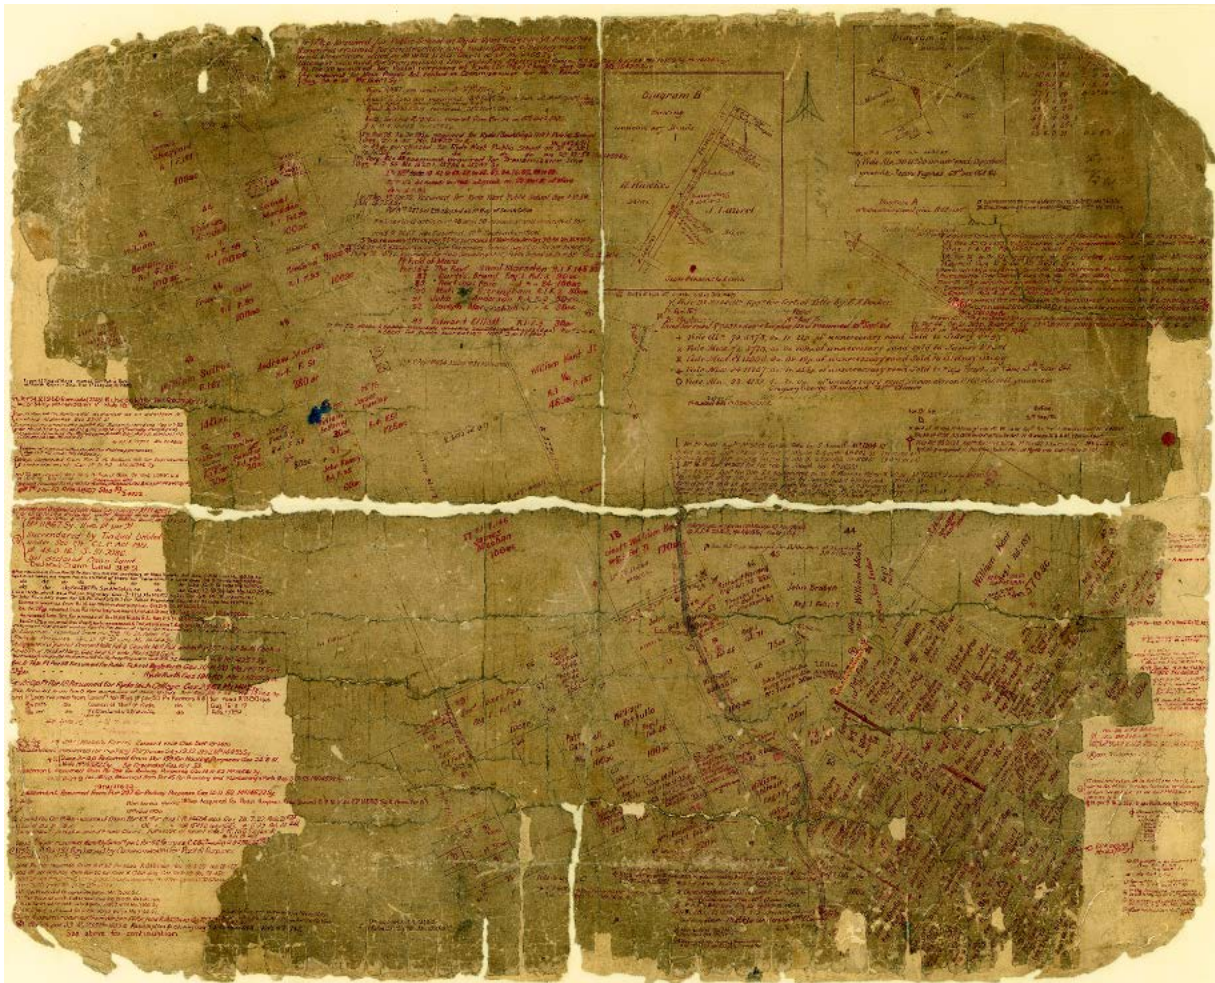
Figure 1: Crown Plan F145, showing the original grants.

Some of the first land grants in the Territory of New South Wales were in Ryde, from 1792, with each land grant being duly signed by Captain General and Governor in Chief, Arthur Phillip. A total of 149 Portions were created, along the shore of the Parramatta River and heading north (Figure 1), one example being Richard Cheers' Portion 15 (Figures 2-4).

Figure 9 shows detail of two parts of Crown Plan 386, where one is decidedly less clear and less legible, looking disconcertingly very like the First Grants plan (Figure 1). Scrivener's survey was undertaken using accurate measuring tools (theodolite and steel riband) and incorporated direct observations from an area-wide network of trigonometrical stations. This survey should form the basis of the modern cadastre in the City of Ryde. De Belin (2017) outlines how Crown Plan 386.2030 was re-stored and re-established into a condition fit to be used. Subsequent field results show Crown Plan 386.2030 is completely accurate to today's standard, and, moreover, is able to be fully replicated. Its importance to the modern cadastre is assured!

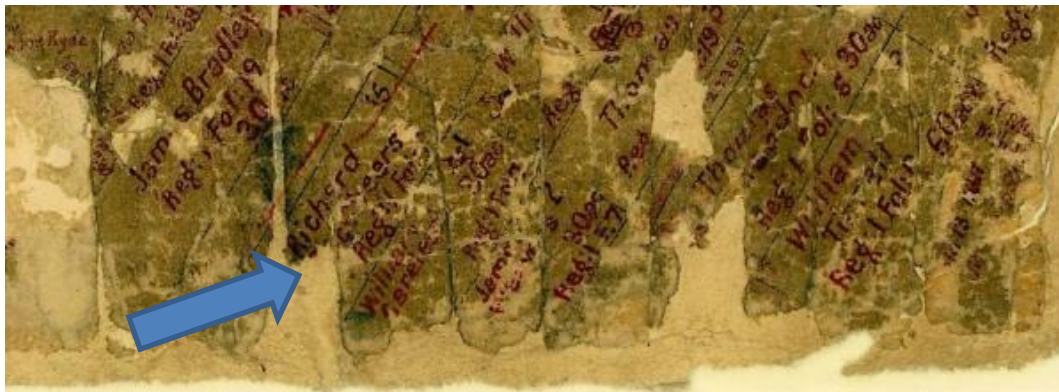
Figure 2: Detail showing Portion 15, Richard Cheers' 30 acre grant.

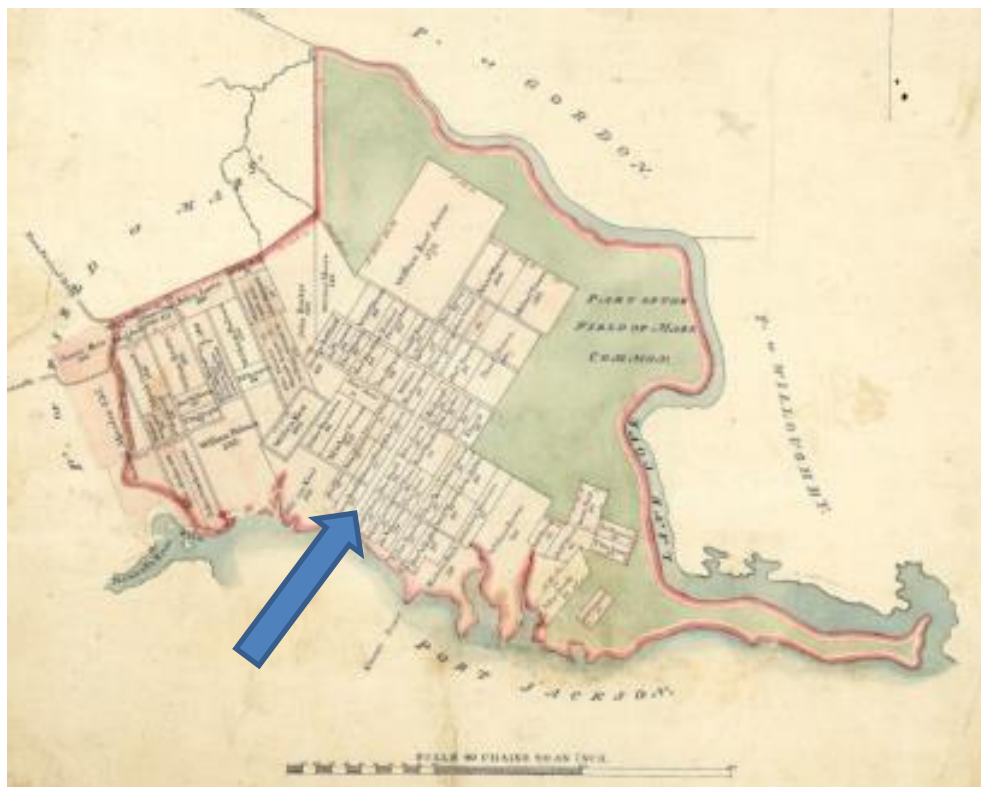
Figure 5: Ryde's original road/driftway pattern.

Free settlers and ex-convicts, who were "of good conduct and disposition to industry" (i.e. hard work) were entitled to a free land grant. Each single male was given 30 acres, an additional 20 acres, if married, with a further 10 acres for each child. 30 acres is a rectangle 30 chains by 10 chains (which is approximately 603 m by 201 m). However, these first maps showed no dimensions (Figure 5). The first cadastre (Figure 6) only showed portion numbers, grant areas and names of the grantees.

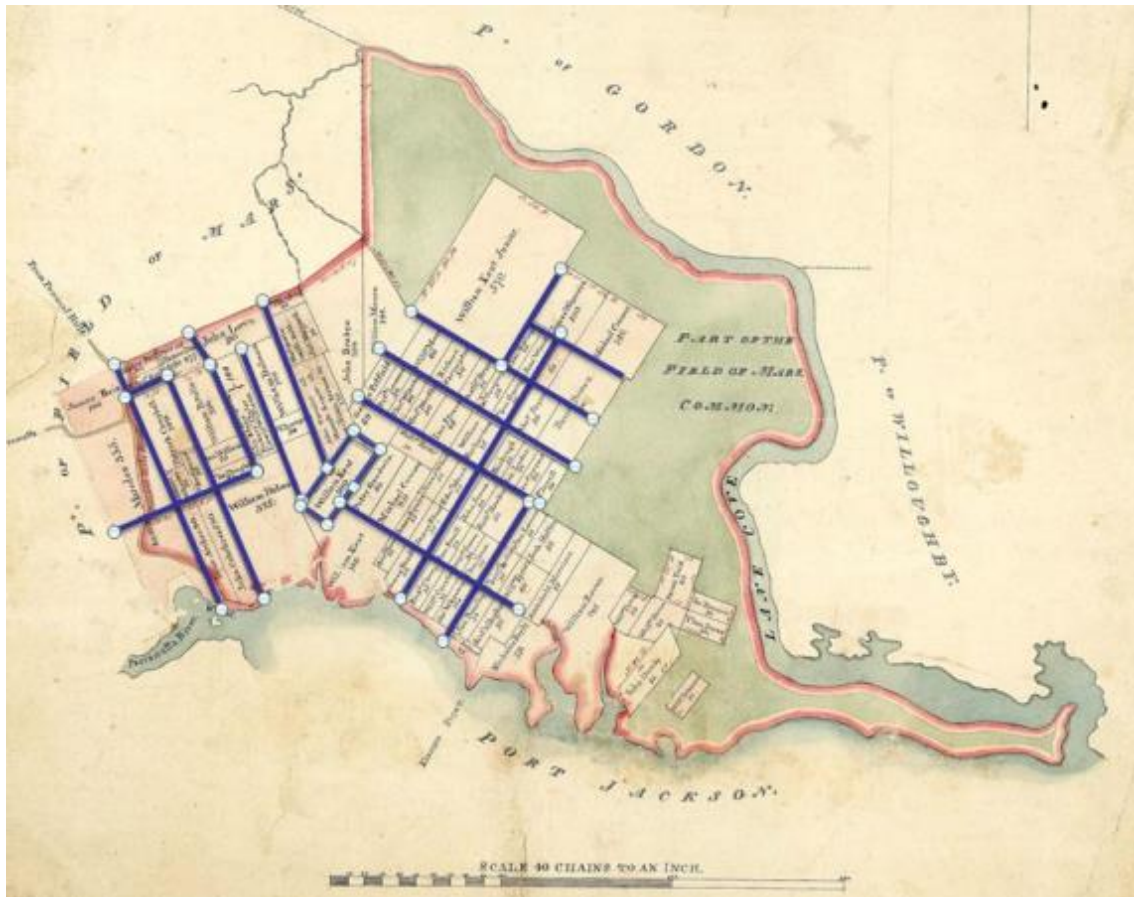
Figure 6: This map of Ryde is, effectively, its first cadastre.

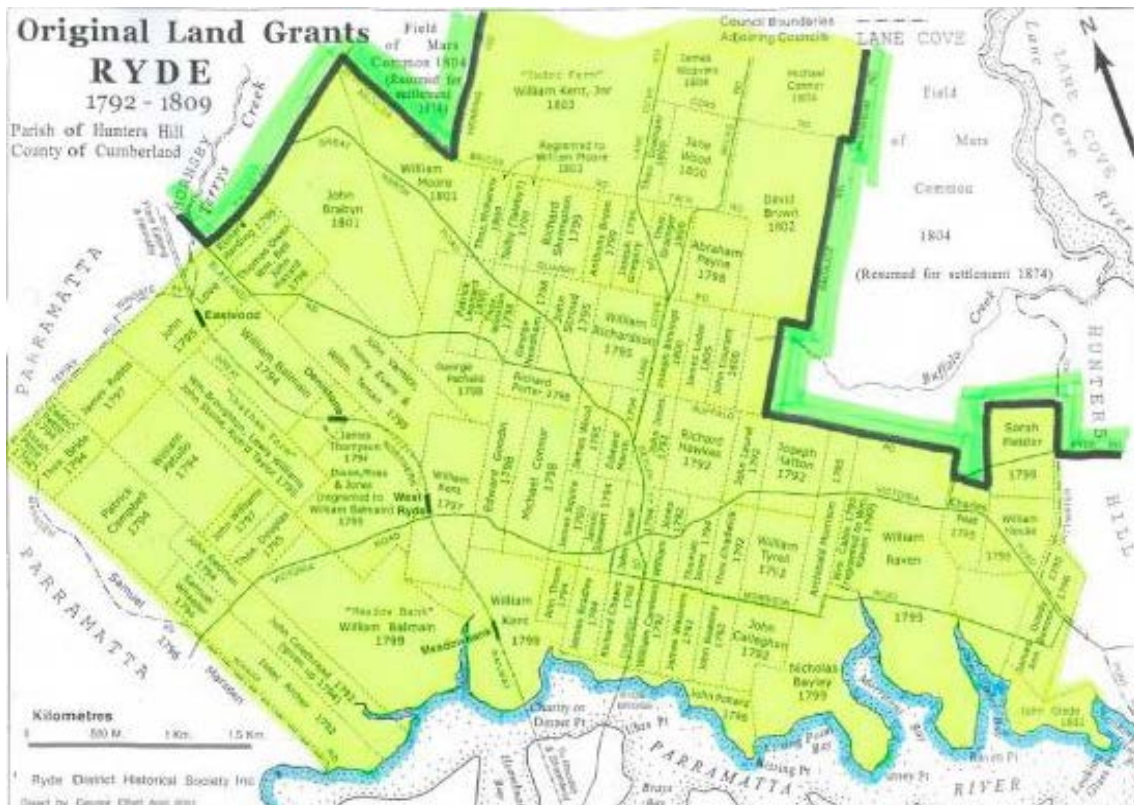
Figure 7: 1881 survey of part of James Weavers' 30 acres.

The boundaries of these grants became established through fencing occupation and by later survey, usually at a time of subdivision or primary application. The cadastre was now being determined by dimension and marking, however, modern survey accuracy was not attained until 1881-82 (Figure 7). Only then could the cadastre be considered more stable and reliable.

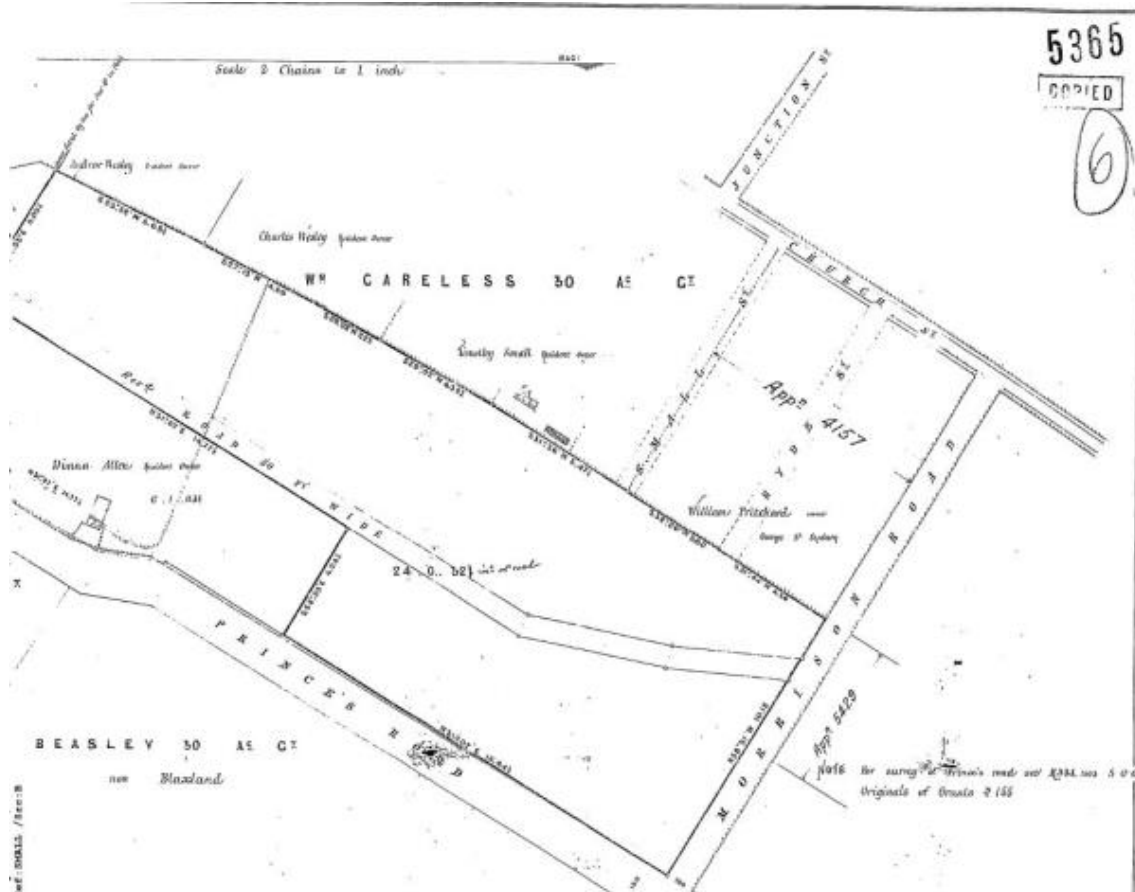
Figure 8: Crown Plan 386.2030, date of survey from September 1881 to May 1882.

At North Ryde in 1881-82, Lands Department Staff Surveyor Charles Robert Scrivener undertook a subdivision of Crown Land, being part of Field of Mars Common. This survey abutted the limits of those first Land Grants. He created 125 Portions (generally 4, 5 or 6 acres each) (Figure 8). This was the first new Crown Land release at Ryde since the original land grants, 90 years earlier. The overall area of this new release was equivalent to one tenth of the current Ryde Local Government Area.

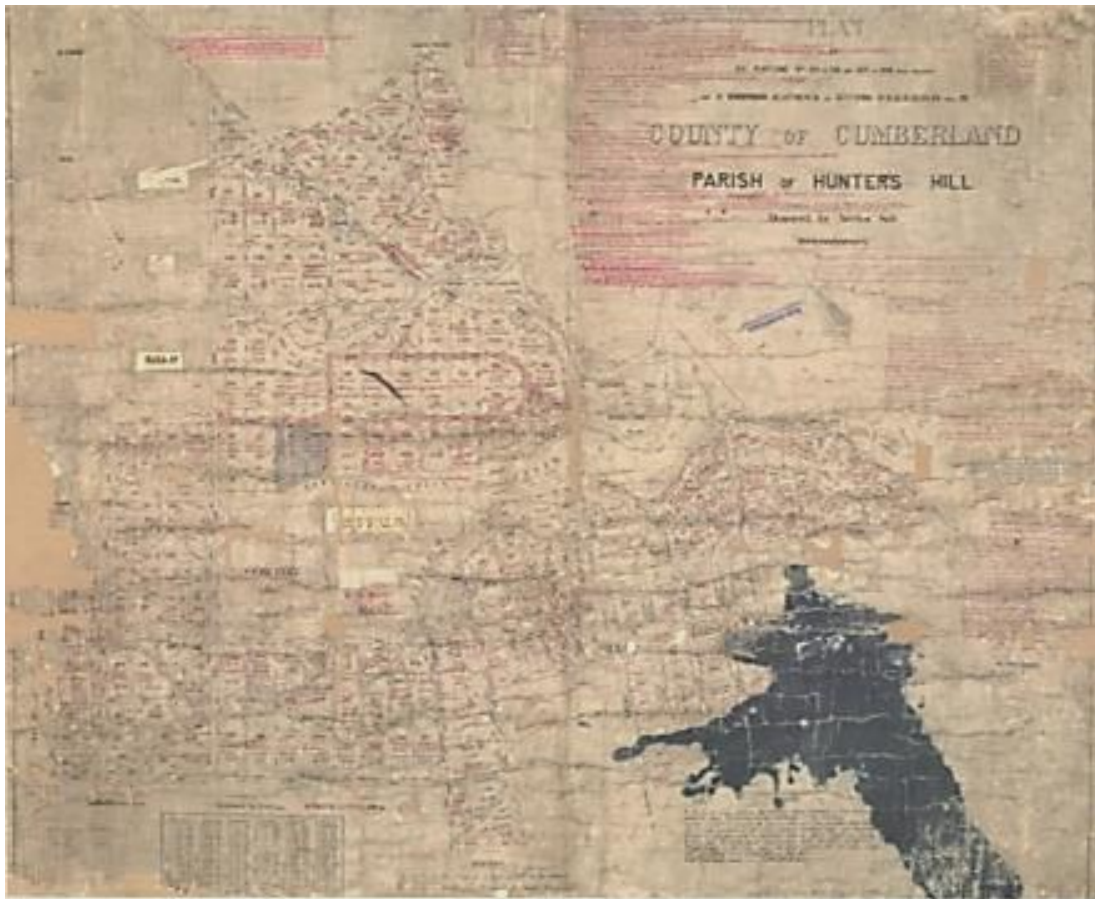
Figure 9: Detail of parts of Crown Plan 286.2030.

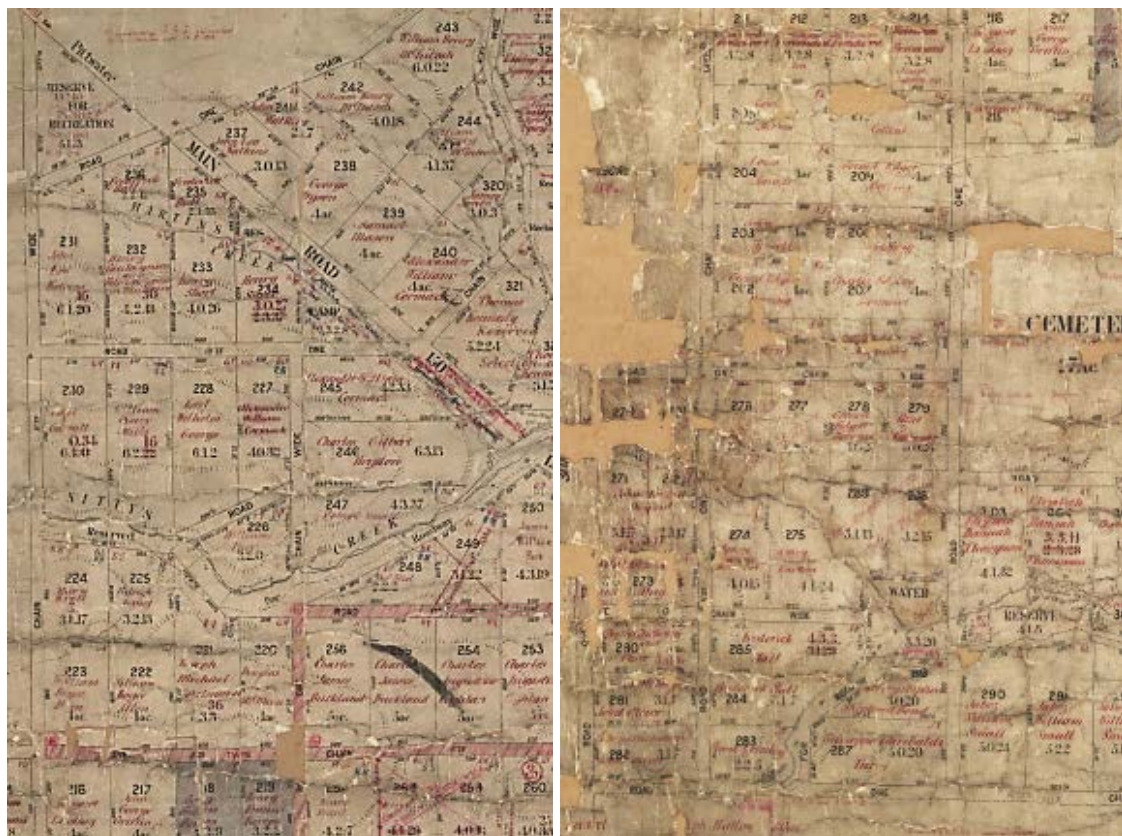
Figure 10: Crown Plan 1137.2030 of 1886, showing the limit of first grants in red.

There are now 2,243 lots descendant from the 125 Portions as surveyed by Scrivener in 1881-82, so there are many ongoing benefits in having and maintaining a sound cadastre. Crown Plan 386.2030 was the first new Crown Land release since the original grants. Crown Plan 1137.2030 (Figure 10) followed four years later in September 1886, and was part of the second new land release, extending from Marsfield to Eastwood. It was four times as extensive, creating 454 Portions.

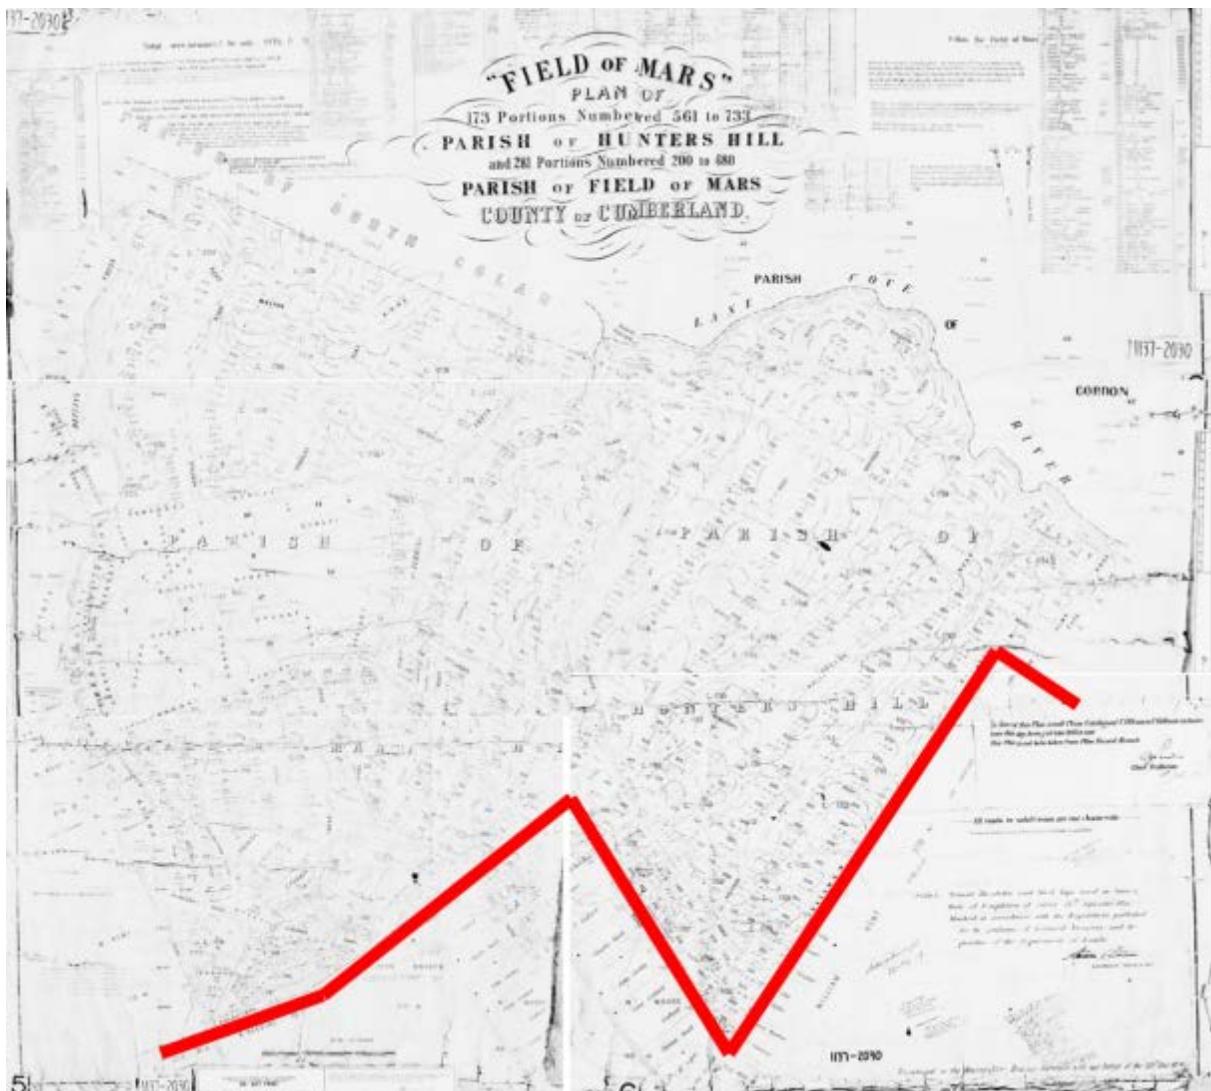
Figure 11: Crown Plan 1156.2030 of 1887, showing the limit of first grants in red.

A further crown subdivision followed in February 1887 (Figure 11), creating 227 more Portions. These two Crown plans were also in such a parlous state that within only 10 years (Figure 12), they had to be completely redrawn, this time onto smaller plans (Figure 13), showing releases of between 10 and 20 Portions each. Notwithstanding the wonderful foresight and skill of the Chief Draftsman in 1896, much survey information was not transferred to the copies, especially the type of marking.

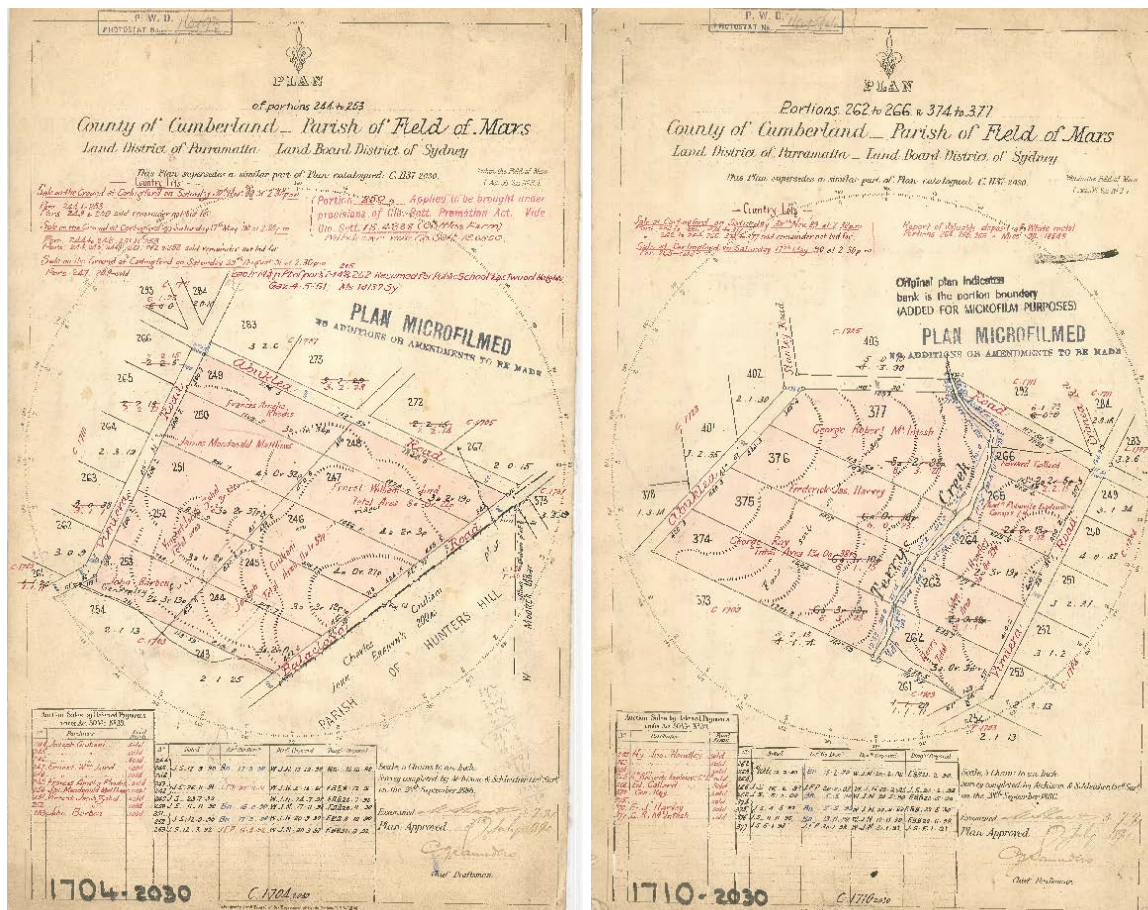
Figure 14: Surveyors' note on Crown Plan 1137.2030 from 1886 – "Transit Theodolite and Steel Tape used".

By 1887, the original land grants in Ryde were completely surrounded by the new grants. These later Crown Plans were surveyed by Atchison and Schleicher, and like Scrivener's plan, were survey accurate (Figure 14). Add to this a network of aligned streets, surveyed by Scrivener, and the framework of the modern cadastre is set... from Gladesville in the east to Eastwood in the west.

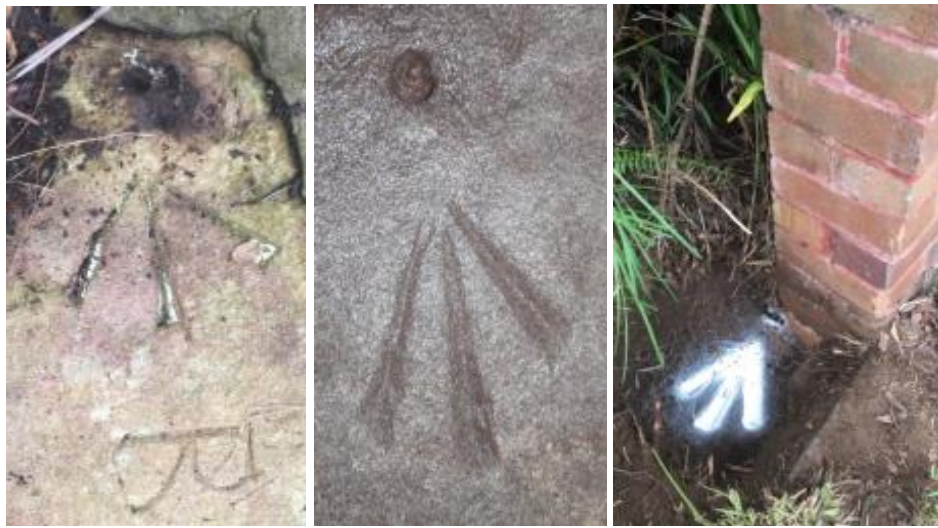
Figure 16: Original trigonometrical marks in Ryde.

Figures 16 and 17 show examples of original trigonometrical marks found in Ryde that are part of the early trig networks of the 1880s. The marks are either carving in rock or metal pins in rock. Note that the rock marks in Figure 17 do not show a broad arrow.

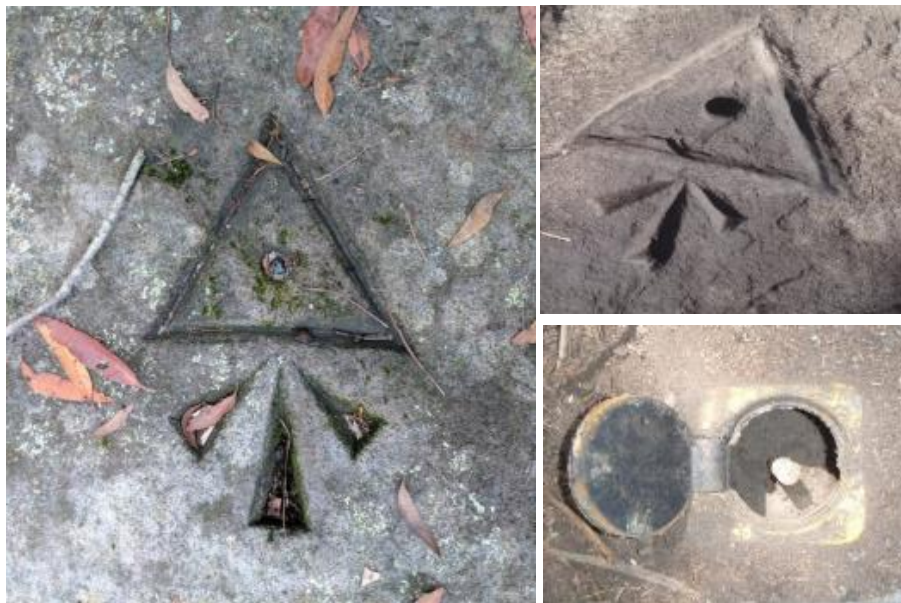
Figure 17: Original foreshore trigonometrical marks at Bedlam Point, Gladesville.

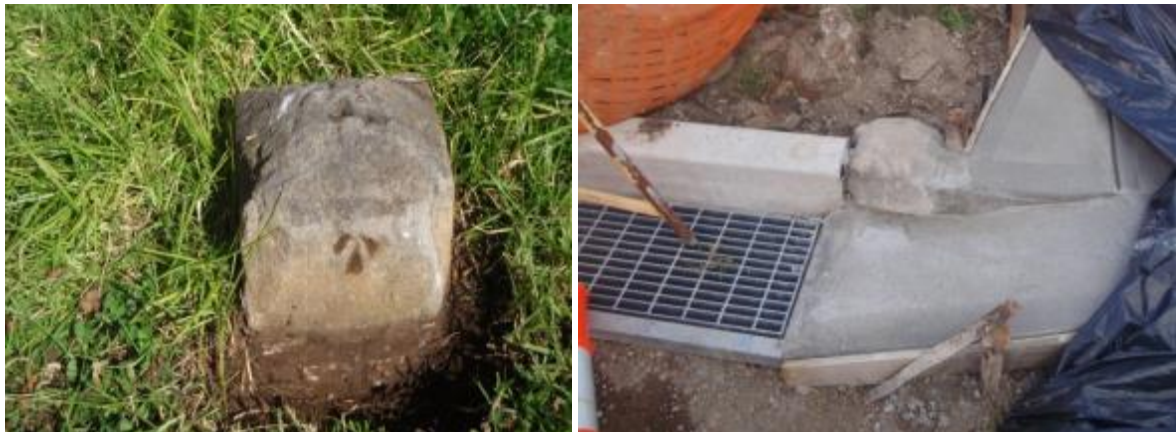
Figure 19: Remains of broad arrow rock mark at the Vimiera Road bend.

Crown Plan 1137.2030 in 1886 creates Vimiera Road containing a bend. Unfortunately, the original plan is very badly faded and indecipherable at this point. Crown Plan 1710.2030 in 1896 (re-draw), shows no mark description at the bend. DP940535 in 1920 finds the “original broad-arrowed rock mark” at the bend. DP25469 in 1946 finds an “old fence post in rock” at the bend. DP394754 in 1955 finds a “rock mark at centre of face of post” at the bend. DP408379 in 1958 finds the “original broad-arrowed rock mark” at the bend. DP210868 in 1961 finds a “rock mark” at the bend. DP217683 in 1962 finds a “drill hole and wings” at the bend.

There have been 19 plans in the 55 years since 1962. However, none of these has mentioned finding anything at the bend, relying instead on finding reference marks placed by the surveys in 1955, 1958, 1962 and later. The butt of an old square fence post (not the 70-year-old post from 1946) sits in a larger, older post hole, and the remains of the broad arrow in rock are still evident today (Figure 19), and fits with the position as re-established from all the found reference marks.

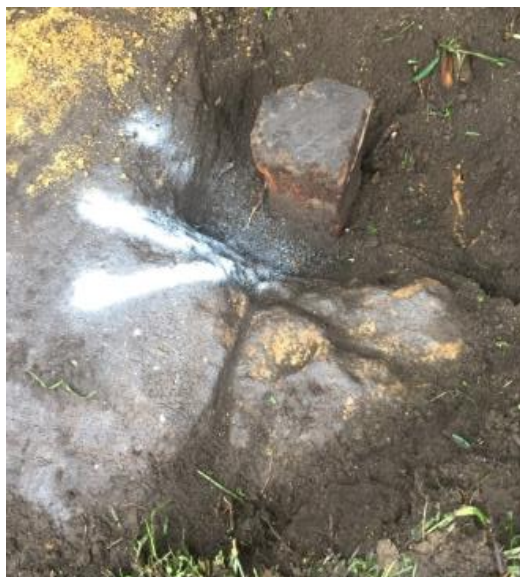
Figure 20: Detail from DP37570 in 1937 and DP1223761 in 2016.

DP1223761 in 2016 re-established the position of an original stone alignment post in Victoria Road by finding two concrete block reference marks, from road-widening DP337570 in 1937,

and using their shown connections (Figure 20). The comparison from this re-established point (it would have been a broad arrow cut on the dressed face) to a broad arrow found on the dressed face of another original stone alignment post is remarkable, achieving agreement to within 10 mm over a total distance of 732.12 m.

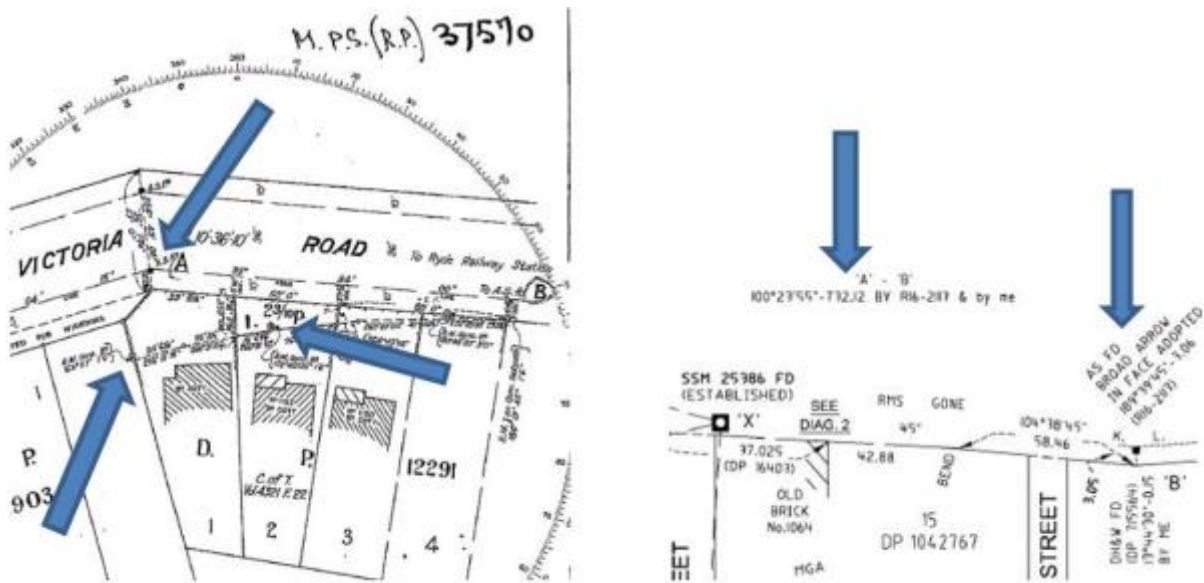
Figure 21: Detail from DP503383 in 1963, showing reference marks placed in relation to alignment marks.

Kerb renewal in Victoria Road has taken the alignment marks but the three reference GI pipes in Providence Road remain (Figure 21). Re-establishing the Victoria Road intersection is thus a straight-forward process (de Belin, 2015).

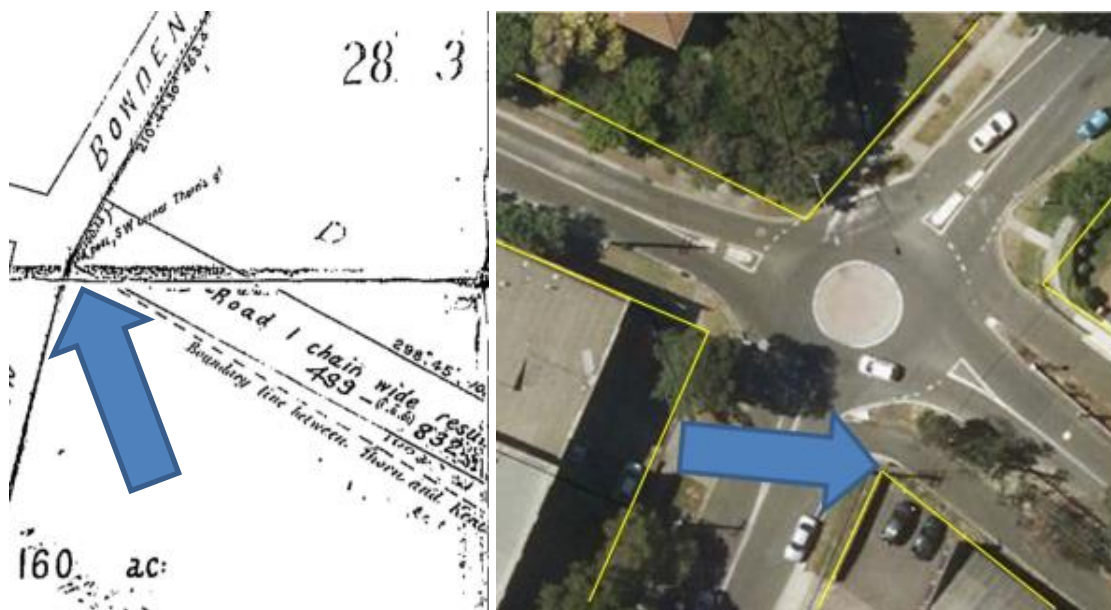
Figure 24: Three GI pipes referencing a corner, where there should be only one!

The importance of key boundary marks and reference marks in maintaining a sound cadastre cannot be stressed enough. One final, fine example is the reference mark (GI pipe) placed in a 1947 land subdivision by DP20789 to define a splayed corner. This reference mark has been found and relied upon over the subsequent 70 years by 12 Deposited Plans to provide definition and street fix. Surveyors have considered this point so important in defining the cadastre that, when one digs down, there are now three GI pipes in the same location (Figure 24)!
