The Sydney Harbour Bridge High-Precision Terrestrial Laser Scanning Survey and 3D CADD Modelling

Roads and Maritime Services is undertaking design and installation of new Arch Maintenance Units (AMUs) on the Sydney Harbour Bridge (SHB) structure. The key component of the project is precise design and installation of rails, on the eastern and western side of the SHB arch, for the AMUs to travel along. Terrestrial Laser Scanning (TLS) has been identified and implemented as the most suitable technique to provide the high-precision, 3-dimensional Computer-Aided Design and Drafting (CADD) model required for the AMU design, accurate manufacture and installation with minimum onsite modifications. Due to the unique location, safety aspects and high degree of relative accuracy required, this project involved developing and testing unique survey methodologies, utilising bespoke equipment and multiple laser scanners operating concurrently. Point cloud calibration and modelling took into account the continual movement of the bridge, constantly changing coordinate systems and customised modelling procedures to effectively model the iconic structure. This included precisely locating in excess o

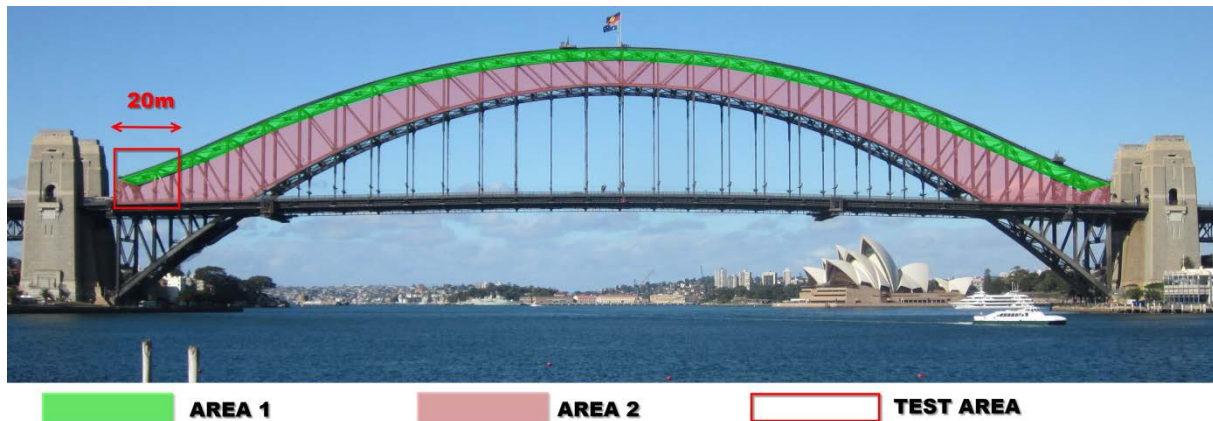
Figure 3: Areas of the bridge to be surveyed.

A detail survey of the SHB structure to provide an accurate 3D Computer-Aided Design and Drafting (CADD) model for the AMU's design, manufacture and installation has been the main requirement of this project. The survey was divided into two parts, each with different tolerances required. Figure 3 describes the extent of each part. The relative tolerance required for area 1 (green) was ± 3 mm and for area 2 (red) was ± 50 mm.

Terrestrial Laser Scanning (TLS) was recommended by Roads and Maritime as the most efficient methodology to capture the most detail information during field survey. However, it was uncertain if it could produce the final deliverables to the required tolerances. Roads and Maritime Surveying Section invited tenders from a select number of highly reputable Roads and Maritime Geospatial Survey Panel members to develop appropriate survey and processing methodologies to deliver the survey model to Roads and Maritime requirements. Jacobs Group (Australia) Pty Ltd was the successful tenderer and awarded the contract work in July 2017. To ensure the proposed field and processing methodologies would deliver the project requirements, Roads and Maritime required a small test area be completed and delivered first (see Figure 3).

In order to ensure that field and processing survey methodologies were successful and that the deliverables complied with the specifications and tolerances required, a test area was nominated for detail survey and modelling. This test area needed to be completed and accepted in full by Roads and Maritime before proceeding with the survey of the whole project area. Combined top and lower arches, over the length of 20 m at the northern end of the SHB, were nominated as the test area (see Figure 3).

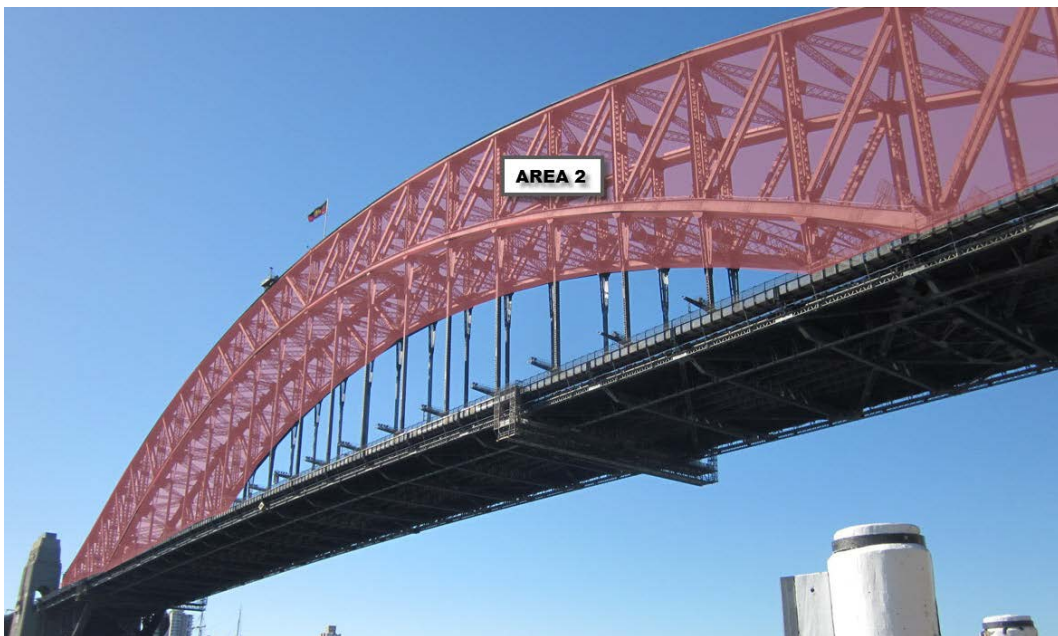
Figure 5: Nominated area 2 for detail survey and modelling (highlighted in red).

Detail survey and modelling of the structure down to and including the lower chords had to be performed to a relative tolerance of ± 50 mm. The level of detail was less than for area 1 and it was not required to model all the individual bridge elements in detail (Figure 5).

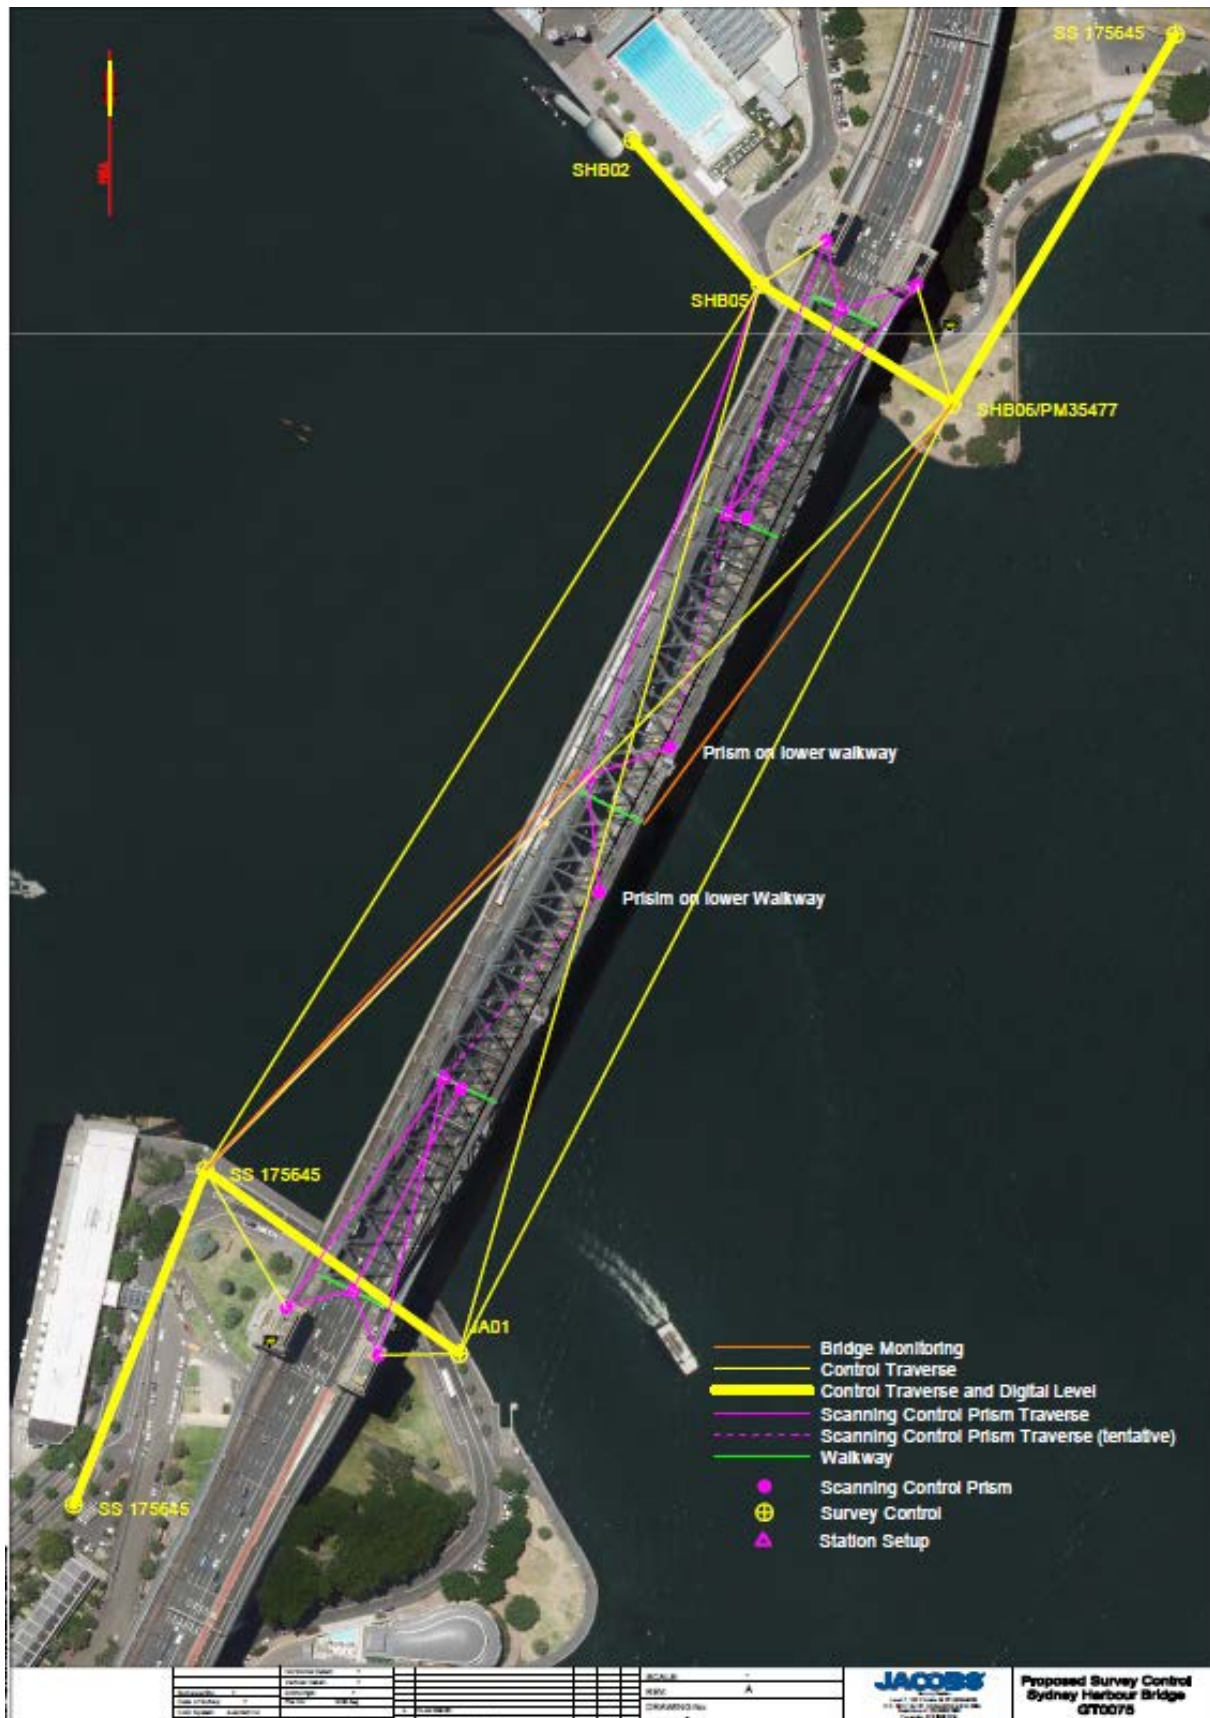
Figure 9: Survey control network.

A robust survey control network was crucial for undertaking the bridge monitoring portion of the project (Figure 9), and it was a fundamental requirement to achieve the high relative accuracy required for the scanning and subsequent modelling of the bridge structure.

A survey control traverse between existing Survey Control Information Management System (SCIMS) control marks, previous monitoring survey control marks and one new survey control mark was undertaken to provide a fully coordinated survey control network in a plane horizontal coordinate system (approximate MGA) and AHD datum meeting the specifications defined in the Roads and Maritime brief.

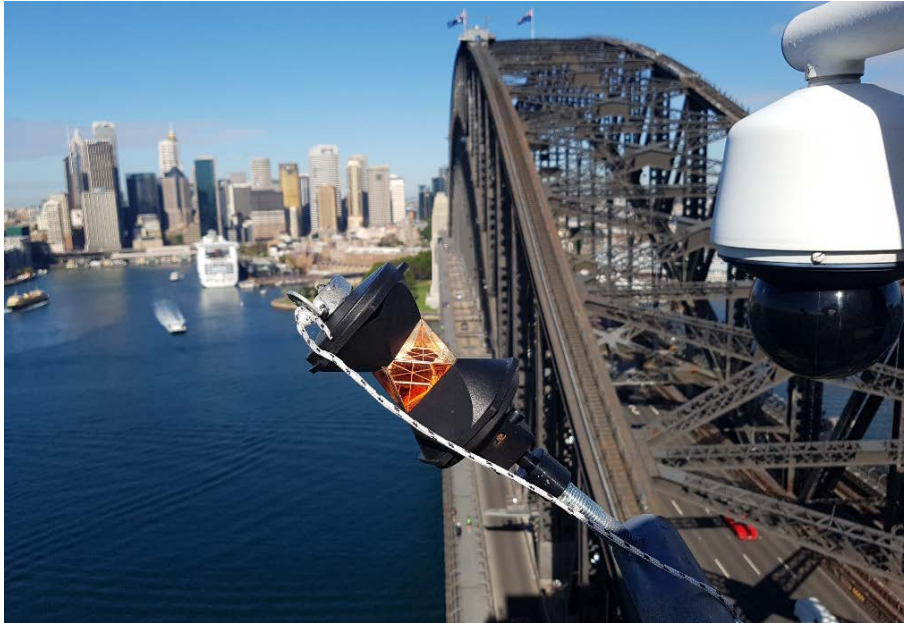
Figure 10: Typical 360 prism install at the pylons.

The coordination of the scanning control prisms was undertaken prior to the scanning work and consisted of firstly coordinating four high-accuracy 360 prisms, one on each of the four bridge pylons. SHB riggers installed the prisms using special mounting adapters specifically fabricated to allow attachment to the hand rails around the top of the pylons (Figure 10).

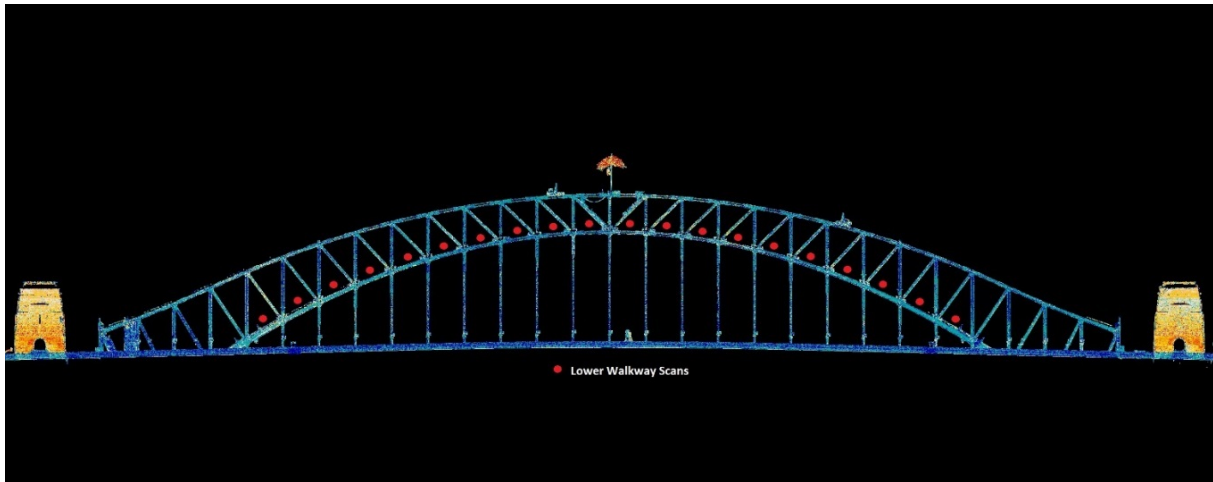
Figure 16: Lower chord scan positions.

To assist with infilling data for both area 1 and area 2, it was proposed to undertake a series of laser scans on the lower level walkway in a similar fashion to the top level scans in order to capture additional detail not visible from the top or the road. This would equate to approximately another 20 scans on each side (Figure 16).

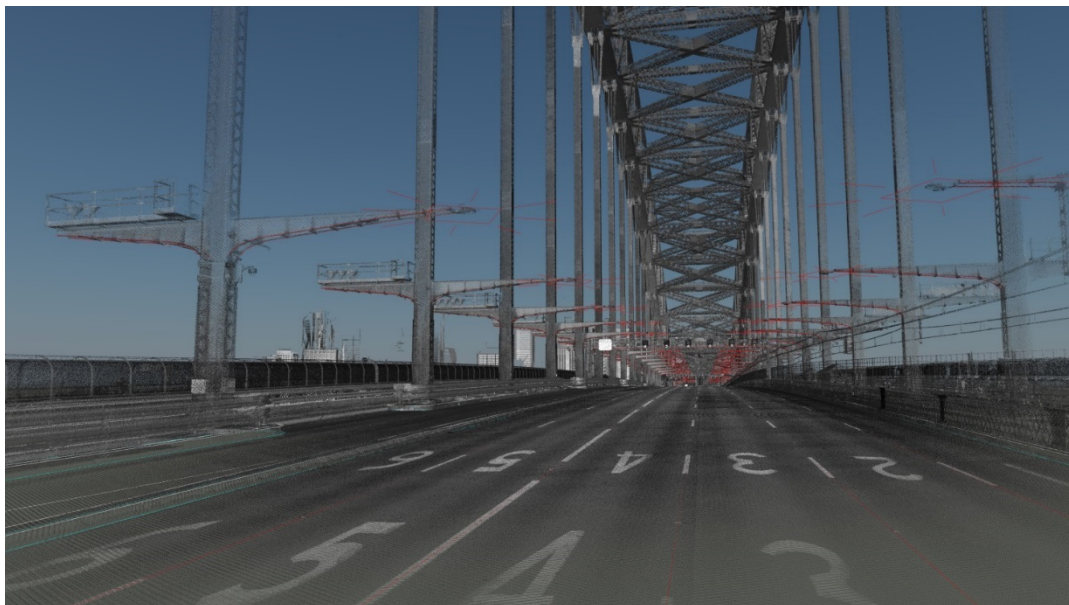
Figure 17: M1 Smart Motorway MLS.

As discussed above, Jacobs was fortunate to have captured an MLS point cloud over the deck of the Sydney Harbour Bridge for the Roads and Maritime M1 Smart Motorway project. The existing cloud is highly detailed, with over 400 million points captured between the main bridge pylons (Figure 17). The existing point cloud had a relaxed accuracy of approximately ± 100 mm, however Jacobs were able to improve this to well beyond the required ± 50 mm and use this point cloud to model the additional detail required.

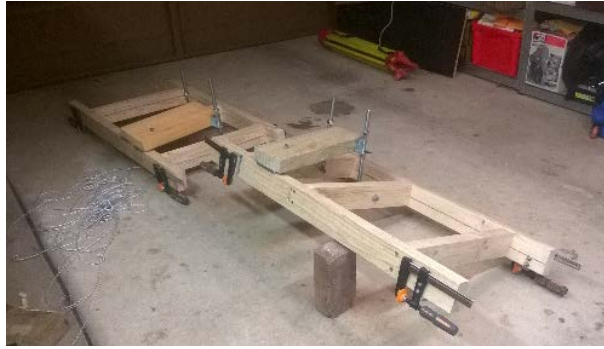
Figure 19: Trial adjustable scan platform.

- Jacobs had developed platforms to mount the P40 scanners that securely attached to the step treads and stringers (Figure 19). However, it became apparent after the test that the platforms were cumbersome and time-intensive to set up and, more critically, there were shadow areas in the resultant cloud as the scanner was not positioned high enough to see over the stair stringers into the inner half of the chords.

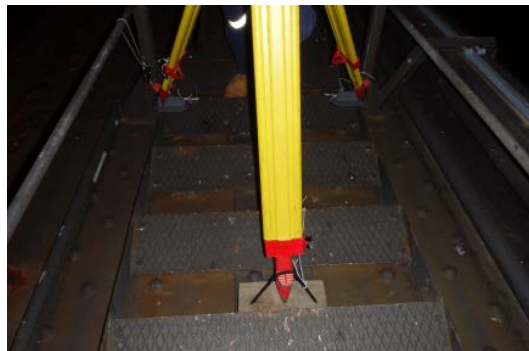
Figure 20: Tripod leg attachment.

- After the test, the scanning platforms were abandoned in favour of tripods. The extra height of the tripod yielded better point cloud coverage. Two feet of the tripods were held by G-clamp brackets to the base of hand rail uprights, the remaining foot was held by a magnet (Figure 20). Tripod setups were more likely to be affected by wind, so scanning was only undertaken in light winds.

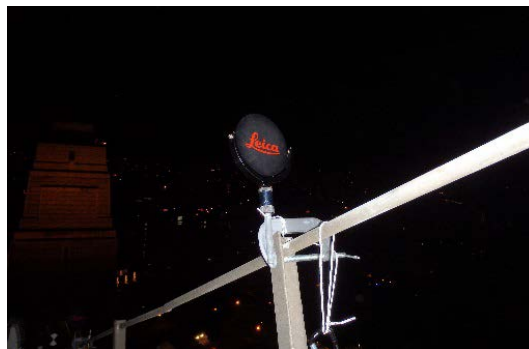
Figure 21: Scan target attachment.

- Upon processing and registering the point cloud from this first night, it became apparent that the targets furthest away from each scanner exhibited poor orientation towards the far scanner. Whilst the initial methodology was to scan concurrently to minimise any relative movement (east/west) between the chords, it was necessary to scan on one side first with all targets orientated towards the active scanner, then reorientate the targets and carry out the second scan (Figure 21). Typically there were only 20-30 seconds between the first scanner finishing and the opposite scanner starting. This resulted in a minor increase in scanning time.
