Cadastral Integrity Loss from Riparian Boundaries

Geoff Songberg
Crown Lands (Retired)
geoffsongberg@gmail.com

KEYWORDS: *Cadastral integrity loss, riparian boundaries.*

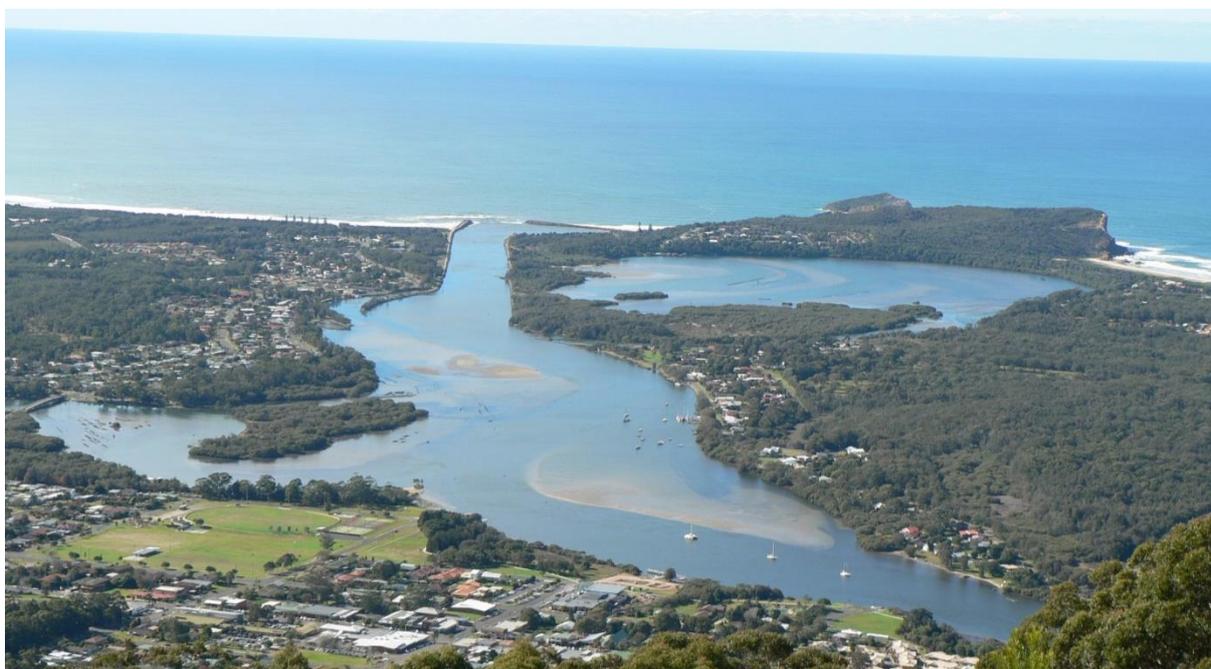
Figure 1: Camden Haven River entrance, North Haven on the left and Dunbogan Camden Haven on the right.

The Camden Haven River enters the sea on the Mid North Coast of New South Wales between North Haven and Camden Head. The river once ran wild to the sea, and from logging practices in the late 1800s the banks of the river have seen many changes. The river has been an important navigation route into the hinterland, with the construction of training walls during 1899-1902 about the entrance to improve navigation being the most significant change. In one reach of the river what was once the navigation channel is now an almost closed lagoon (Gogleys Lagoon) with only a narrow entrance remaining through which the tidal current races (Figure 1).

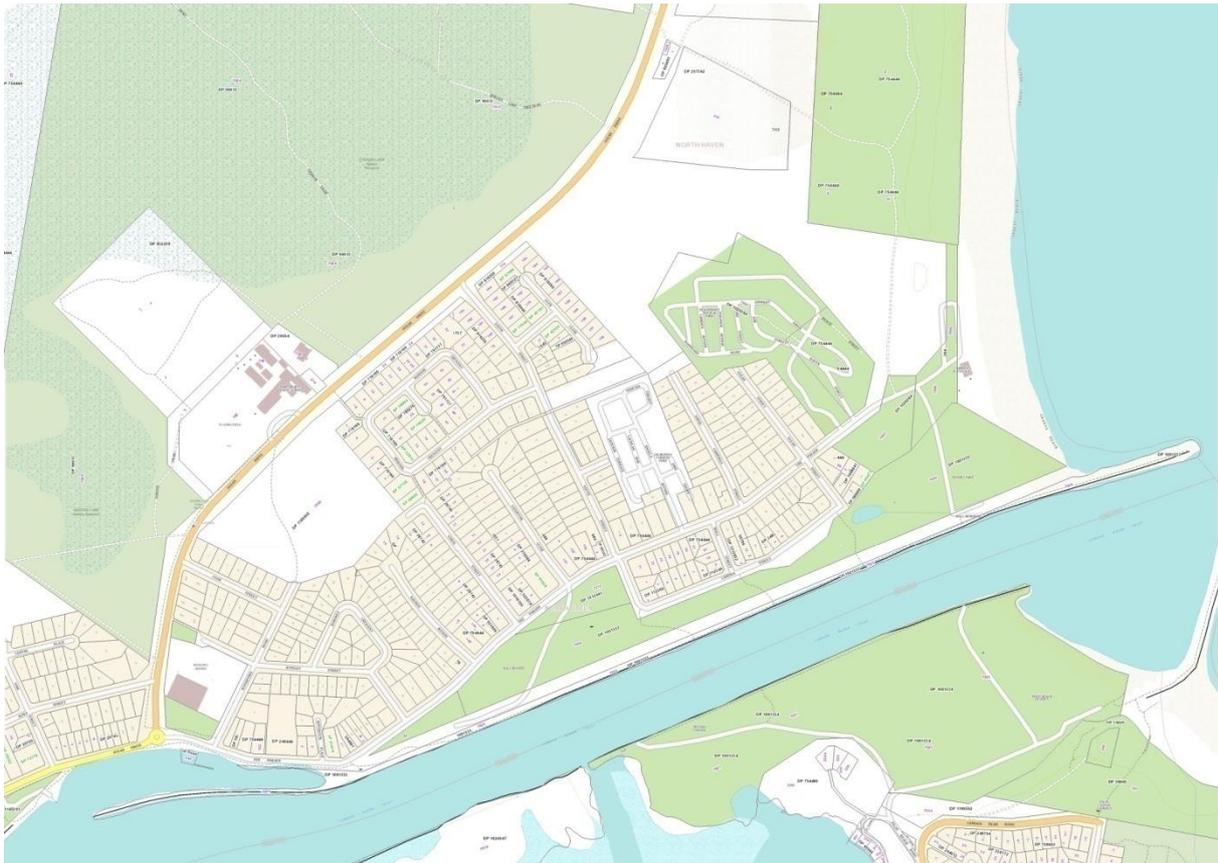
Figure 2: Cadastre north of Camden Haven River entrance.

In Figure 2, the white band north of the river and south of the green is shown to be two entities. Interrogation of the cadastre reveals the one next to the river is lot 7020 DP1001333 and it is Crown Land. Further enquiry with Crown Lands provides information that the land, amongst other attributes, is Reserve for Access 10324. The other is revealed as Public Road. Although both entities exist in the real world, the record of them in the cadastre is invalid. Neither are shown at their correct extent or location. In fact, what is shown as R10324 is not. The impact of just this one error translates latterly into other parts of the cadastre, creating further errors. Since the initial errors were made, other elements have been created when they should not have. There would be great uncertainty in their validity as they were made based on information that was incorrect.

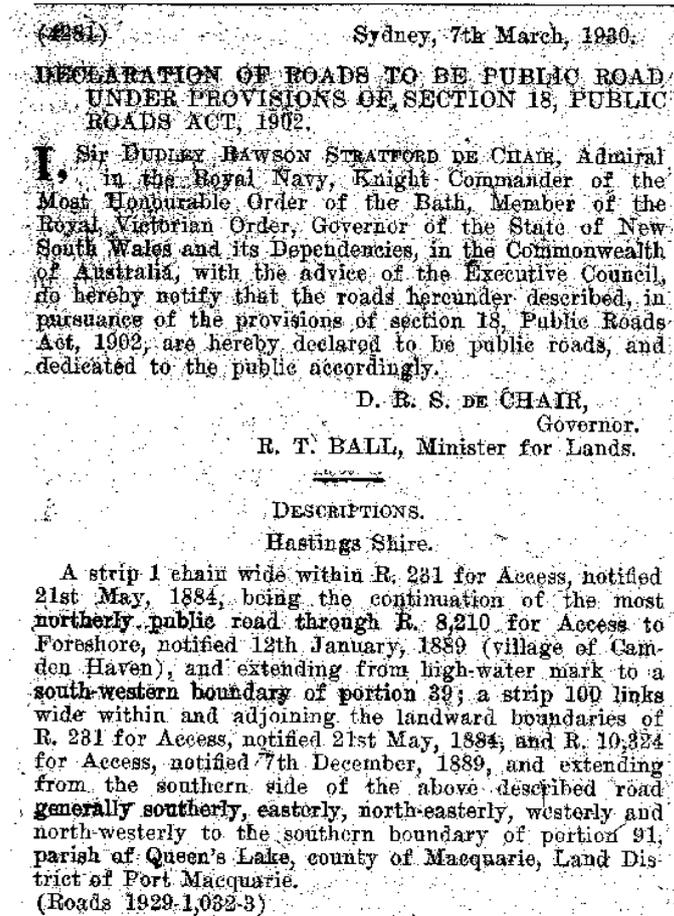
Figure 3: Public road gazette, 7 March 1930.

The road was gazetted in 1930 (Figure 3), extending from the road crossing of Stingray Creek (“the continuation of the most northerly public road through R8210”), along the entrance to Queens Lake, further up the estuary, down the estuary, then northerly to the southern boundary of portion 91. The road was also stipulated to be 20.115 (1 chain) wide against the landward boundary of R231 and R10324.

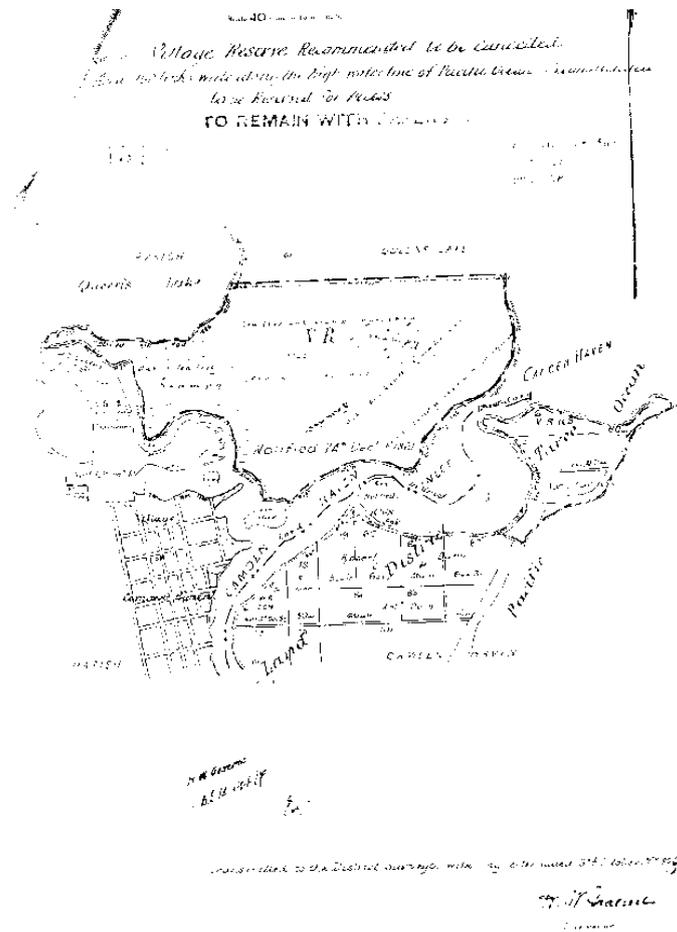
Figure 5: Village reserve, c. 1861.

The village reserve plan shows the shape of the Camden Haven Inlet significantly different to that of the current cadastre depiction as it predates the entrance reconstruction. The plan is dated 1889 because it was used to identify what was to be revoked in a reserve restructure in 1889. It does however show the extent of R231 going down the Camden Haven inlet to the entrance. It does not show R10324 but gives the area along the coast as a proposed reserve. This plan is not in agreement with the Queens Lake parish maps of the era. Editions 1 and 2 (Appendix A1 & A2) show R231 only extending to the junction of the Queens Lake Inlet and the Camden Haven River, although edition 1 does not depict the Camden Haven parish to the south or the Camden Haven River. It simply labels the area as Camden Haven which may have caused some of the

confusion. By contrast, Camden Haven is shown on the village plan as the bay within the ocean beyond the mouth of the Camden Haven River. The gazette for R231 (Appendix B) describes the reserve as going around Queens Lake, then down the inlet to Camden Haven and along the shores of Camden Haven.

The problem with the village plan and parish maps is that they are only diagrammatic. Edition 1 of the parish map is confusing, edition 2 not much different to the village plan which does not show any survey base of how it was derived. A graphical overlay tie to the present cadastre would be very loose. What is needed is a plan that is based on surveyed data and which could be linked to the present cadastre with a reasonable degree of accuracy.

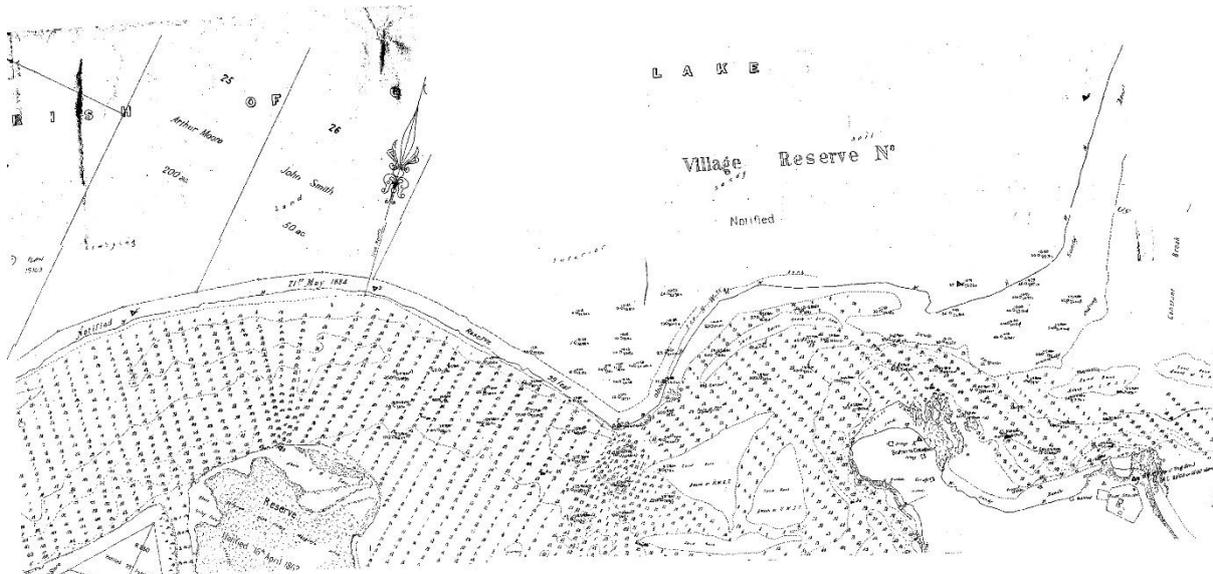
Figure 6: Part of hydro survey of Camden Haven Inlet, c. 1897.

Edition 2 of the parish map, in use from 1898 to 1914, despite its lack of quality graphics, does provide further information that leads to a surveyed plan but not one of the land. The shoreline is noted as being reduced from a plan within the works department. As it turns out that plan was still being held in the Public Works plan room at the time of research. It was the hydro plan (Figure 6) of the inlet and immediate coast conducted in 1897 prior to the commencement of site works to realign the entrance.

The plan shows some of the cadastre within North Haven as well as part of a reserve notified 21 May 1884 (R231), extending eastward past the eastern boundary of portion 26 to about the river entrance where it vaguely disappears as though the precise termination is unclear. This plan agrees with the information on the village reserve and what can be deduced from the gazetted descriptions. It again confirms the location of the R231 and R10324 common boundary as being at the river entrance to the ocean. The hydro plan also shows the location of the pilot station on the south side of the river. There is subsequently sufficient information on the plan to orientate this survey in time and space reasonably accurately over the present cadastre. The survey may not have been carried out over the land but it is detailed enough to reasonably locate the mean high water mark in relation to the land parcels. Despite being conducted 8 years after the gazette of R10324 (1889) and 13 years after the gazette of R231 (1884), the times are close enough that this representation can be considered as sufficiently accurate to locate the reserves. It is also the only surveyed information available.

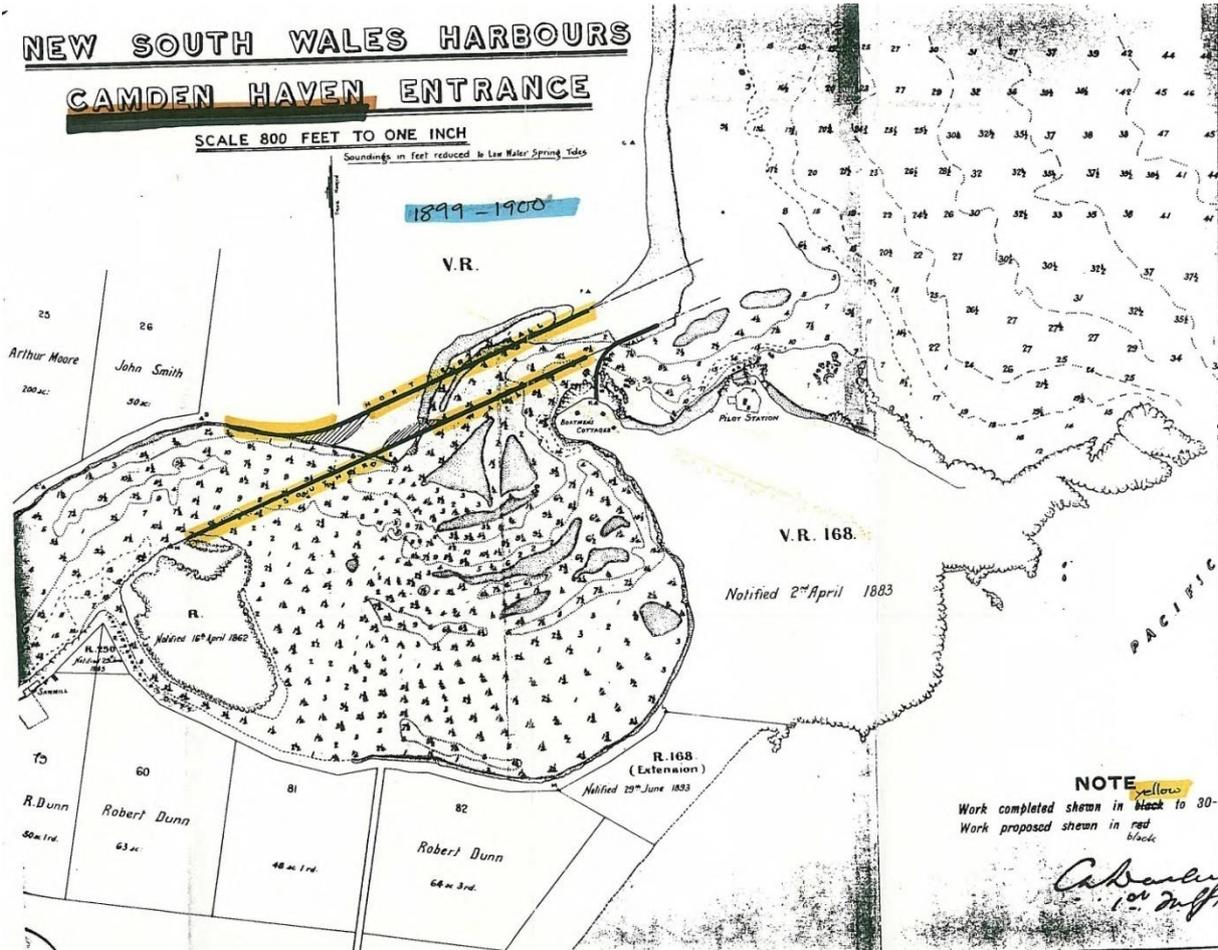
Figure 7: Extent of Camden Haven entrance construction 1899-1901 (Colthart and James, 1987).

So what did Public Works do that made things go so horribly wrong with the cadastre? They straightened up the course of the river by dredging through the south-facing spit, leaving part of it on the south side of the reconstructed river and blocking off the reach of the river to the south with constructed rock walls (Figure 7). What was once a broad sweep of the river to the south became Gogleys Lagoon which now has two narrow entrances, only one of which is navigable by small craft. The entrance training walls have since been extended from what is shown as the plan was an early edition during the full course of the works. Although the project was commenced in 1893, planning and preliminary works such as the hydro survey (1897) were conducted prior to construction. The preliminary construction on the entrance was not carried out until 1899-1900 (Coltheart and James, 1987).

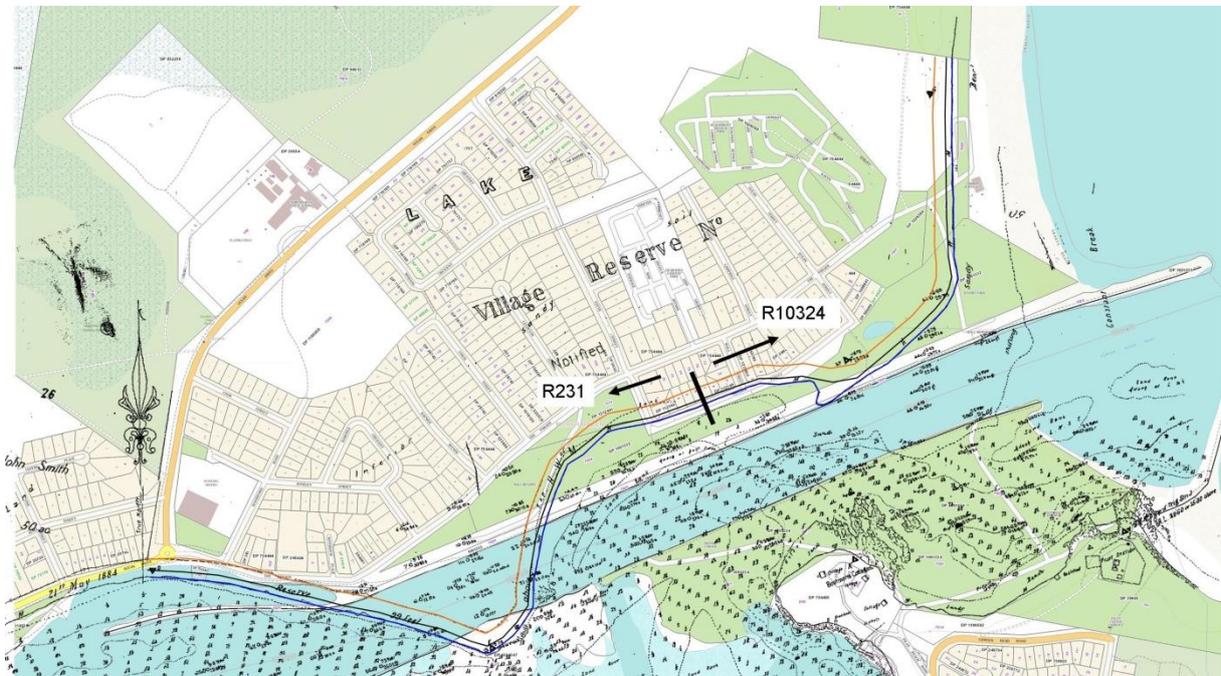
Figure 8: Hydro survey overlaid to cadastre. Landward boundary of R231-R10324 and side of road marked in orange. Opposite side of public road marked in black, and mean high water marked in blue.

A simple graphic overlay of the hydro plan to the existing cadastre is sufficient to provide an adequate picture and reveal some startling anomalies (Figure 8). Not only is the gazetted location of the reserves, and thus the road, in complete contrast to what the cadastral record portrays, there are overlapping entities, some of which would have adverse impacts upon people's personal holdings. Most impacts are fortunately upon what has been often referred to as the Crown Estate. The impacts mostly affect other reserves and the course of the river itself. The boundary between R231 and R10324 can also now be located though still only approximately as there is a bit of latitude as to what position along the foreshore the entrance of the river is found. As the boundary between the reserves was at the entrance to the river, by extrapolation that boundary, if the riparian boundary rules were ignored, would still be at the entrance which is now located out through the training walls. The reserve inside the entrance should be R231 and that outside R10324. Thus it can be established that what is shown in the current cadastre as R10324 should have been shown as R231, all be it in the wrong place.

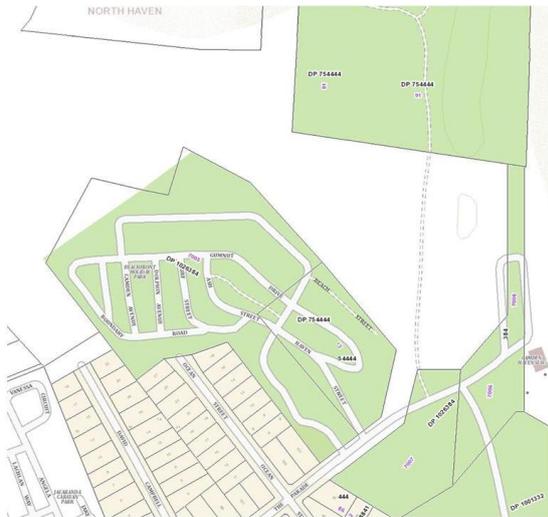
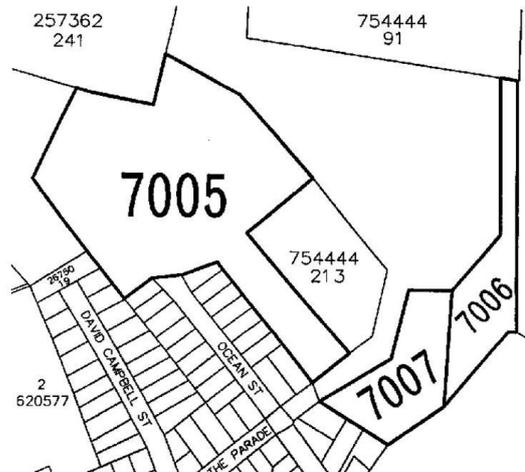
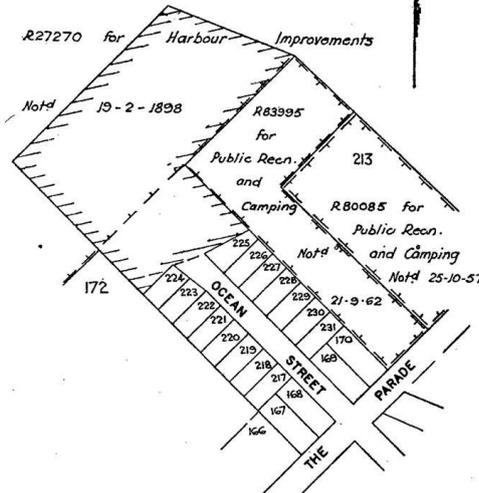
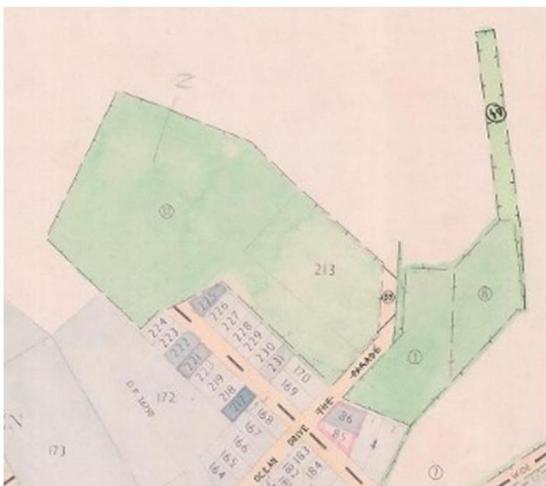
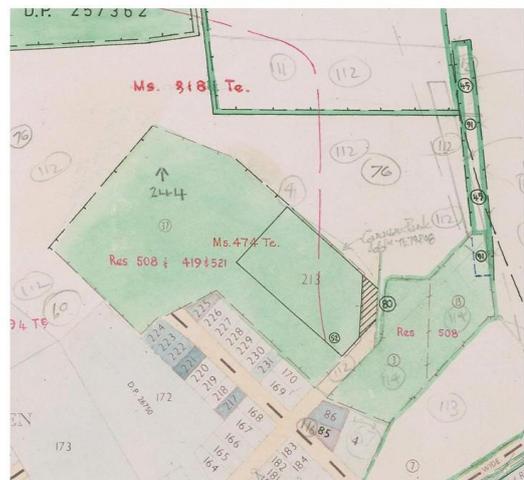
Electronic cadastre

Diagram from Gazette 25 September 1970 addition to reserve R83995

Of particular note is the north west boundary of lot 7005. Only one version of the cadastral record shows the boundary in its correct alignment.

Parish Queens Lake edition 9 Diagram A
 Head office version

Parish Queens Lake edition 9 Diagram A
 Local office version

Figure 9: Boundary anomalies with lot 7005 DP1026384.

Lot 7005 DP1026384 is another example of how descriptions and diagrams in gazettes that establish the existence of a cadastral entity can get misinterpreted. Add to this inappropriate record manipulation, and the result is another part of the cadastre is in error. Figure 9 shows the various states of the cadastral record in comparison to the gazette diagram that created the

Prior to the creation of the electronic cadastre, this parcel did not exist. It was inappropriately created solely from the imagination of the builders of the electronic cadastre and has no basis for existing from any activities throughout the analogue era of the cadastre. By rights much of the parcel should be the Camden Haven River.

As can be seen from the aerial photography, the fictitious parcel covers a number of different landforms including the remains of the spit that should by rights be on the northern side of the river and in the parish of Queens Lake. There may have been attributes assigned to the parcel since the commencement of the electronic record, but as the parcel is invalid so too are these attributes. The only attribute valid within the area at the close of the analogue cadastre was over the small island located in the western corner of lot 7019. This was Reserve 88143 for future public requirements and certainly did not extend beyond the mean high water mark of the island. The remains of the spit from the north side of the river in the north-east should be another lot. The instance of R10324 and the associated public road have already been established as being recorded incorrectly. The correct location of these entities also impacts on this fictitious parcel. These are but a few of the errors that still exist in this area.

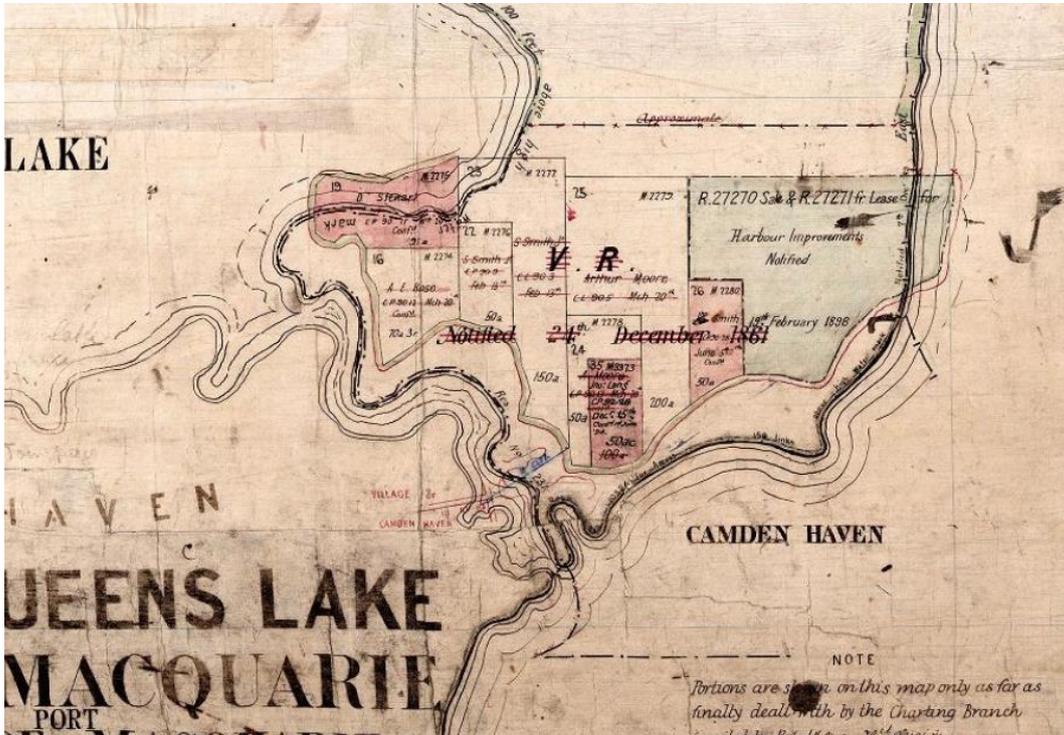
Appendix A1

Edition 1, in use from 1881 to 1898. There was no indication as to why the double image should occur.

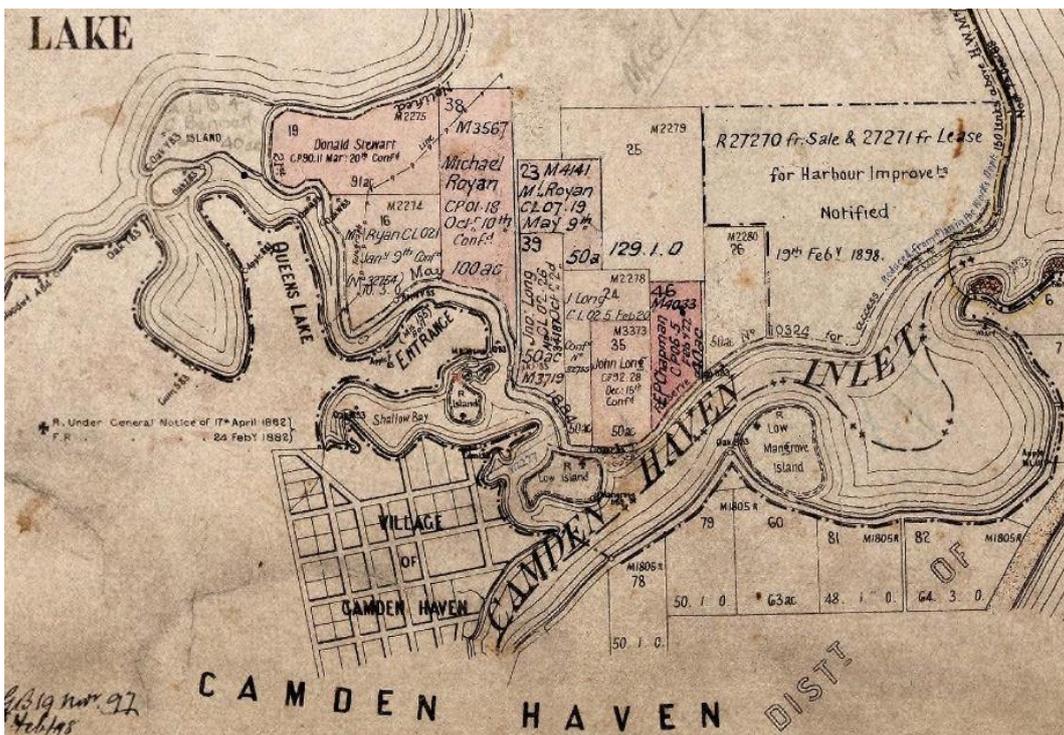
Appendix A2

Edition 2, in use from 1898 to 1914.
