Nepean River Green Bridge (Yandhai Nepean Crossing)

ABSTRACT

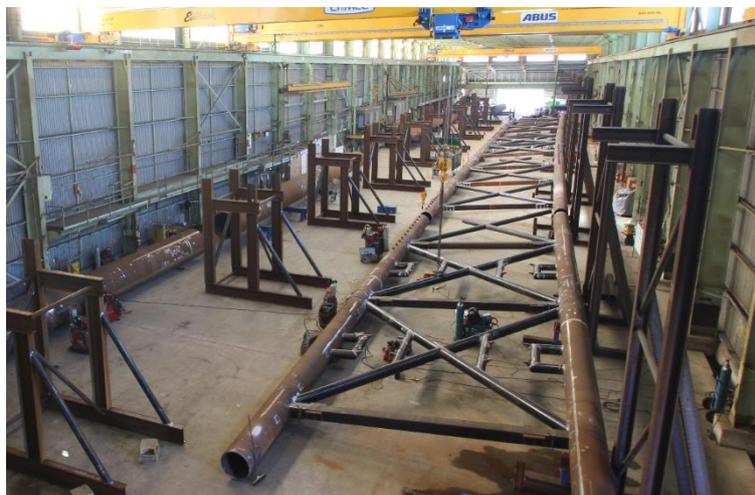
Figure 2: Manufacturing of top and bottom chords/bays. These we surveyed to ensure correct lengths and grades.

The fabrication of the structural steel components was undertaken by Civmec at their Tomago (Newcastle) Engineering Facility for a ‘trial fit’. This trial fit was basically manufacturing and then constructing the steel truss bridge (tack or pre welding) to ensure the strict spatial tolerances were achievable. After conformity, the structural steel of the bridge would be dismantled and delivered in 8 bays – 25 m long by 8 m wide. Each bay was split by the bottom floor and top truss due to height restrictions, supplying the complete bridge in components (Figures 2-4).

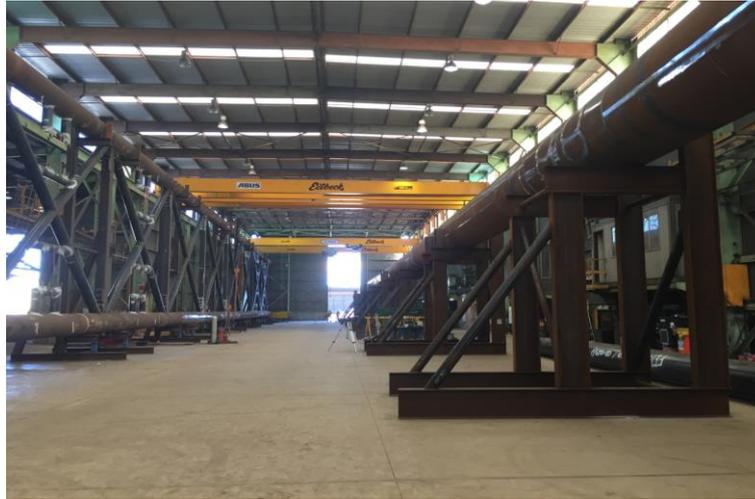
Figure 3: Bottom and top chords/bays lifted into their correct horizontal and vertical alignments. These alignments were positioned by survey. Inter-connecting bays at this stage were only tack/pre welded together as a part of the trial fit.

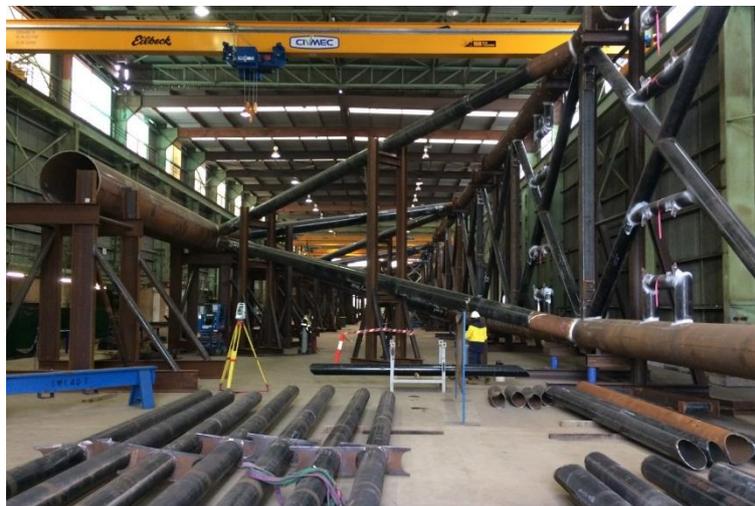
Figure 4: Diagonals being craned into position with the aid of survey and then being tack/pre welded together ready for conformance surveys.

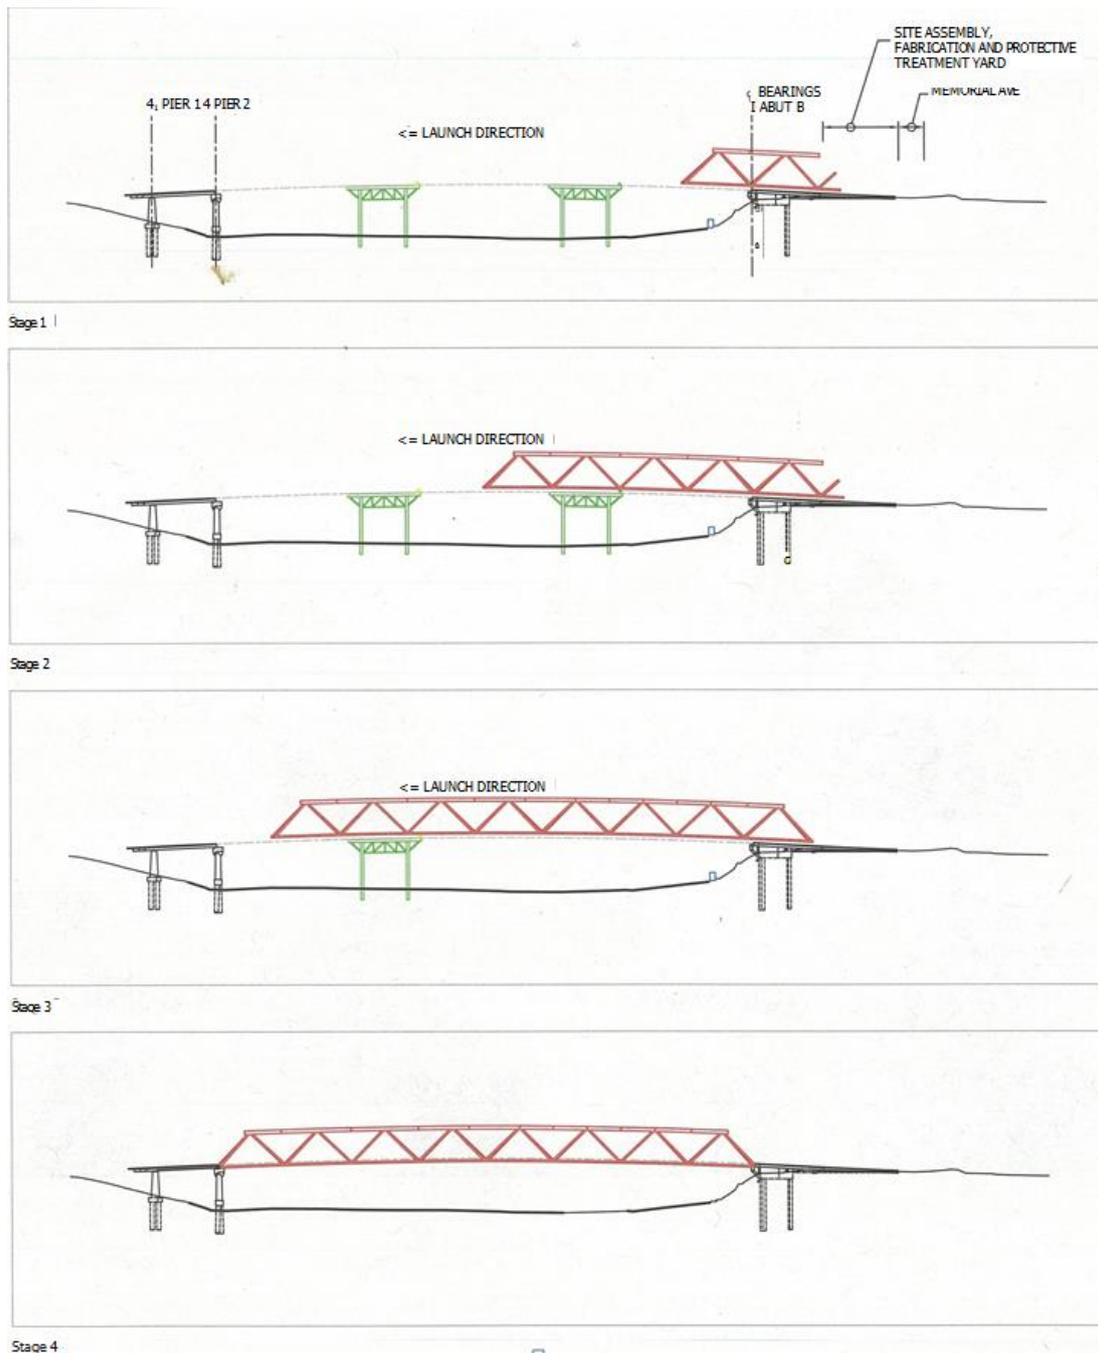
Figure 5: Using temporary piers to progressively launch the bridge across the river.

Once in Penrith, the final bridge section re-assembly took place in a 65-metre long and 15-metre high purpose-built workshop, which included two brand new 20-tonne gantry cranes and engineered collapsible access platforms 12 m high. After the re-assembly and conformance of each bay, which was a very meticulous process for the bridge fabricator and surveyors, the bridge was painted and progressively launched across to the western side. Temporary piers were

installed while the bridge was being moved to its final position (Figure 5).

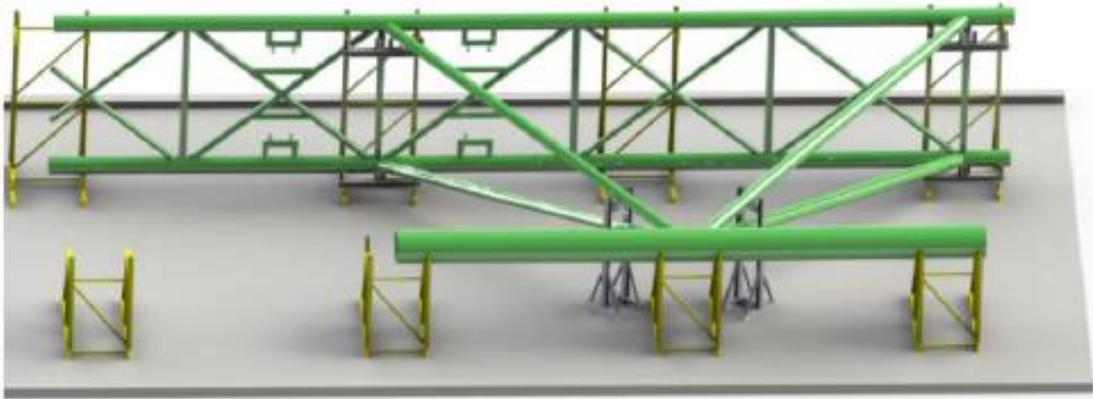
Figure 6: Assembly sequence of nodes/braces into the final jig.

Bays 1-5 along the bottom two chords and bays 1-4 along the top chord was section 1. After truss fabrication and 3-dimensional conformity the bridge was dismantled, sent for painting and transported to Penrith for re-assembly. Section 2 consisted of bays 5-9 along the bottom two chords and bays 4-8 along the top chord. To make this 2-staged process a little more difficult, the truss had to be constructed on a rotation of 90 degrees so that it would fit into the workshop. The re-assembly in Penrith was performed with the truss in the upright position.

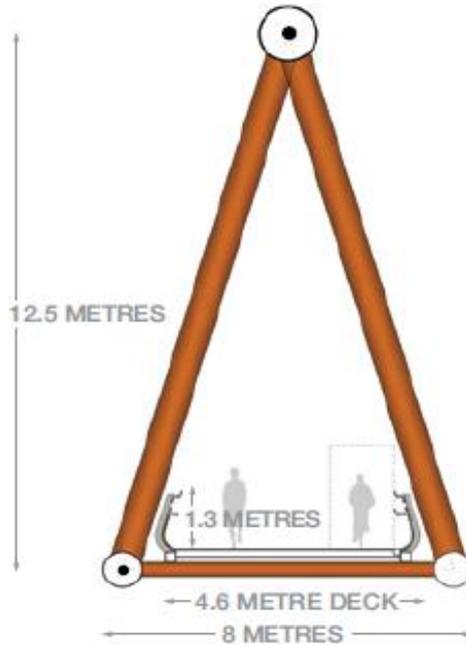
Figure 7: Scaled cross section of the bridge (indicative only).

The enormity of the project becomes clear when a scaled cross section of the bridge is produced (Figure 7). The top chord diameter is 1450 mm with the bottom two chords being 750 mm. The thickness of the steel varied from 25 to 40 mm.

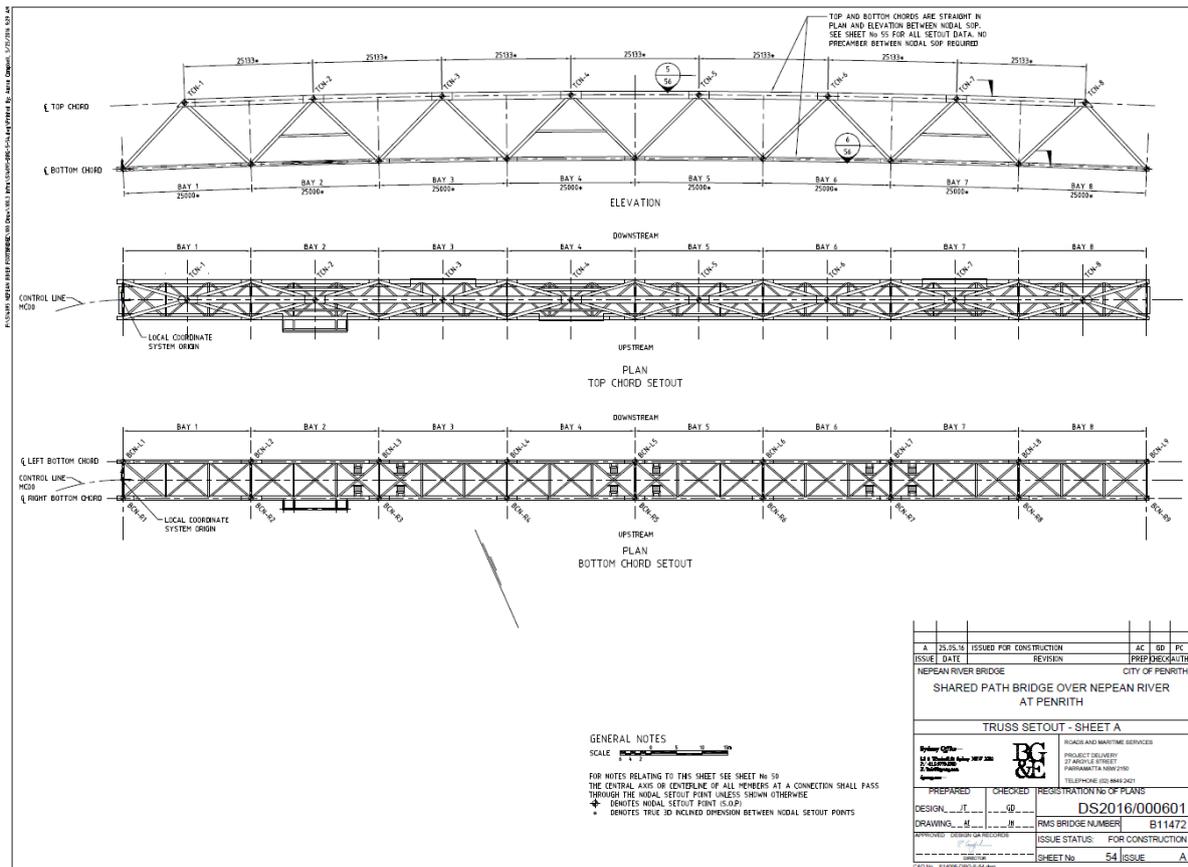
Figure 8: Diagram illustrating The Nepean River Bridge.

From a surveying perspective in terms of just the steel truss, the points of interest referencing all of the individual components together were the ‘nodes’. There were nine nodes along each bottom chord and eight on the top chord. In total, there were 26 nodes requiring positioning to a very high precision (Figure 8).

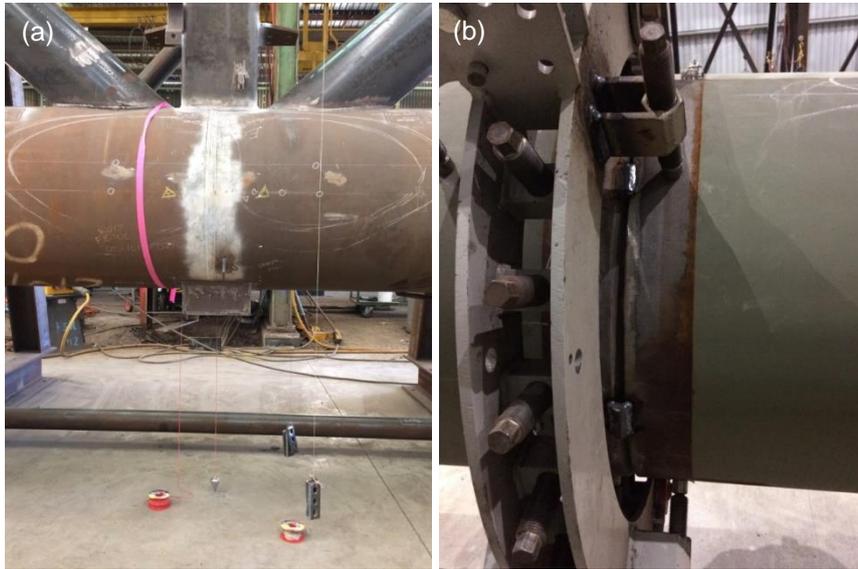
Figure 9: (a) Node positions are the centre point of the intersecting chords, and (b) butt joint alignments were critical and difficult to survey due to accessibility (here the joint is being tack welded together).

The complexity associated with surveying, calculating, coordinating and positioning the nodes was that they were a point in space that could *not* be accessed. They were actually the centre point on the inside of intersecting tubular steel (Figure 9a). In addition to positioning these node 'reference points', it was critical that the butt joints connecting each node exhibited little to no deflections. The butt joints were located mid span between each node (Figure 9b). For the truss to maintain its structural integrity, it was paramount to have these joints within millimetres of the horizontal and vertical alignments.

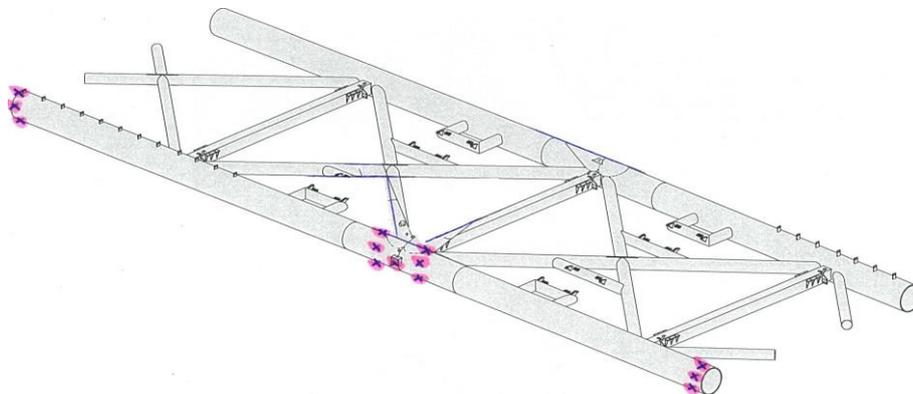
Figure 10: Diagram illustrating indicative field observations on the bottom truss bay.

Node positions were calculated and verified by surveying the outside of pipes (measuring the circumference, dividing the pipe into equal quadrants and locating accurately by EDM), creating pipe centrelines and extrapolating lengths until a common chainage was reached (Figure 10). Through trial and error, it was concluded that intersecting lines on flat grades produced large error ellipses which rendered the technique not viable for this project.

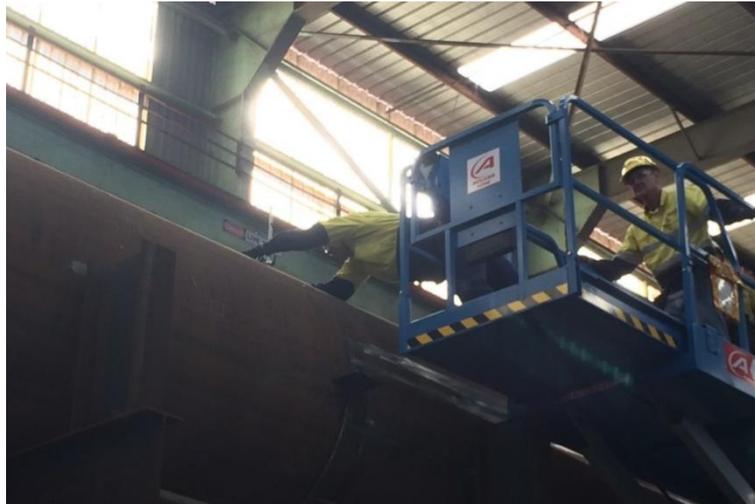
Figure 11: Taking a measurement on top of a pipe suspended 4 m or higher above the ground.

Figure 11 illustrates that taking a measurement on top of a pipe suspended 4 m or higher above the ground required problem solving skills. It was impossible to see directly onto the top of the pipe, and due to obstacles and safety, accessibility was very difficult. Holding a ranging pole vertically and record accurate measurements safely was next to impossible. The hidden point tool (Figure 12) became invaluable in this situation.

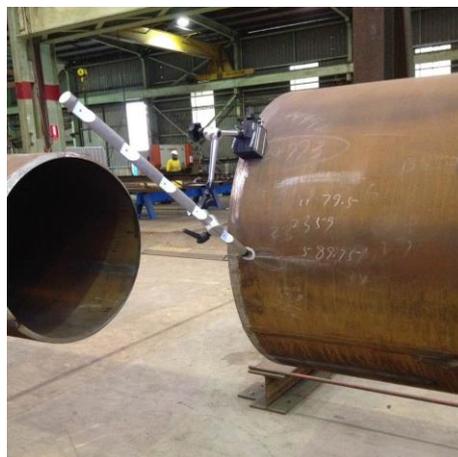
Figure 12: Hidden point tool in action.

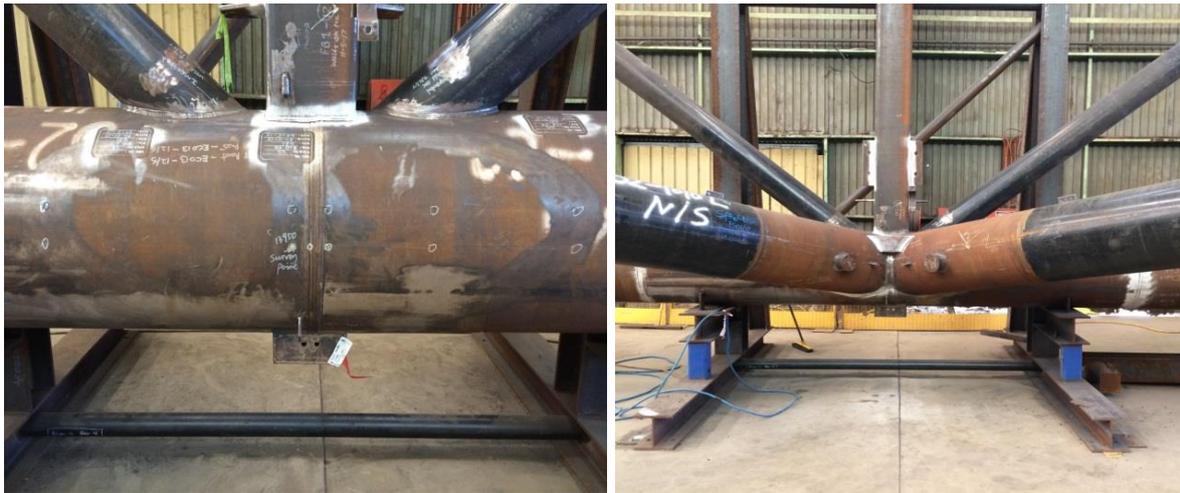
Figure 13: Adding pipes to the truss caused punch marks to be destroyed.

However, as more and more pipes were being added to the truss, punch marks started to be destroyed (Figure 13) – just like traditional survey marks! It was therefore necessary to continuously monitor, upgrade and replace marks.

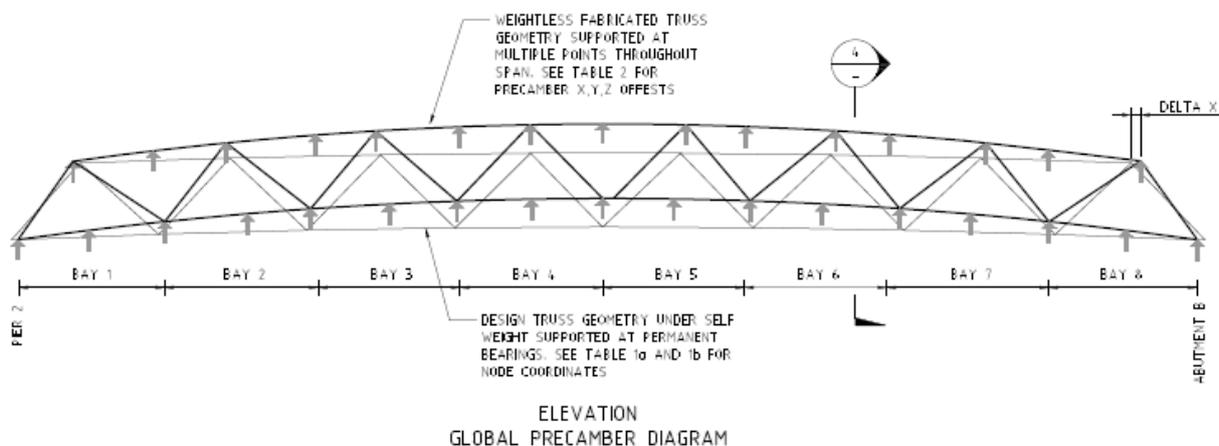
Figure 14: Visual difference between the ‘weightless’ and ‘under self-weight’ bridge geometry.

Figure 14 illustrates the visual difference between the ‘weightless’ and ‘under self-weight’ bridge geometry. In order to determine the weightless fabricated node geometry that was used to perform the set-out work in Tomago, pre-camber offsets had to be applied to the under self-weight design truss node values. Extreme care was required in performing these calculations because pre-camber values were sometimes positive and sometimes negative.

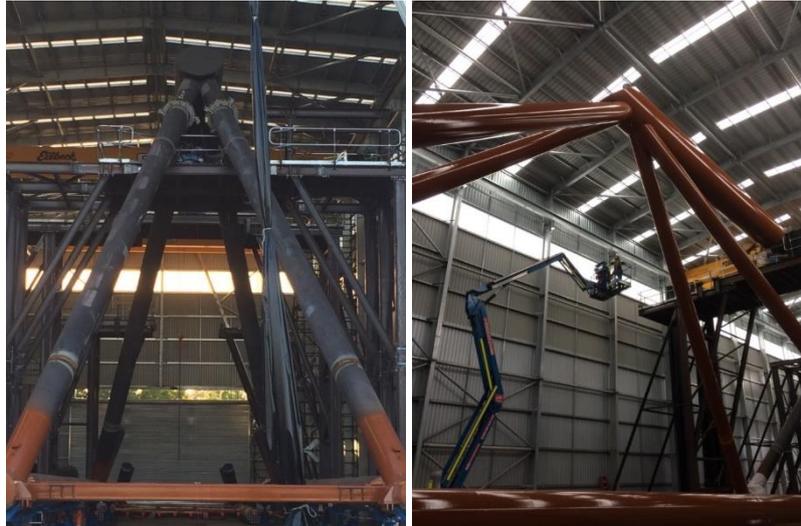
Figure 16: Re-assembly process.

In order to re-position the nodes, our reference/punch mark values derived in Tomago were utilised, now *rotated* upright (Figure 15 & 16). To take advantage of optimum temperature conditions, RMS performed critical survey measurements of nodes and butt joints in the very early hours of the morning. It took around 2 hours to record approximately 15 precise measurements because accessibility in the purpose-built workshop was slow and difficult. Extreme care was taken for all surveying activities to ensure accurately recorded measurements were taken on every occasion.

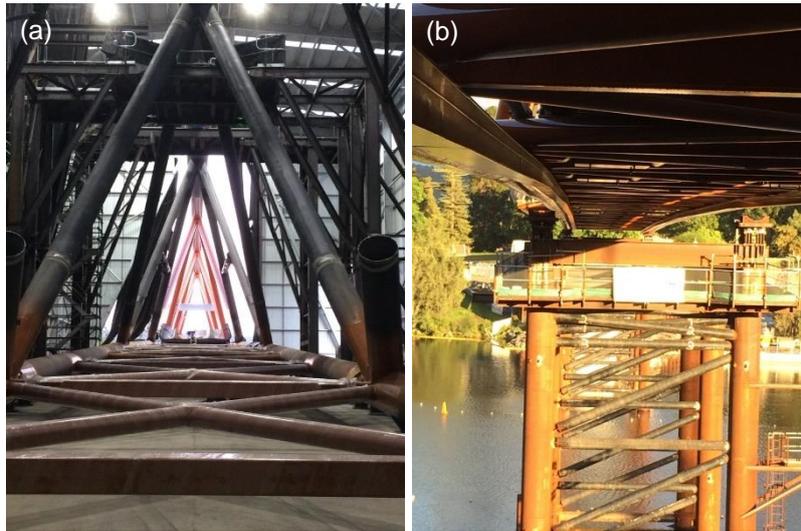
Figure 17: (a) View of triangular shaped truss being re-assembled in sections, and (b) nodes being supported during launch vary due to the vertical alignment.

Figure 17b illustrates that as the bridge was being progressively launched, the nodes being supported would vary due to the vertical alignment.

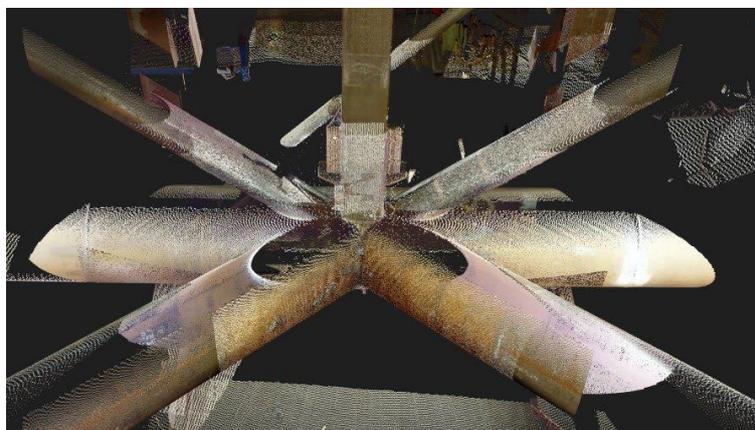
Figure 18: Scanned image of a node.

By utilising the latest surveying theodolites and traditional surveying techniques, real-time results were provided on a very complicated project. Being able to assist, guide and provide information in real time on a construction site in a pressurised environment is paramount, hence the reason for using traditional equipment. As an independent sanity check, nodes were often scanned to verify the conformance reports (Figure 18). The scanned results provided excellent comparisons often to within millimetres to the values determined by conventional means.

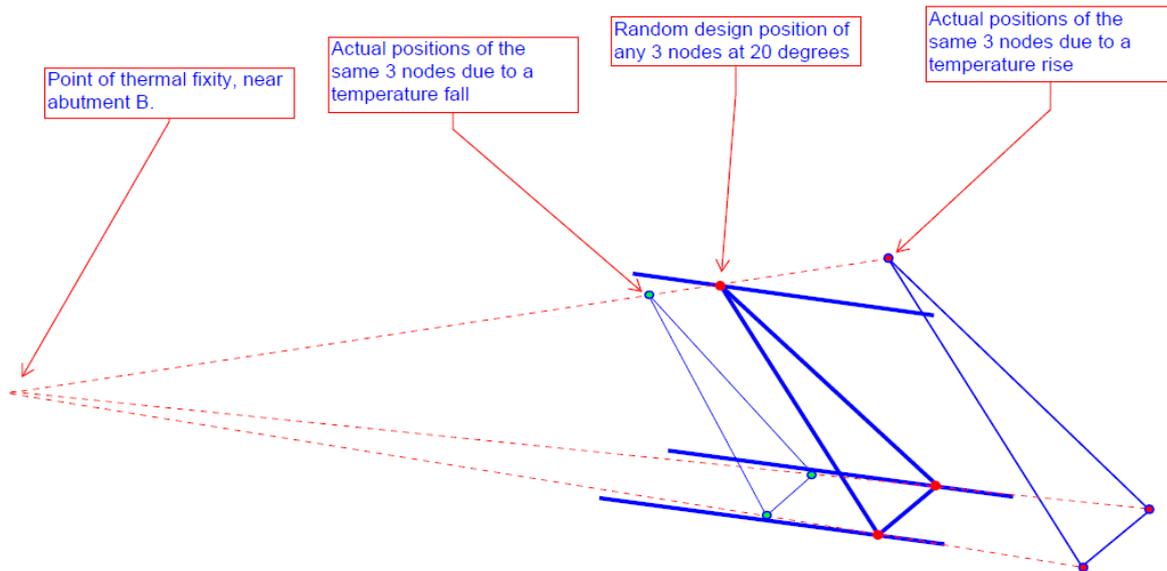
Figure 19: Diagram illustrating that thermal expansion is 3-dimensional.

With these extremely high summer temperatures, the expansion of the steel truss was so significant that it actually started to distort out of its true geometrical shape, even after being completely welded. The uncertainty in these circumstances was how consistent can the linear thermal expansion of steel be applied? A 20°C temperature variation over the length of a 25 m bay is equivalent to approximately 6 mm in length. Taking this into consideration and remembering that the thermal expansion of the truss will occur 3-dimensionally (Figure 19), trying to achieve this spherical (pea size) accuracy of 5 mm was becoming more and more difficult to achieve. Another factor that required consideration was the further away from the standardised 20°C temperature critical surveying measurements were performed, the least confident or accurate the corrections for the linear thermal expansion of steel became.

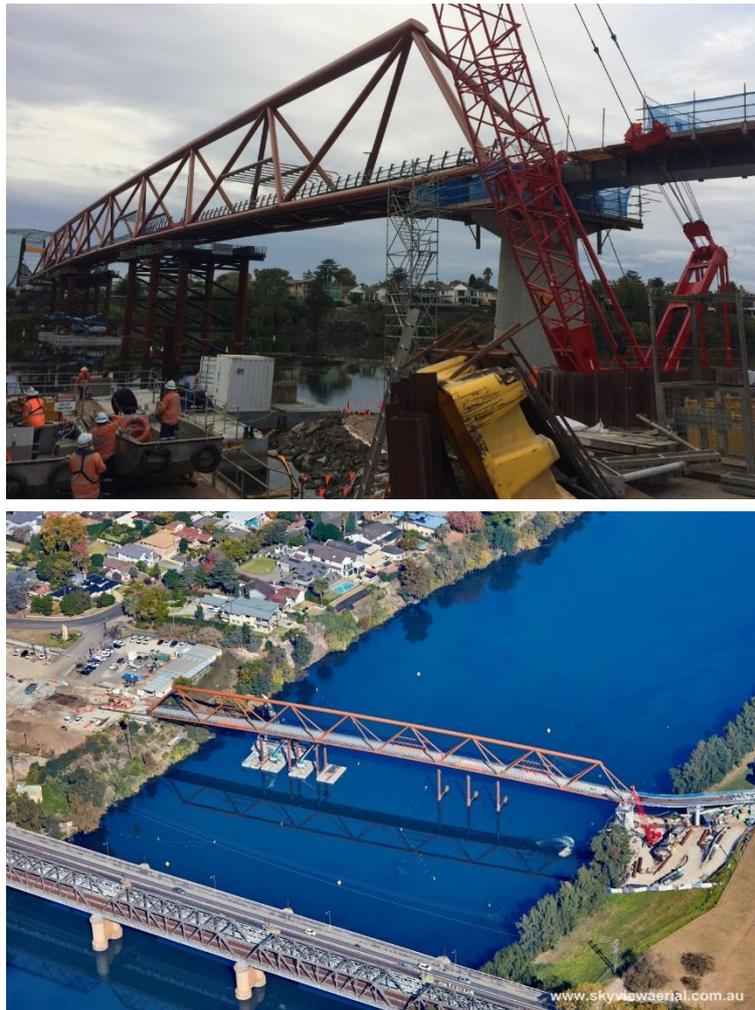
Figure 20: Construction of the Nepean River Green Bridge.

This paper has outlined the numerous surveying challenges encountered during the fabrication, construction and launch of the Nepean River Green Bridge (Figure 20), which was officially opened on 28 October 2018 and is now called Yandhai Nepean Crossing. In undertaking this project, many difficulties were encountered, which required an elevated level of problem solving skills and technical excellence to overcome.
