The Skeletons in Shrimpton's Creek

Fred de Belin

City of Ryde

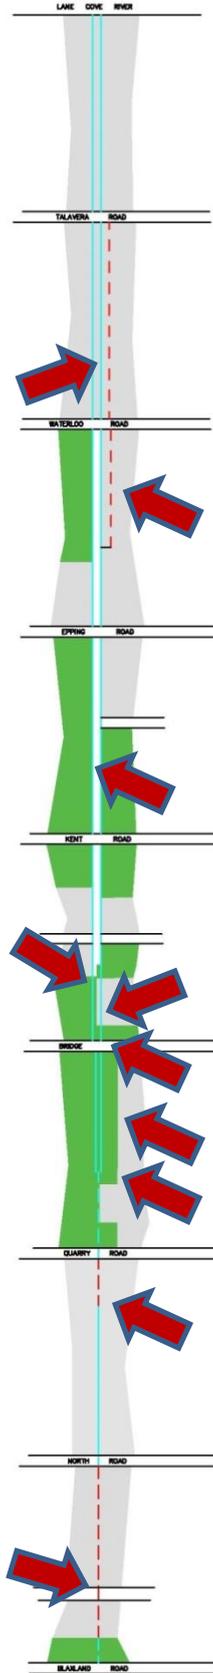
Figure 1: Schematic diagram of Shrimpton's Creek, showing ownership by City of Ryde (green) and the whereabouts of the skeletons.

Shrimpton's Creek is approximately 5 km long and flows through the largest stormwater catchment area within the Local Government Area of the City of Ryde. Issues uncovered by de Belin (2019) have produced an abundant array of anomalies and strange happenings when it comes to such straightforward processes as the definition of land subject to a Primary Application, the creation of natural boundaries for land parcels and the creation of drainage easements for the benefit of City of Ryde. These anomalies and strange happenings are the skeletons in Shrimpton's Creek (Figure 1).

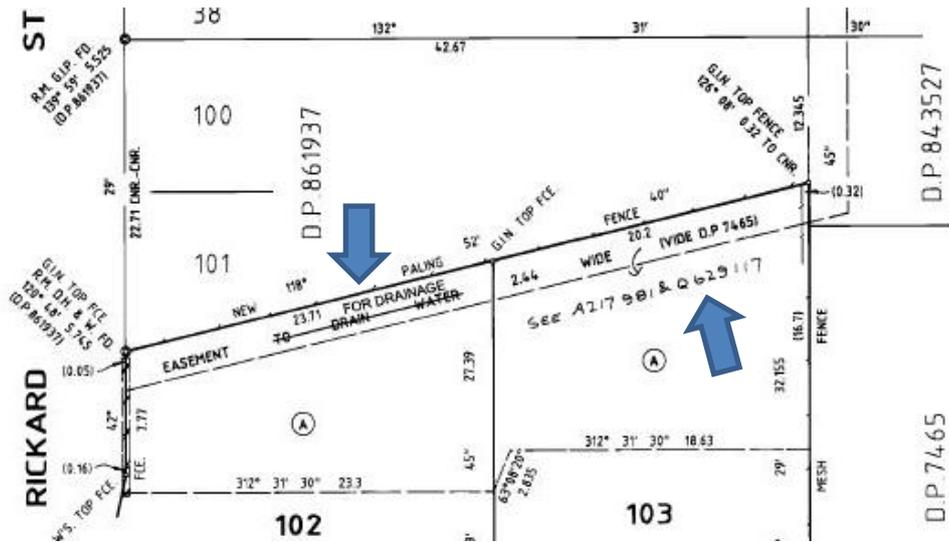
Figure 4: Detail of DP 1016711 (1999), showing “Easement for Drainage 2.44 wide”.

How did this easement suddenly become 2.44 m wide? No new easement was created! Recent Strata Plan 91335 (2016) shows “*Right of Drainage*” and “*Easement for Drainage*”, both 2.44 m wide (Figure 5), and the Certificate of Title also cites to the two original transfers mentioned previously.

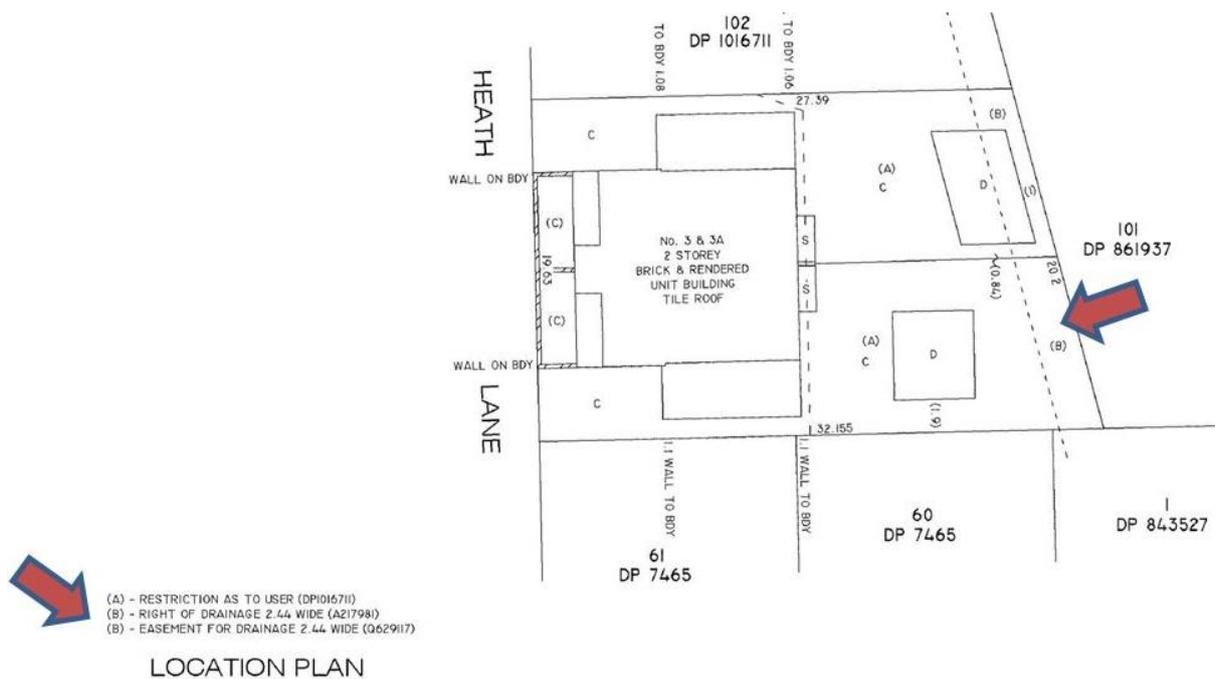
Figure 5: Detail from SP 91335, showing “Right of Drainage” and “Easement for Drainage”, both 2.44 m wide.

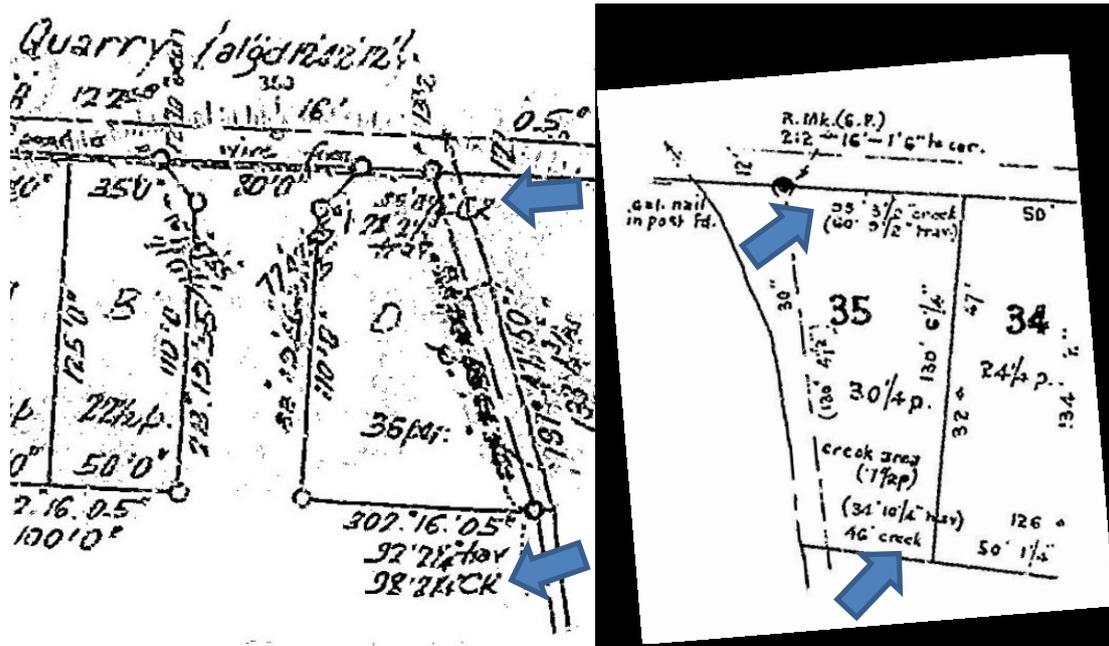
Figure 6: Detail of DP 393494 (1955) and DP 27088 (1956), showing boundaries, Lot D and Lot 35, “to creek”.

DP 389640 (1954) and DP 27088 (1956) created adjoining lots with a natural boundary between, being the centreline of a “*small watercourse*”. Dimensions in these two DPs, surveyed by two different firms, indicate that the creek has no width. DP 393494 (1955) and DP 27088 (1956) show dimensions “*to creek*” but mean to the centreline of creek (Figure 6).

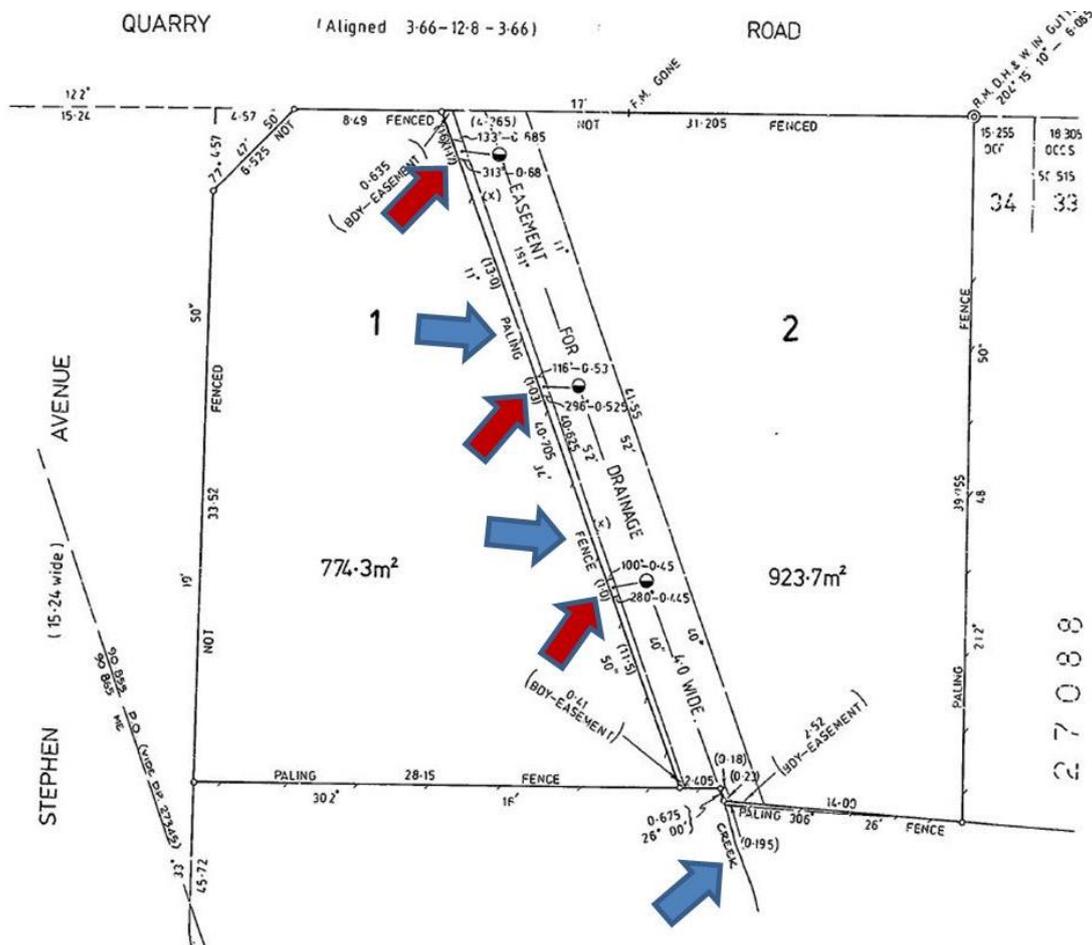
Figure 7: Detail of DP 701738 (1982), showing right line boundary between Lots 1 and 2.

DP 701738 (1982), a 2-lot subdivision of Lot D and Lot 35, created a single right line boundary, generally following along a fence occupation, between the new Lots 1 and 2, which effectively eliminated the previous natural boundary (Figure 7).

This DP 701738 (1982) created an “*Easement for Drainage 4.0 wide*”, for the benefit of City of Ryde, over a large concrete stormwater drainage culvert, which was constructed roughly along the centreline of the original small watercourse. The western edge of this Easement for Drainage fell short of the new lot boundary by between 0.41 m and 0.635 m.

DP 701738 (1982) also created three “*Easement for Drainage 1.0 wide*” for the benefit of Lot 1. It seems strange that the Easement for Drainage on Lot 2 was not created as variable width right up to the new boundary in the first place, which would have eliminated the need for the other three easements.

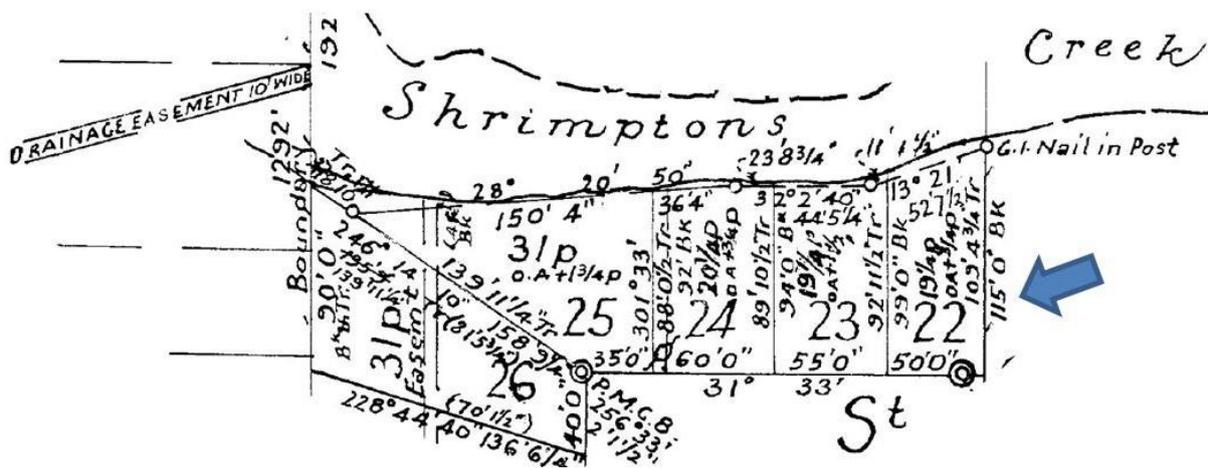
Figure 8: Detail of DP 29029 (1958), showing 115 feet and natural boundary at rear.

A residential subdivision, DP 29029 (1958), created four lots, each having a rear natural boundary, being the bank of Shrimpton’s Creek, with Lot 22 showing a side boundary dimension of 115 feet (Figure 8). An adjoining subdivision, DP 30420 (1959), created lots having a rear right line boundary with Lot 18, which abuts Lot 22, showing a side dimension of 120 feet (Figure 9). How is the 5-foot difference in side boundary length accounted for? One survey states “*bank of creek is boundary*”, the other is 5 feet longer and shows a right line boundary and no creek. What happened to the creek bank in the intervening 12 months?

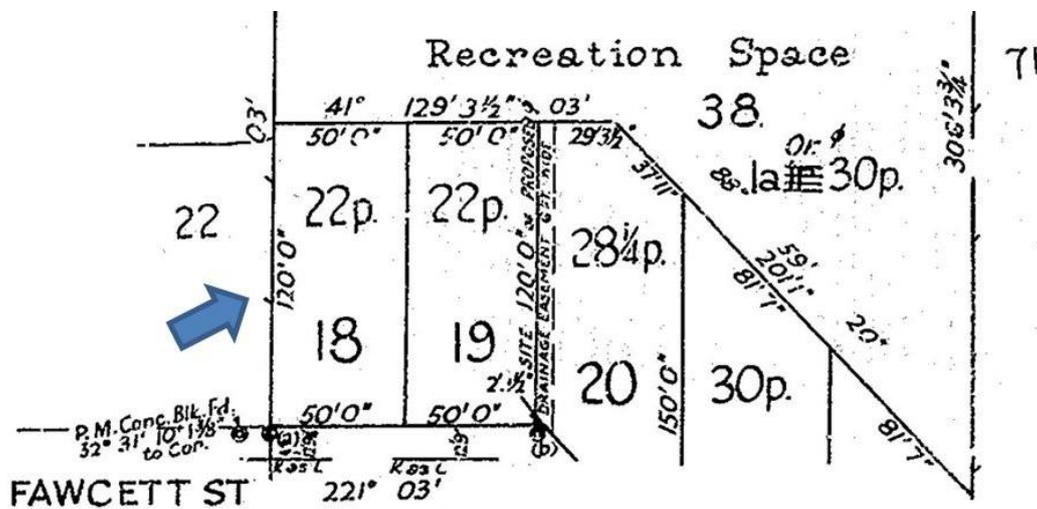
Figure 9: Detail of DP 30420 (1959), showing 120 feet and right line boundary at rear.

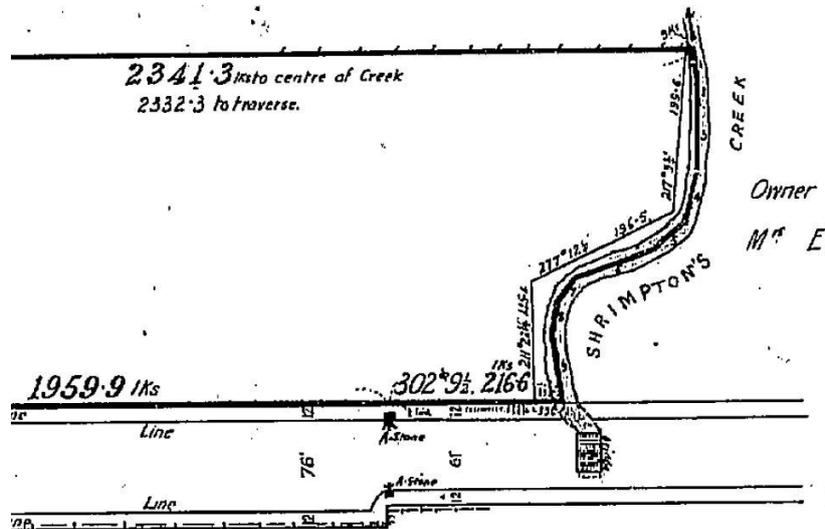
Figure 13: Detail of DP 65830 (1908), showing boundary is centreline of creek.

This is a cautionary tale of creek bed shift, occurring as it did over the years between 1908, 1943, 1957, 1971 and 2018. The land in DP 65830 (1908) (Figure 13) was the subject of Real Property Application 15830 which created Certificate of Title Volume 2059 Folio 121 in 1910, with the description “to the centre of Shrimpton’s Creek thence by the centre of that creek”.

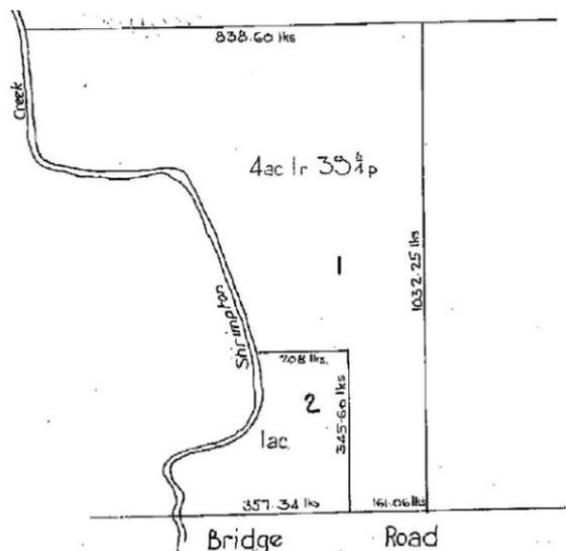
Figure 14: Detail of DP 150926 (1926), showing Old System parcels of land.

On the opposite side of the creek, DP 150926 (1926) (Figure 14) was the whole of land in conveyance Registered No. 990 Book 1147 (1919), which contained the description “to Shrimpton (sic) Creek thence on the North West by the said Shrimpton Creek”.

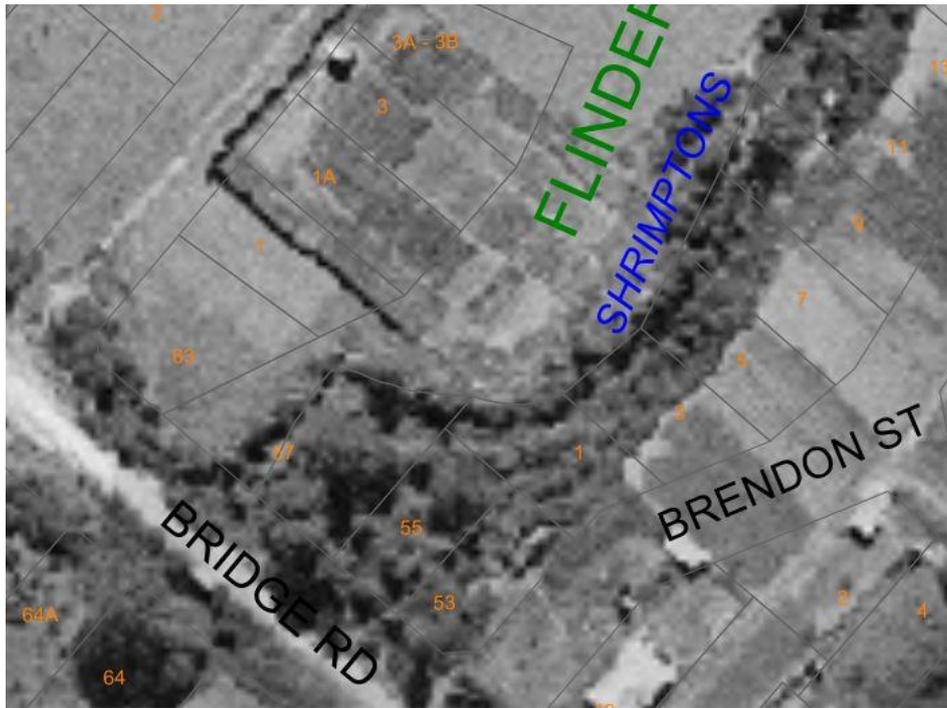
Figure 15: Detail from 1943 aerial image, showing the flow path of Shrimpton's Creek.

The 1943 aerial image (Figure 15) shows the flow path of Shrimpton's Creek.

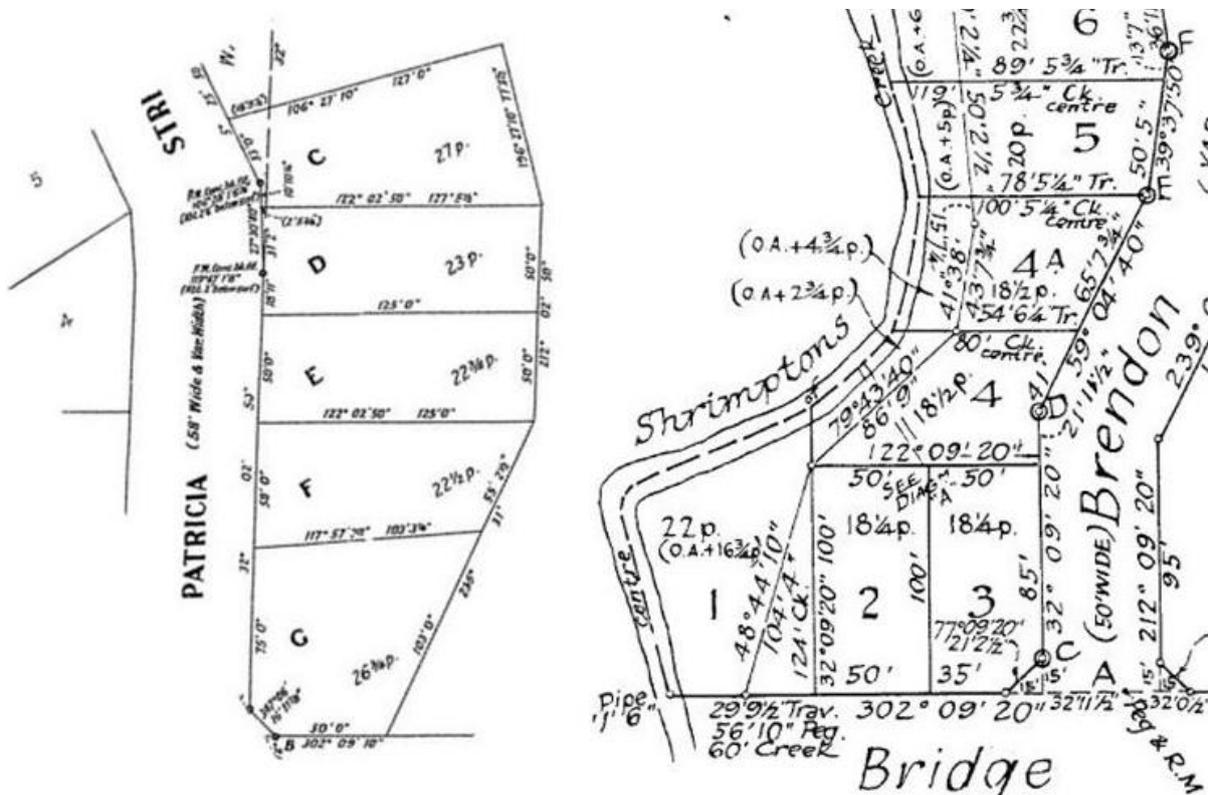
Figure 16: Detail from DP 39133 (1957), on the right, shows boundaries to centreline of creek, while detail from DP 36767 (1959), on the left, shows no reference to the creek.

DP 39133 (1957) created lots with natural boundary clearly being centre of creek (Figure 16), while DP 552490 (1971) was another later plan that also defined the centreline (Figure 17).

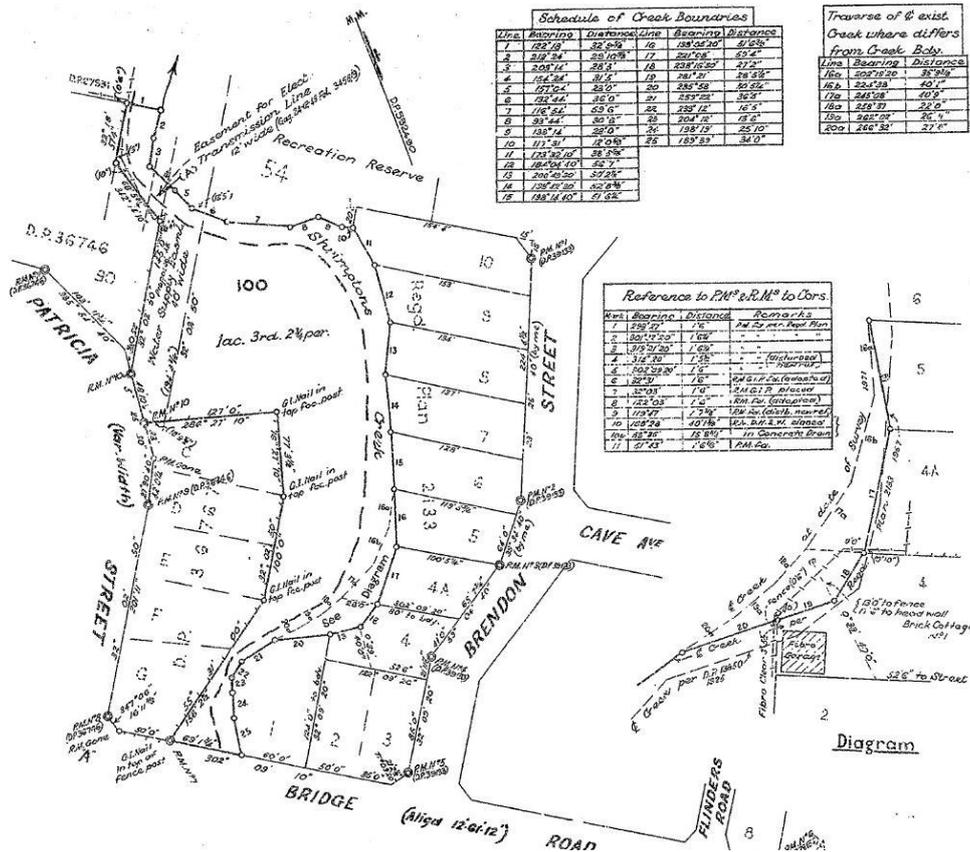
Figure 17: DP 552490 (1971), showing definition of centreline of creek.

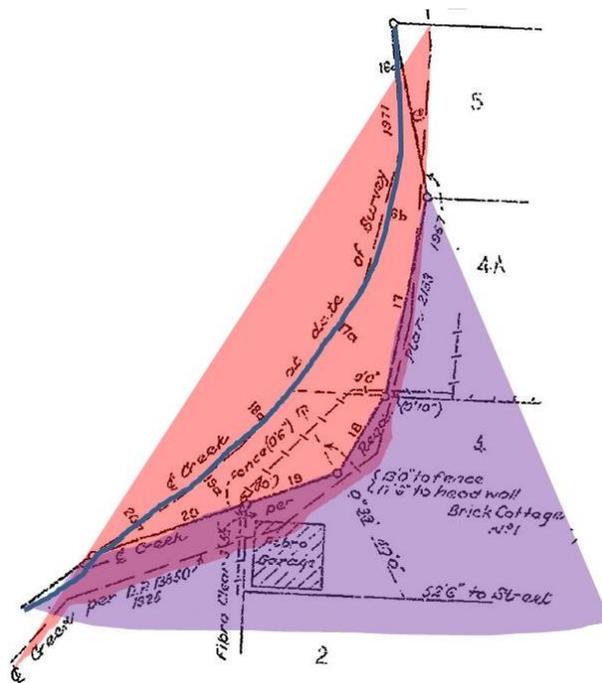
Figure 18: Diagram from DP 552490 (1971), showing centrelines and overlap.

DP 552490 (1971) is a plan of consolidation for the Department of Housing, comprising remnant land along the creek, left over from its residential subdivisions, and shows a history of the position of the creek centreline (Figure 18). The current position, as shown in Figure 18, appears to be shaping back towards earlier times.

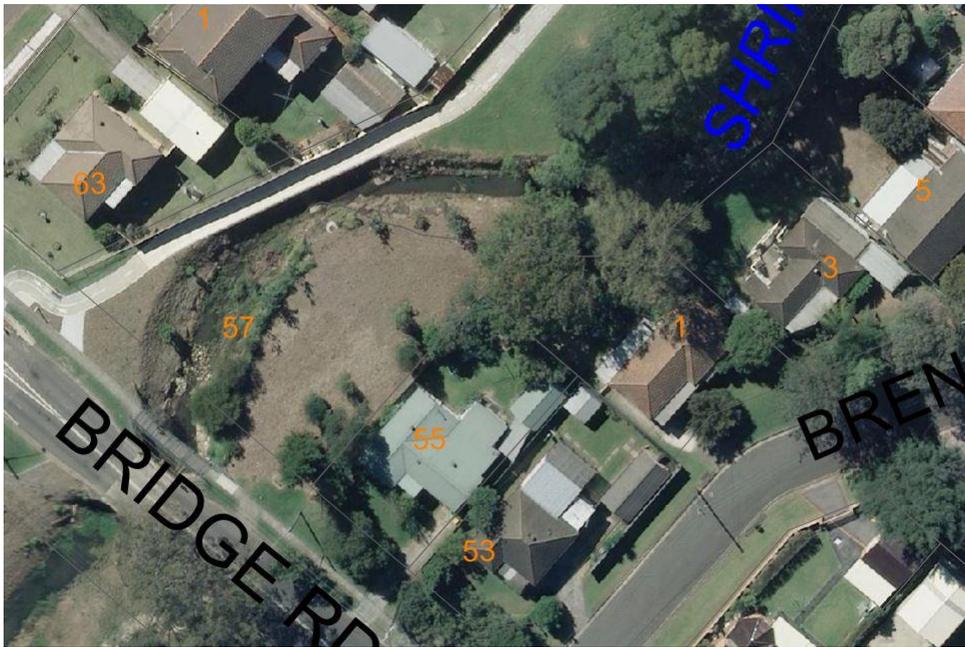
Figure 19: Detail of the creek from a 2010 aerial image.

A modern aerial image from 2010 (Figure 19) shows the relevant section of Shrimpton's Creek. For those wondering why the latest up-to-date image was not used to show the course of the modern creek, Figure 20 illustrates the result of 8 years of reforestation.

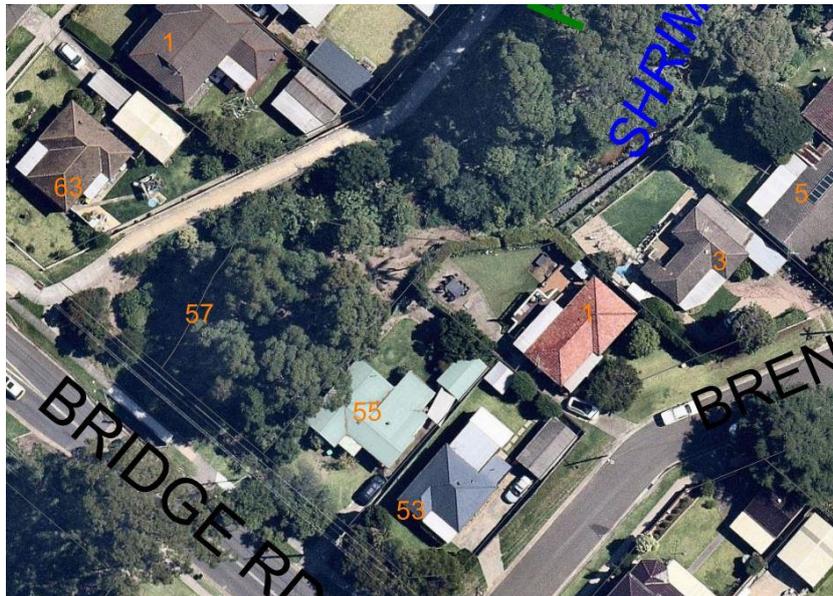
Figure 20: Detail from an aerial image in 2018, showing the result of 8 years of reforestation.

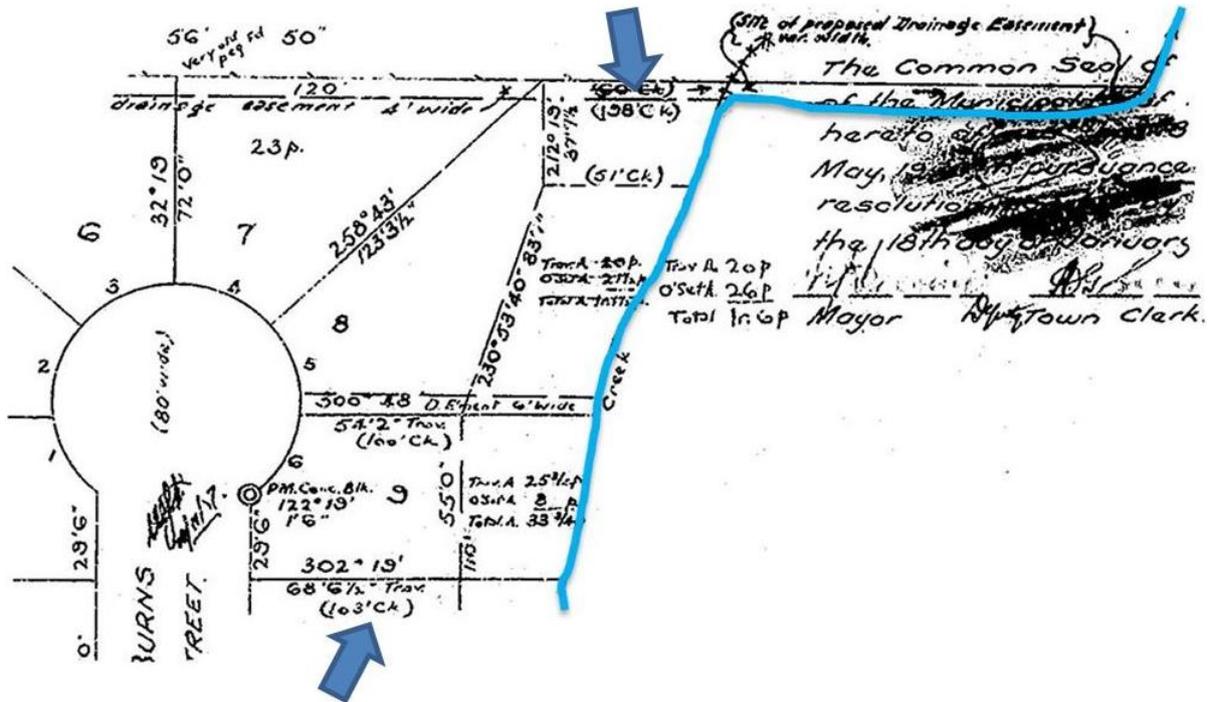
Figure 21: Detail from DP 29229 (1956), showing left bank as title boundary.

In the case of natural boundaries, if the bed (and therefore the bank) movement is incrementally imperceptible, the boundary moves with the bank. However, in this example, the movement is certainly greater and faster than gradual. DP 29229 (1956) is a subdivision that shows the left bank as title boundary (Figure 21). Notice the dramatic direction change in the creek at Lot 8. Notice also the 6-foot wide drainage easement along the southern boundary of Lot 8, which runs 100 feet to the creek bank.

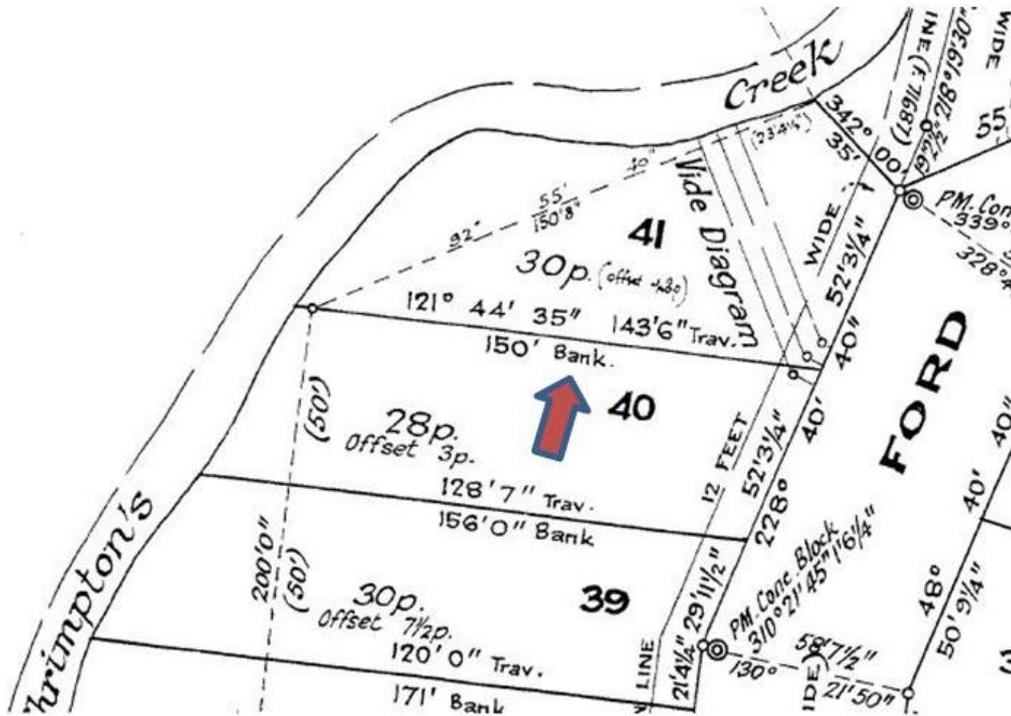
Figure 22: Detail from DP 26924 (1956), showing right bank as title boundary.

DP 26924 (1956) is a subdivision directly opposite, which shows the right bank as title boundary (Figure 22).

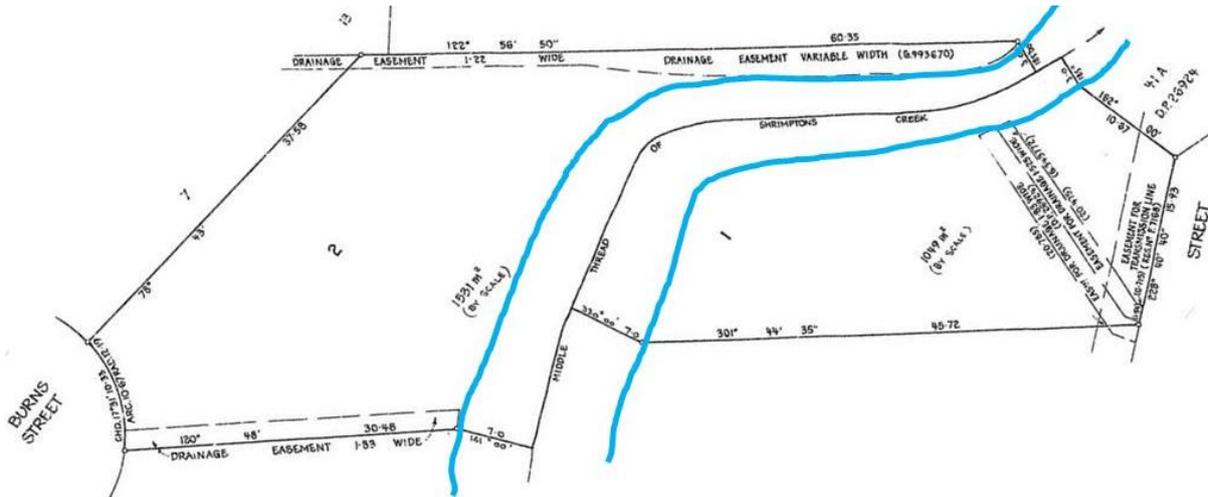
Figure 23: Detail from DP 709174 (1984), showing creek centreline as subdivision boundary.

When DP 709174 (1984) created a subdivision involving Lot 8 and Lot 41 on either side of Shrimpton's Creek, the centreline of the creek was adopted as a natural boundary (Figure 23).

A line was extended from the side boundary, at the end of the drainage easement in Lot 2 (formerly Lot 8 in DP 26924), running at right angles to the creek centreline. In similar fashion, lines extended from each of the other side boundaries in a direction at right angles to the creek centreline.

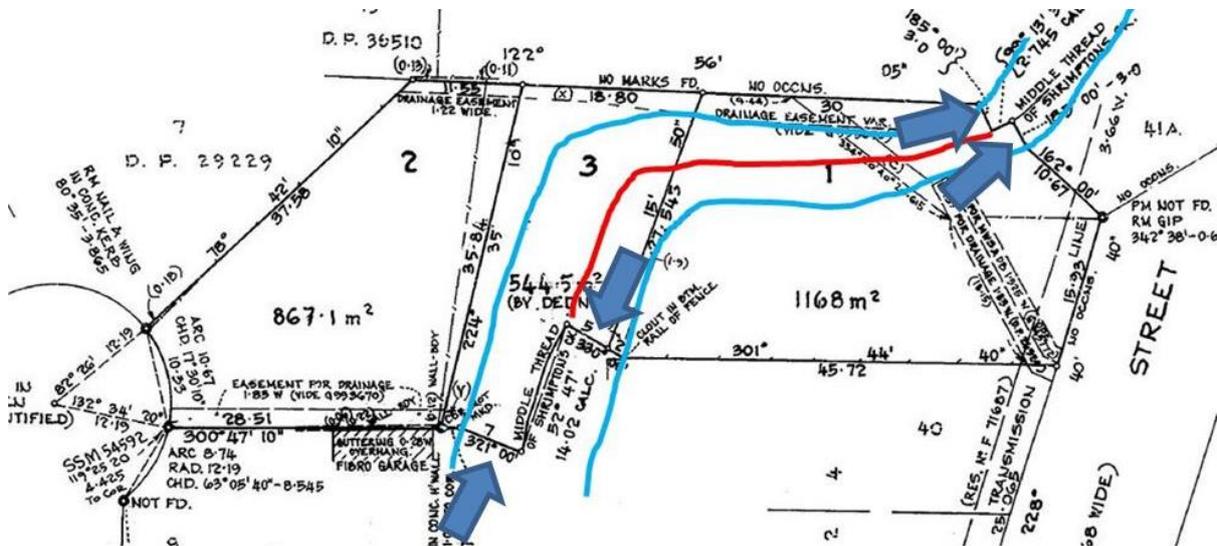
Figure 24: Detail from DP 778388 (1985) with overlay of creek centreline as it was in 1984.

The two lots in DP 709174 (1984) were re-subdivided by DP 778388 (1985), which maintained the middle thread as boundary and created three new lots, two of which encompassed the bed of the creek (Figure 24): Lot 1 and Lot 3.

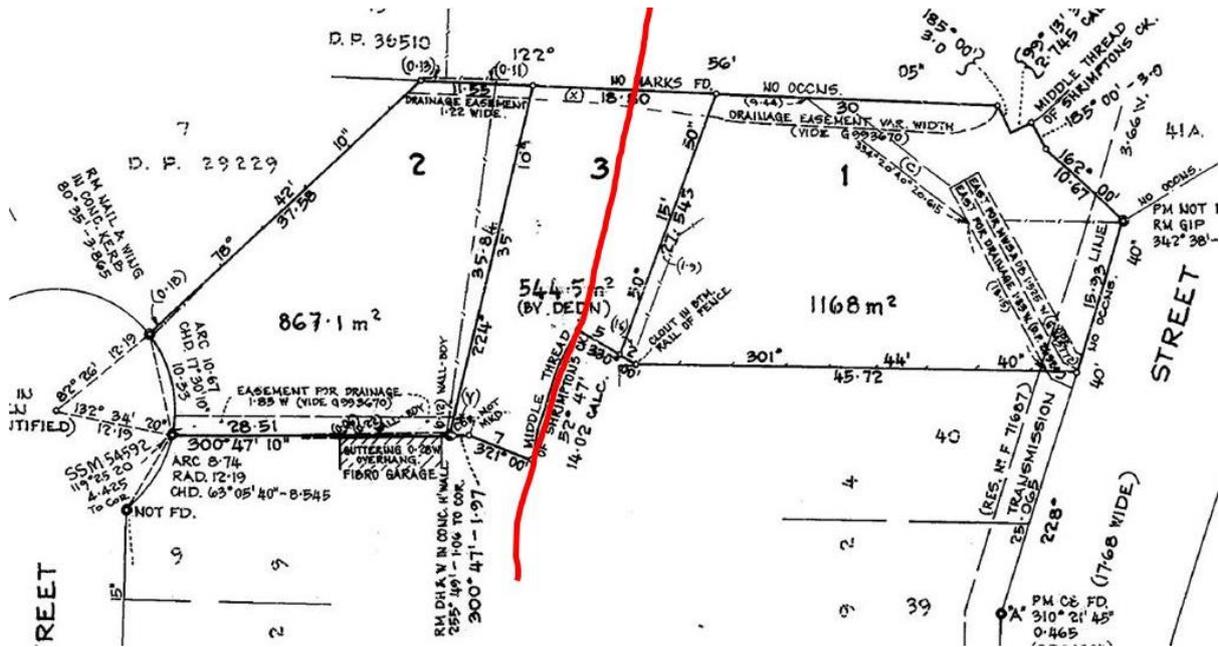
Figure 25: Detail from DP 778388 (1978) with overlay of creek centreline as it is today.

The creek bed has since been shifted over 40 m and re-directed completely away from Lot 1 (Figure 25). City of Ryde owns Lot 3, which now contains the whole of the bed of Shrimpton's Creek. Notice Lot 1 now shows no evidence, nor the whereabouts, of a previous creek bed (Figure 26). This is all very well, but what is the effect of a 40 m shift on riparian boundaries downstream? Luckily, there is only one lot affected, Lot 41A in DP 26924, which is owned by City of Ryde and forms part of Tindarra Reserve. Other residential subdivisions downstream have right line rear boundaries and do not have a natural boundary being Shrimpton's Creek.

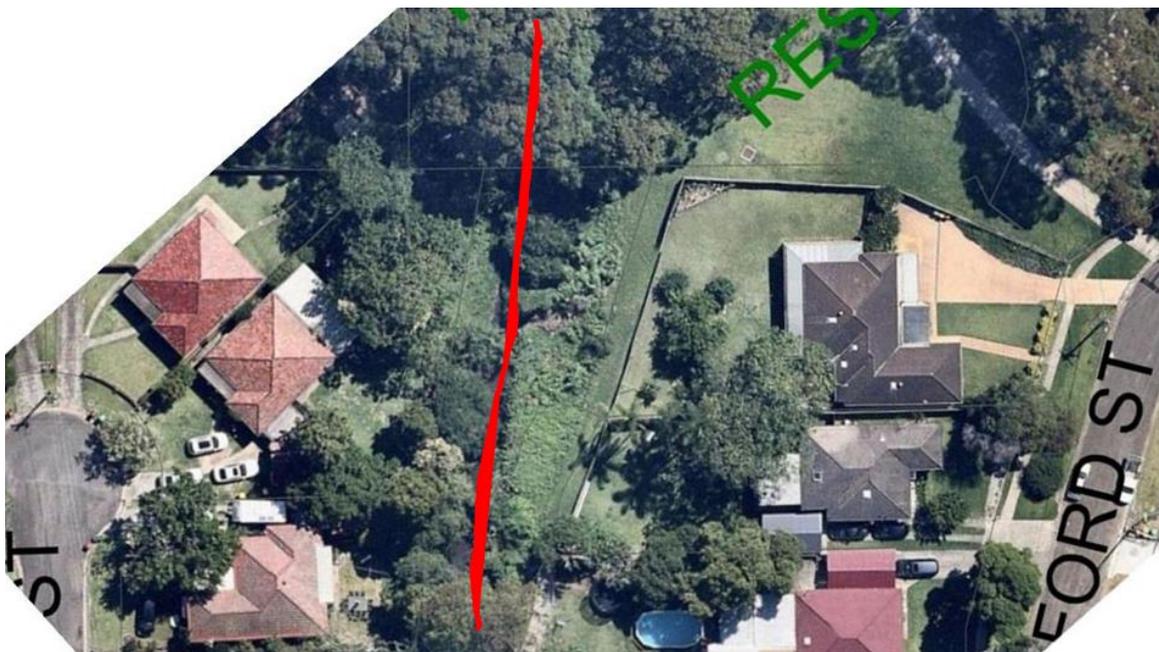
Figure 26: Detail from aerial image (2018) with overlay of creek centreline.

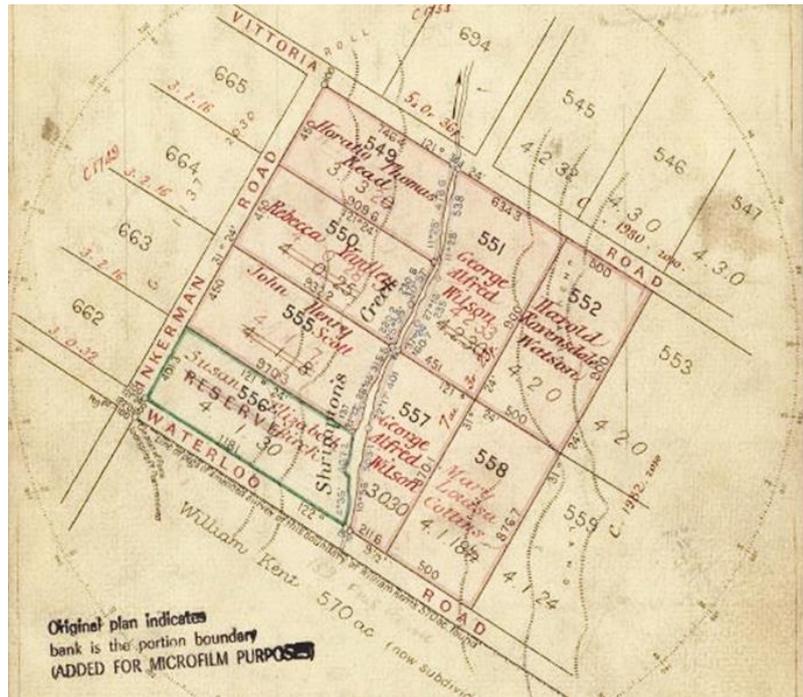
Figure 27: Crown Plan 1983.2030 (1887), showing original granted portions.

The Crown Grants in 1887 for Portions 549, 550, 551 and 552 together with Portions 555, 556, 557 and 558 (Figure 27) each carried both a margin plan and a written metes and bounds description. The bed of Shrimpton’s Creek, which separated these portions, was not included in the Crown Grants. The Crown Grants clearly indicate “right bank” and “left bank”. However, the status eventually changed when one owner acquired the land on either side of Shrimpton’s Creek.

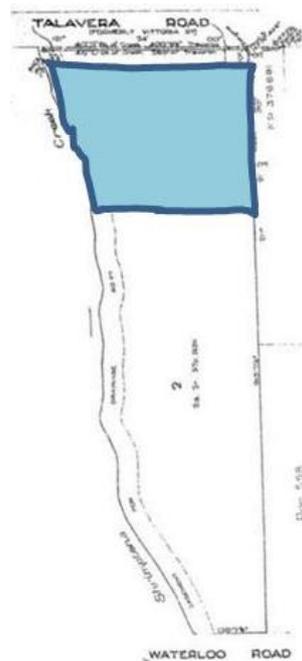
Figure 28: DP 559303 (1972) subdivided Portions 551 and 557 into two lots (Lot 1 highlighted).

Portions 551 and 557 on the Eastern side of Shrimpton's Creek were subdivided by DP 559303 (1972) into two lots (Figure 28), with the natural boundary being the right bank of the creek. An "Easement for Drainage 40 ft wide" (12.19 m) was created, which was parallel to and abutted the right bank of the creek. DP 565709 (1973) consolidated some of the land on either side of Shrimpton's Creek (Figure 29): Lot 1 from DP 559303 (1972) with Portions 549, 550, 555 and 556. The original natural boundaries of Portion 549 and part of Portion 551 were abolished, and the bed became part of the land within the consolidation.

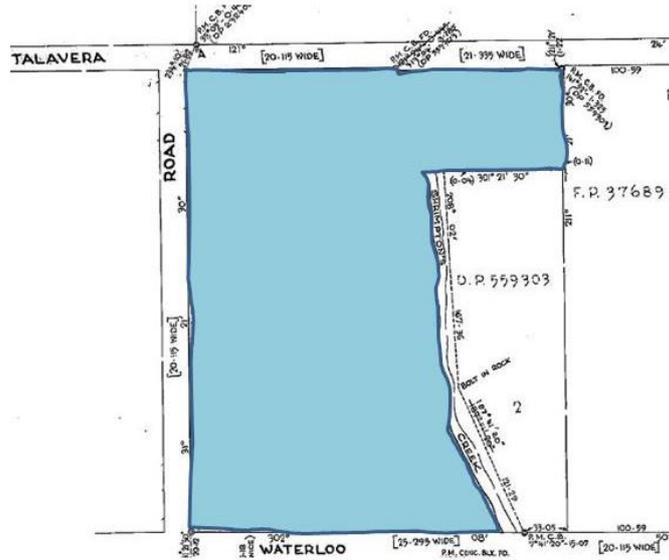
Figure 29: DP 565709 (1973) consolidated land on either side of Shrimpton's Creek.

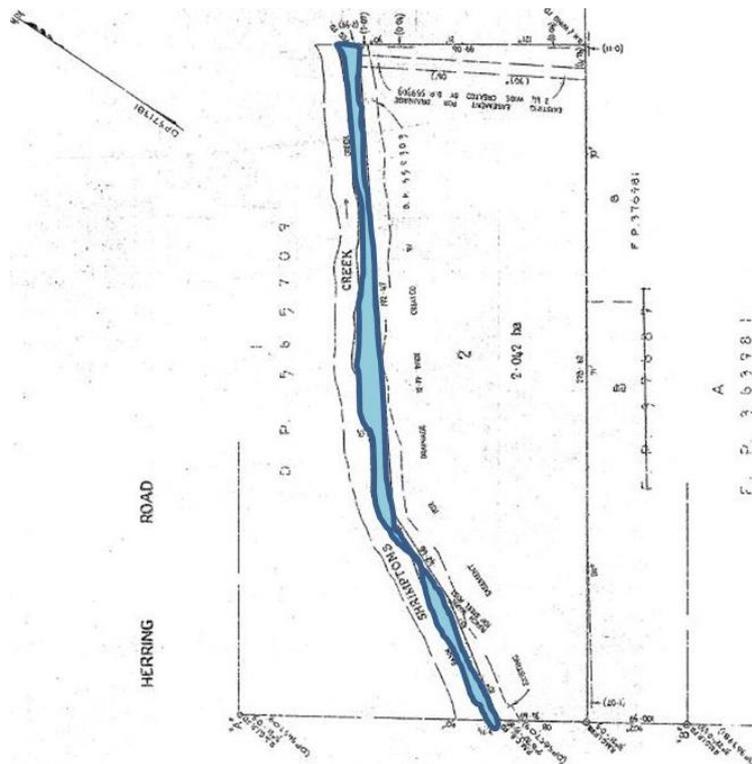
Figure 30: Lot 1 in DP 571381 (1974) is a narrow strip of land abutting the right bank of Shrimpton's Creek.

DP 571381 (1974) subdivided Lot 2 and created one new lot as a narrow strip of land along the right bank of Shrimpton's Creek (Figure 30), with one side being defined by the natural boundary of the creek and the other side being defined by right lines. This new lot partially covered the easement for drainage 12.19 m wide.

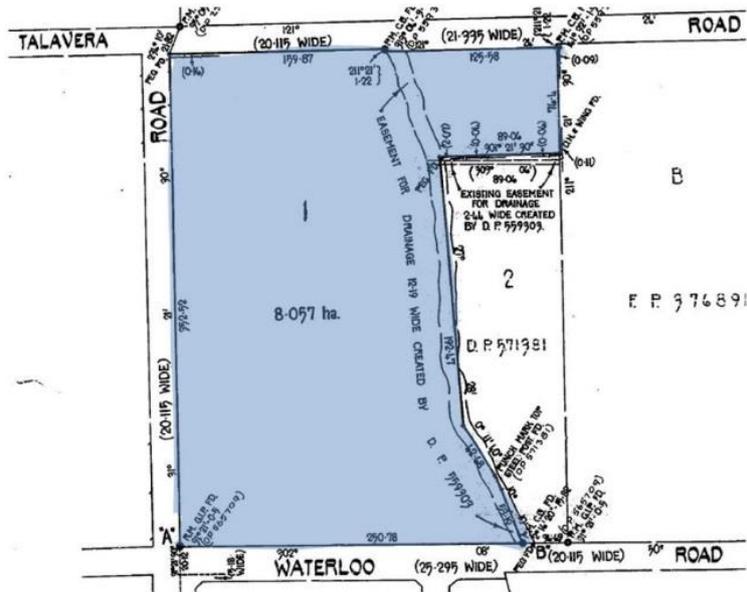
Figure 31: Detail from DP 576355 (1975).

At this point, all of the land was consolidated into one parcel and all reference to a *bank as natural boundary* ceased (Figure 31). DP 614852 (1979) completed the last piece of the consolidation puzzle (Figure 32) and a fresh, right line "Easement to Drain Water" was created over the approximate site and route of the "Easement for Drainage", which had been created adjacent to the original creek bank.

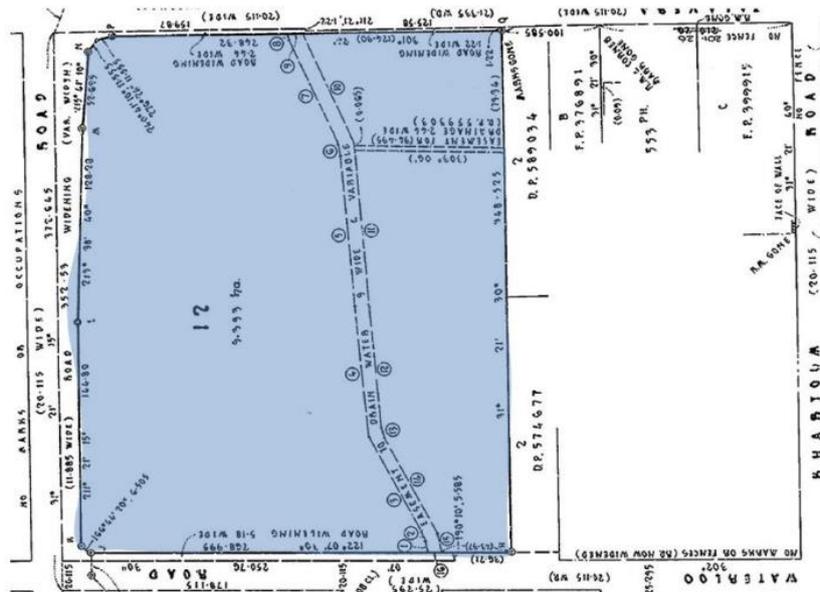
Figure 32: Detail from DP 614852 (1979).

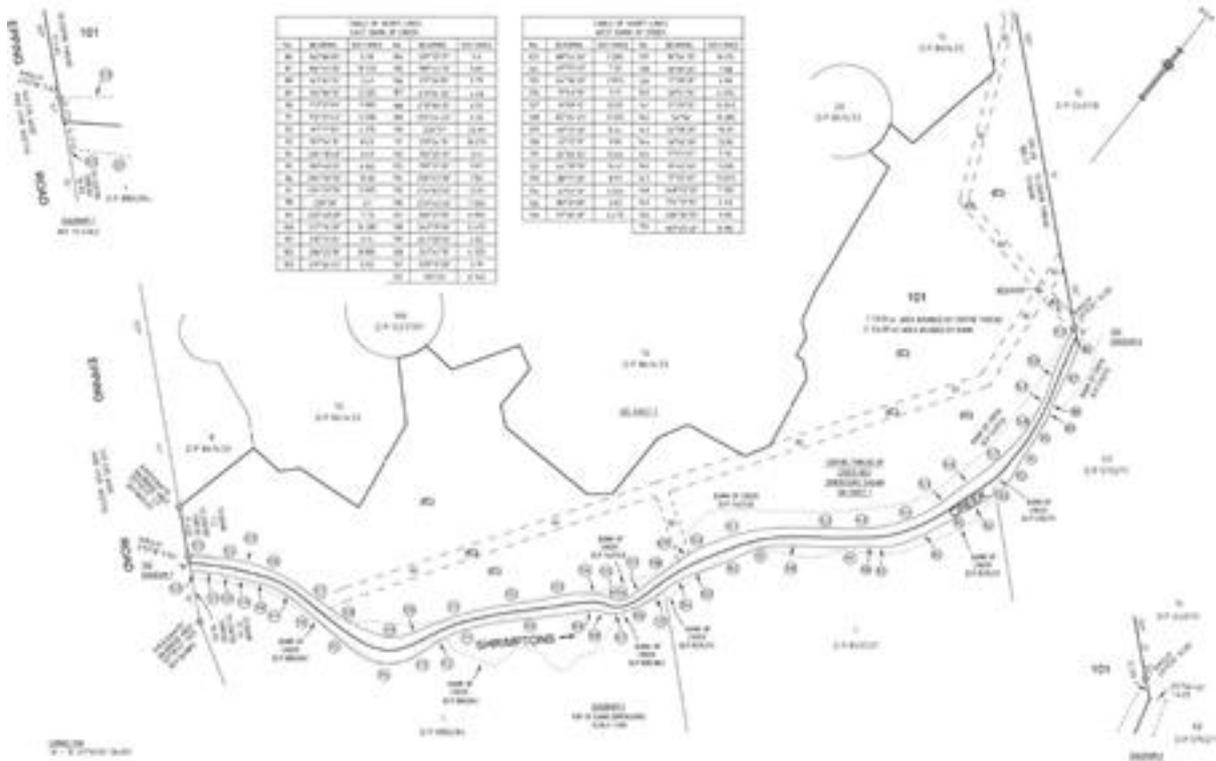
Figure 33: Redefinition plan DP 1247443 (2018).

only to the bank of the creek. In this case, RPA 31194 (1929) and RPA 35657 (1944) converted two parcels of land up to the bank. The adjoining strip of land, comprising half the bed of Shrimpton's Creek, remained in Old System Title with the applicant of the RPA being the land owner. As part of a recent redevelopment of this site, a redefinition plan DP 1247443 (2018) was created, which claimed ownership of the two remnant parcels up to the centreline of the creek (Figure 33), with a new RPA raised for the Old System land of the bed.

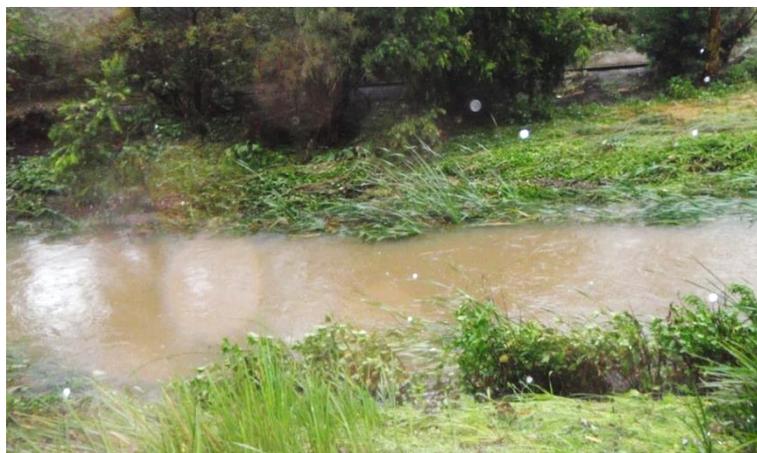
In the aftermath of a storm event in 2019 (Figure 34), a tree that was undermined by flooding water fell across the rear of a property, which abutted Shrimpton's Creek, and caused significant damage to two fences.

Figure 34: Shrimpton's Creek in full flow.
