The Cadastre of Little Cattai Creek (Re-Defining Original Crown Grants)

Fred de Belin

City of Ryde

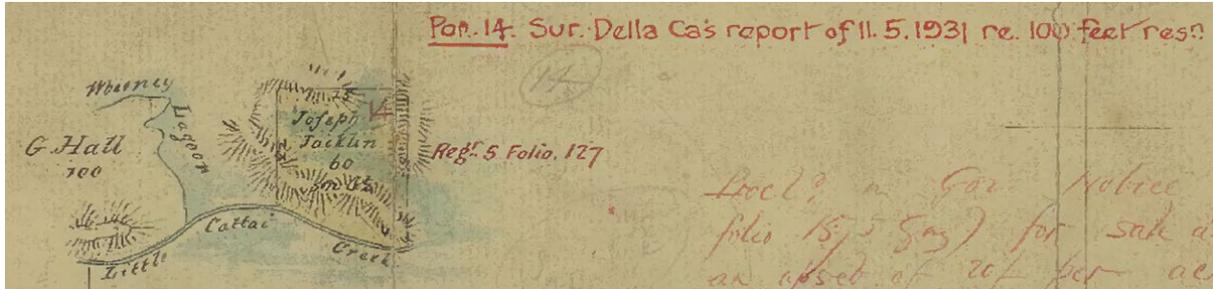
Figure 1: Crown Plan 33.690 of Portion 14 – 1832.

In April 1832, a Crown grant survey, Crown Plan 33.690 (Figure 1), comprising 60 acres and situated on Little Cattai Creek, was carried out by Felton Matthew (Assistant Surveyor), and much later, in 1885, was adopted as Crown Portion numbered 14.

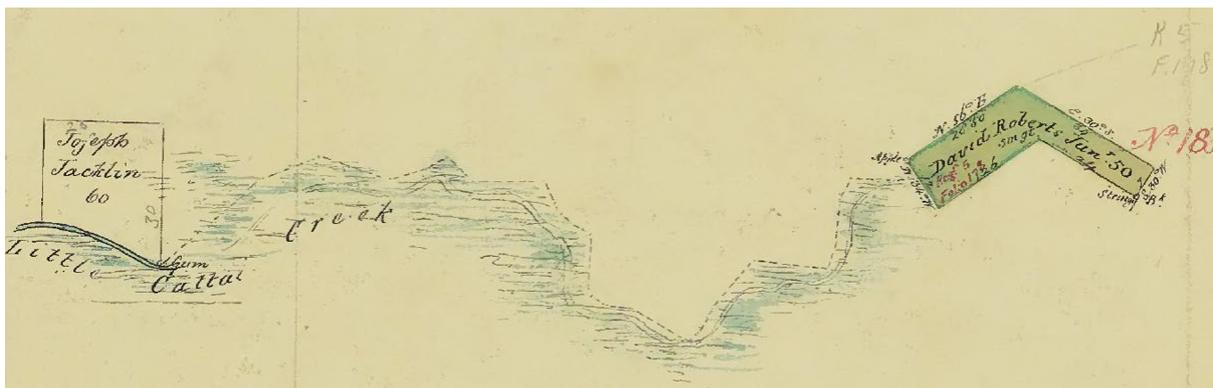
Figure 2: Crown Plan 139.690 of Portion 18 – 1833.

In November 1833, a Crown grant survey, Crown Plan 139.690 (Figure 2), comprising 50 acres, was also carried out by Felton Matthew, and later adopted as Crown Portion 18 in 1885.

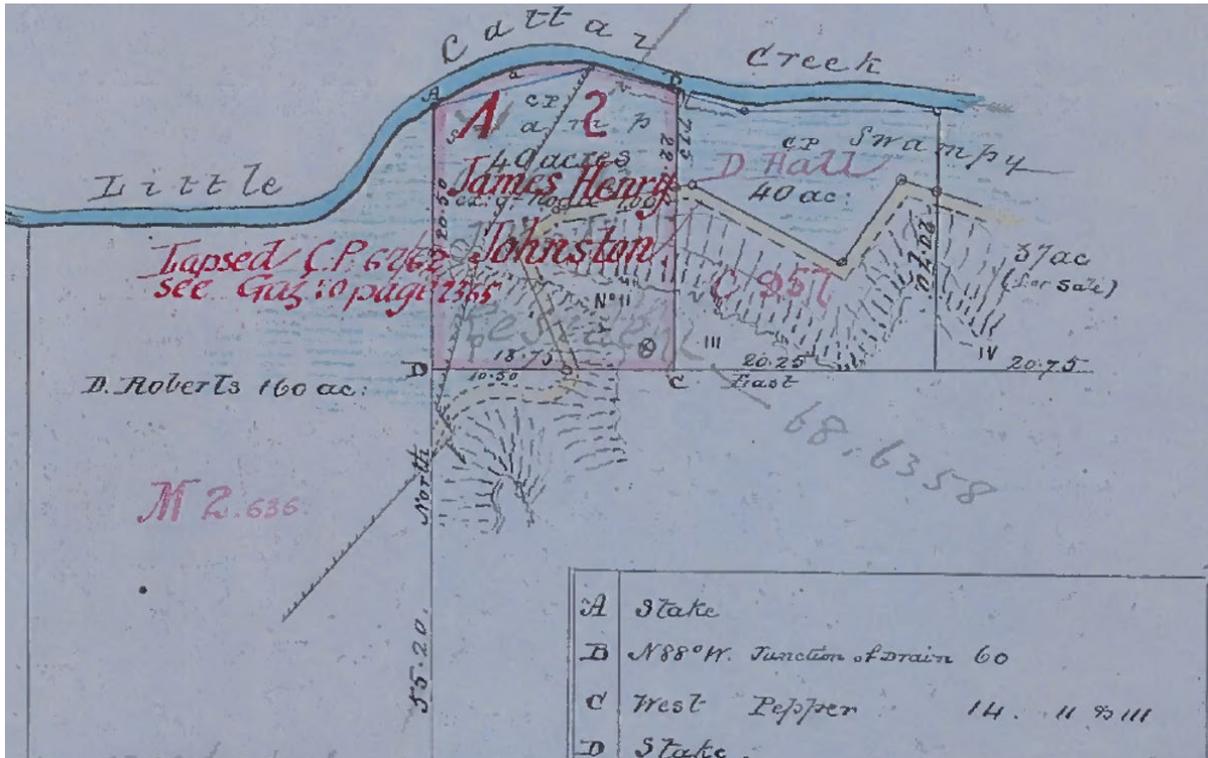
Figure 3: Detail from Crown Plan 956.690 – 1867.

Country Lot A, now known as Portion 2 (Figure 3), was surveyed in 1867 with circumferentor and chain by Licensed Surveyor George Matcham Pitt Jr. (who was licensed in 1859). Unfortunately, the Crown Plan (M2.636) of the adjoining 160-acre parcel is unobtainable.

Note that corner 'B' is referenced from the junction of a drain 60 links distant. It is unknown at this stage if there is existing evidence of this drain on site. A drain cut through rock (constructed in 1820) was adopted as a corner on Portion 10 in the Parish of Maroota in 1871 (Figure 4). Portion 10 was situated on the banks of the Hawkesbury River, and even though the survey for the grant did not occur until 1871 (surveyed by George Matcham Pitt Jr.), the land had been occupied and farmed since 1809.

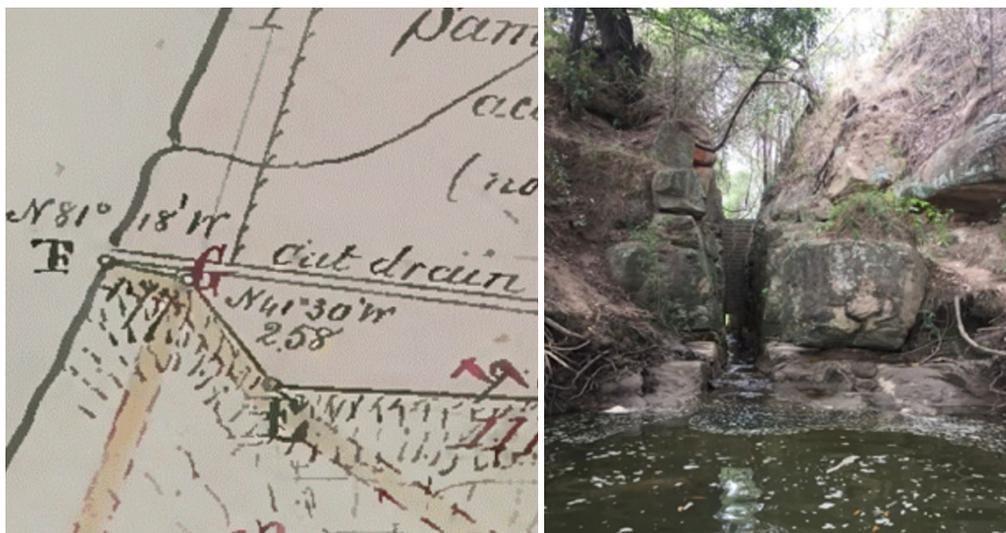
Figure 4: Drain cut through rock c. 1820 as shown by George Matcham Pitt Jr. in 1871 and photo in 2018.

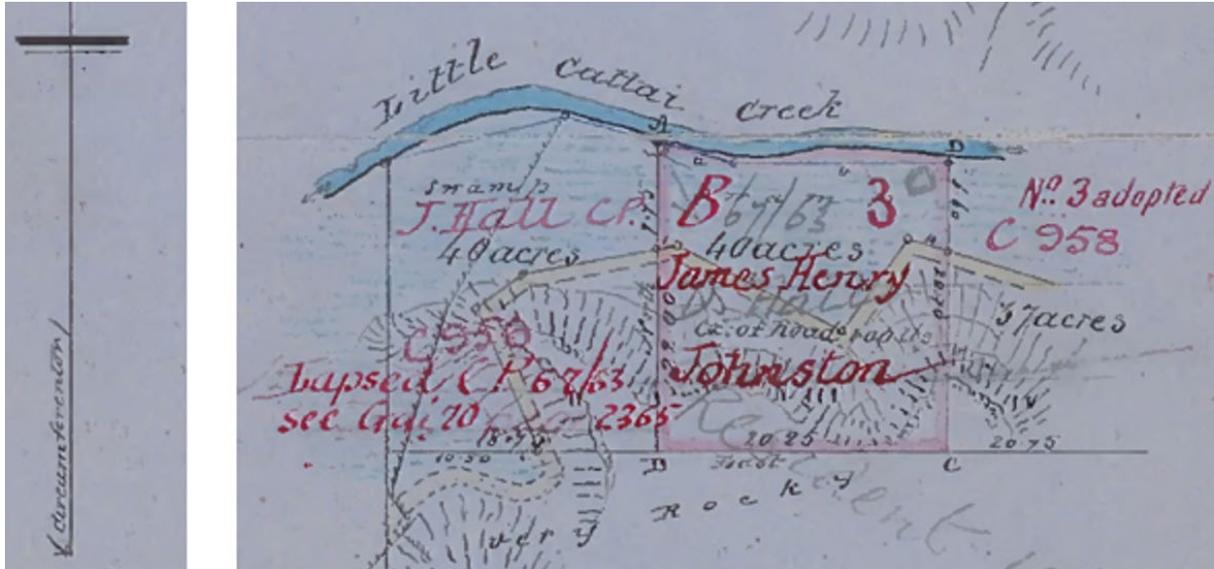
Figure 5: Detail from Crown Plan 957.690 showing circumferentor reference – 1867.

Alongside Country Lot A, Country Lots B, C and D, now known as Portions 3, 4 and 5 (Figures 5 & 6), were also surveyed in 1867 by Licensed Surveyor George Matcham Pitt Jr. with circumferentor and linked chain. The intention of the surveys was to create land parcels of 40 acres in area, with the side boundaries parallel and the rear boundaries being on one

straight line. This meant that the width of the parcel varied because of the irregularity of Little Cattai Creek being a natural boundary. In fact, the variability of the creek was so influential that Portion 4 could only achieve an area of 37 acres and yet maintain the straight-line rear boundary. It appears that Portion 5, which comprised only 27 acres, was governed more by the surrounding terrain. The view upstream of the swamplands of Portions 2, 3 and 4 in flood is shown in Figure 7.

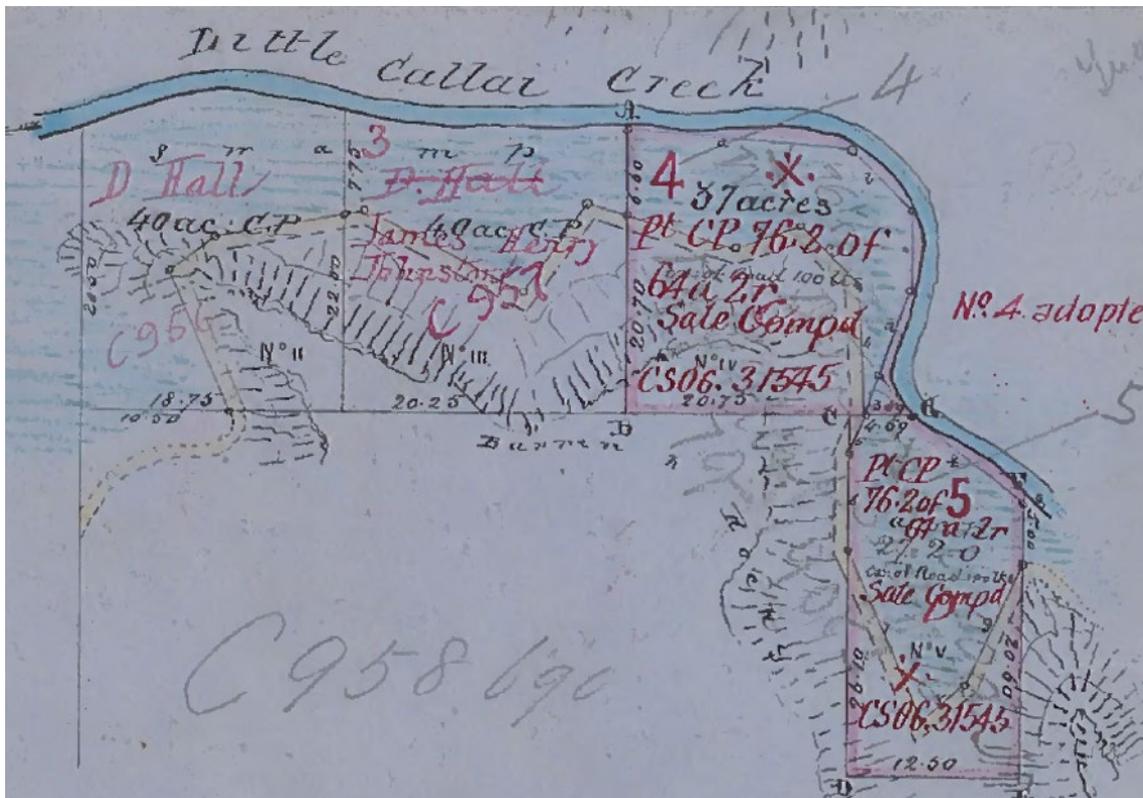
Figure 6: Detail from Crown Plan 958.690 – 1867.

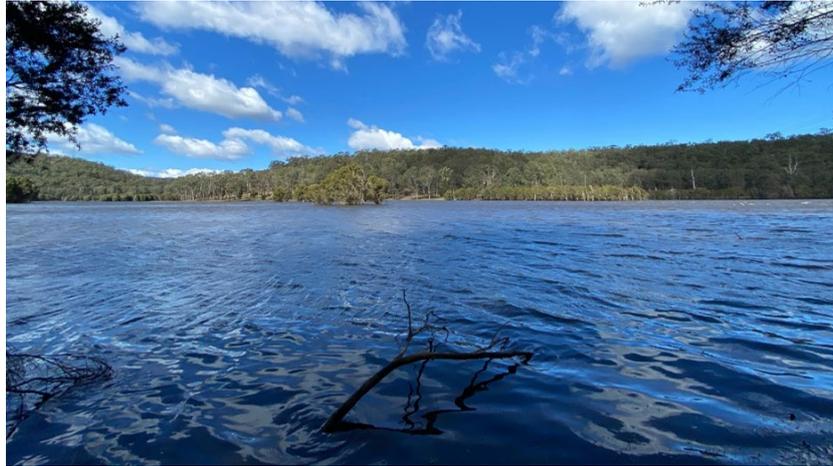
Figure 7: The view upstream, with the swamplands of Portions 2, 3 and 4 under flood – 2020.

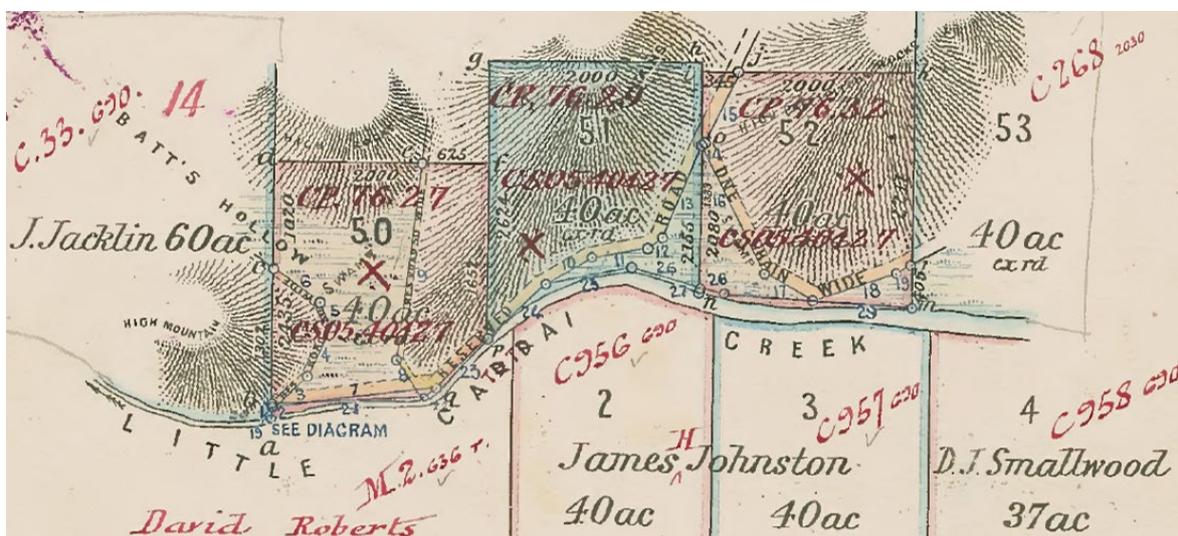
Figure 8: Detail from Crown Plan 267.2030 showing Portions 50 to 52 – 1880.

Upstream along the creek, between Portion 14 and Portion 18, Portions 50 to 60 (applied for under the Crown Lands Alienation Act 1861) were surveyed in 1880. Each of these portions was 40 acres in area. The original intention was for each portion to comprise 40 acres and that the side boundaries of each portion would be parallel and on the cardinal (i.e. running north-south), with the rear boundary being a line square. The first three portions (numbered 50, 51 and 52) were surveyed 20 chains wide (Figure 8), with the land area of 40 acres being governed and determined by the shape of Little Cattai Creek (a natural boundary) and the length of the side boundary. Note that the watercourse was notated as ‘Little Cattai Creek’ in the plans of 1833 but called ‘Little Caddai Creek’ in the survey of 1880, which was later amended back to the original ‘Cattai’.

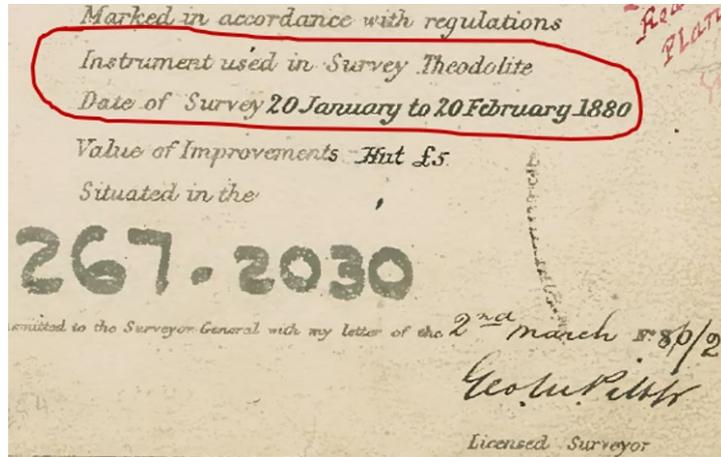
Figure 9: Detail from Crown Plan 267.2030 showing instrument used is theodolite – 1880.

These surveys in 1880 were conducted using a theodolite (Figure 9) and chain. From 1872, the use of a theodolite in land surveys was mandatory. Accurate distance measurements were not attainable in all Crown land areas until the mid-1880s with the introduction of the steel riband, so we know that at Little Cattai Creek in 1880 the angles were survey accurate and the distances not quite so.

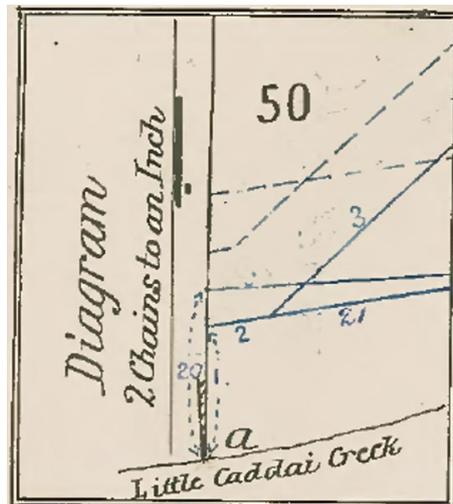
Figure 10: Diagram from Crown Plan 267.2030 showing corner 'a' – 1880.

Corner 'a' of Portion 50 (Figure 10) is a large stake placed 'near corner of fence'. There appears to be no other reference to the eastern side boundary of Portion 14, which is the intended kick-off point for the land grants in 1880. These latest land grants were also surveyed by Licensed Surveyor George Matcham Pitt Jr. Remembering that the boundary of Portion 14 was first surveyed by Felton Matthew in 1832, there is a good chance that the fence at corner 'a' was *adopted* by Pitt Jr. as defining the south-eastern corner of Portion 14 and therefore common to both surveys.

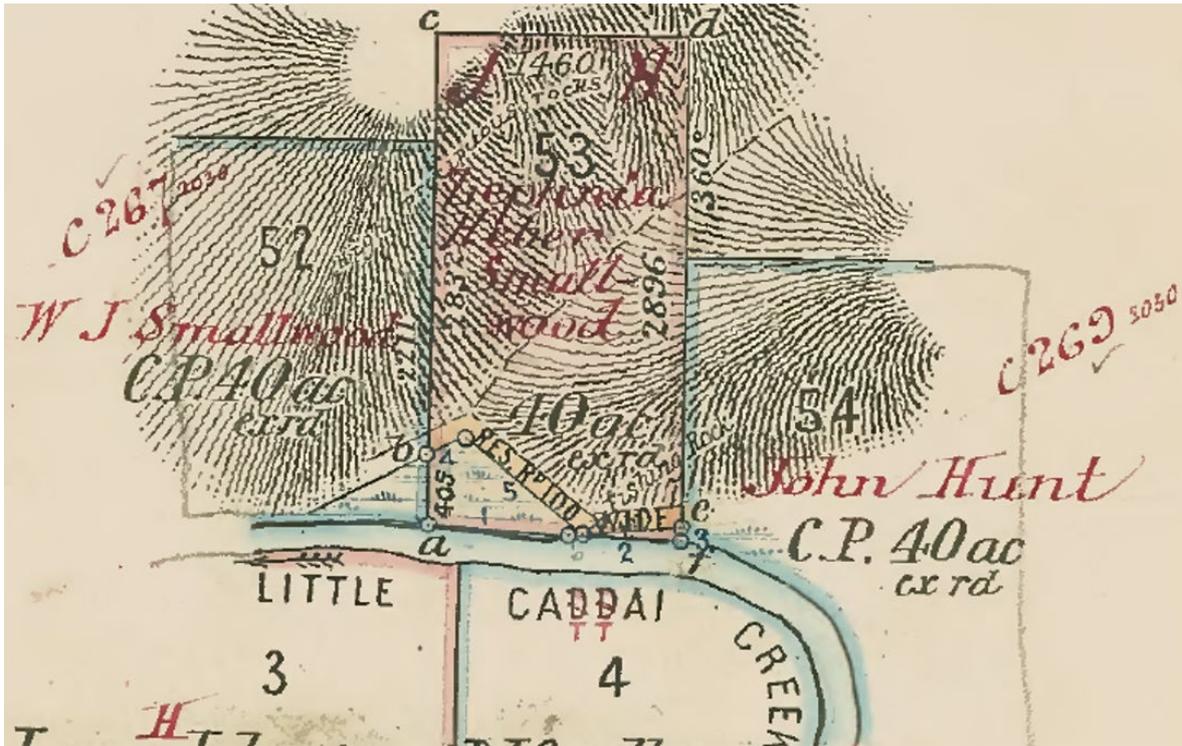
Figure 11: Detail from Crown Plan 268.2030 showing Portion 53 – 1880.

Portion 53 is only 14.6 chains wide (Figures 11 & 12) and adjoins Portion 52. The common side boundary extends further inland in order to maintain the acreage of 40.

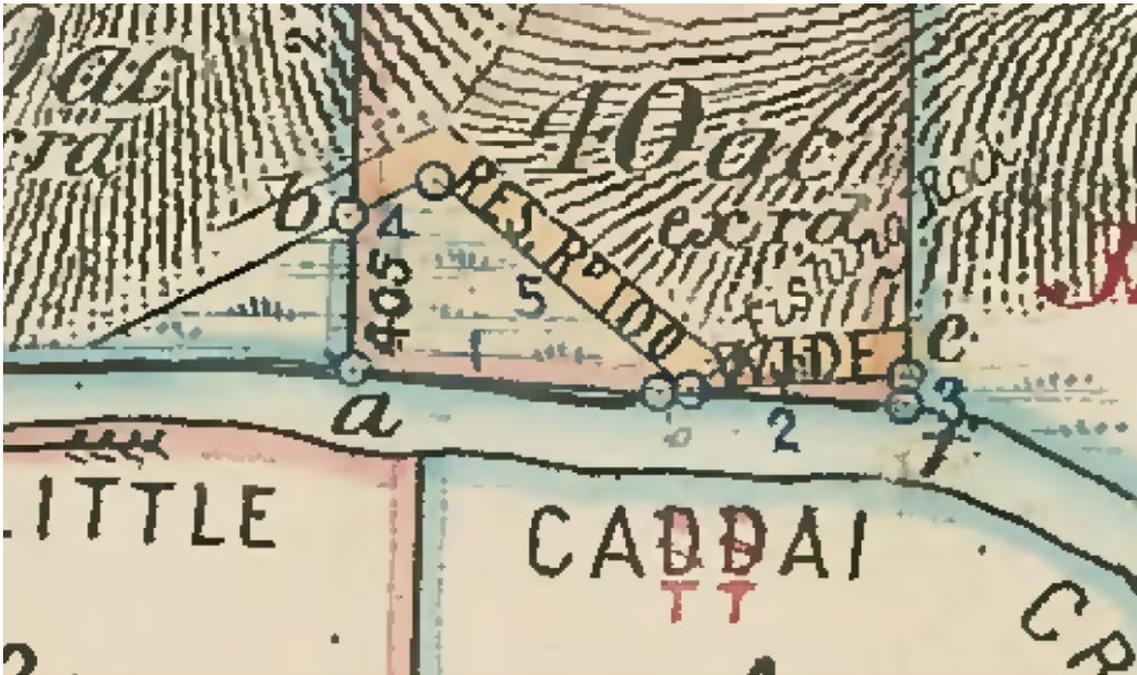
Figure 13: Detail from Crown Plan 268.2030 showing 'Fishing Rock' – 1880.

Detail from Portion 53 (Figure 13) shows a feature called ‘Fishing Rock’. The obvious first question is: Was this a recognised Aboriginal heritage site? Various landowners, over the decades, have scoured the Fishing Rock in the hope of finding evidence of Aboriginal carvings or artefacts but have remained unfulfilled. Perhaps the Fishing Rock (Figure 14) was simply a natural waterside feature used by the early survey teams to indulge in a little food gathering and recreation.

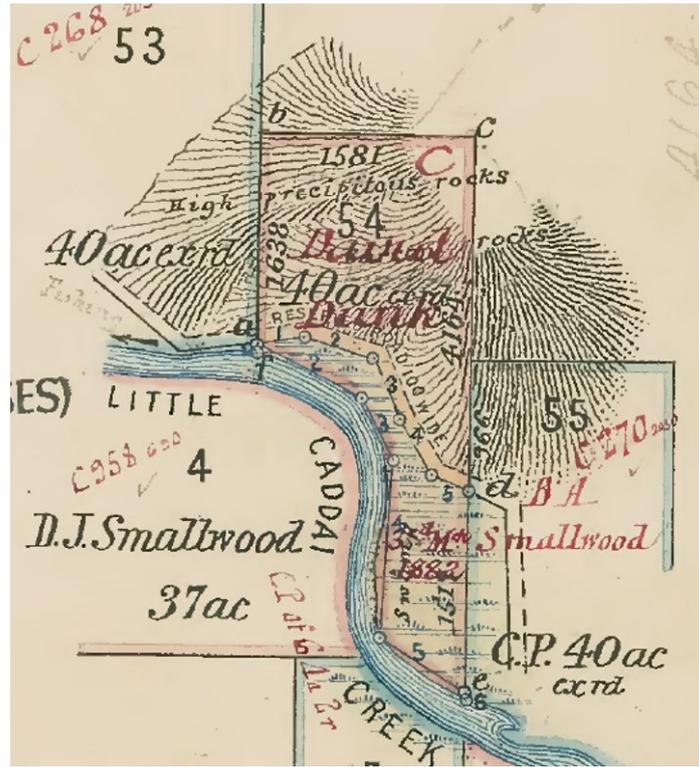
Figure 15: Detail from Crown Plan 269.2030 showing Portion 54 – 1880.

Portion 54 is 15.81 chains wide (Figure 15) and adjoins Portion 53. Once again, the side dimensions are set to achieve the desired area of 40 acres.

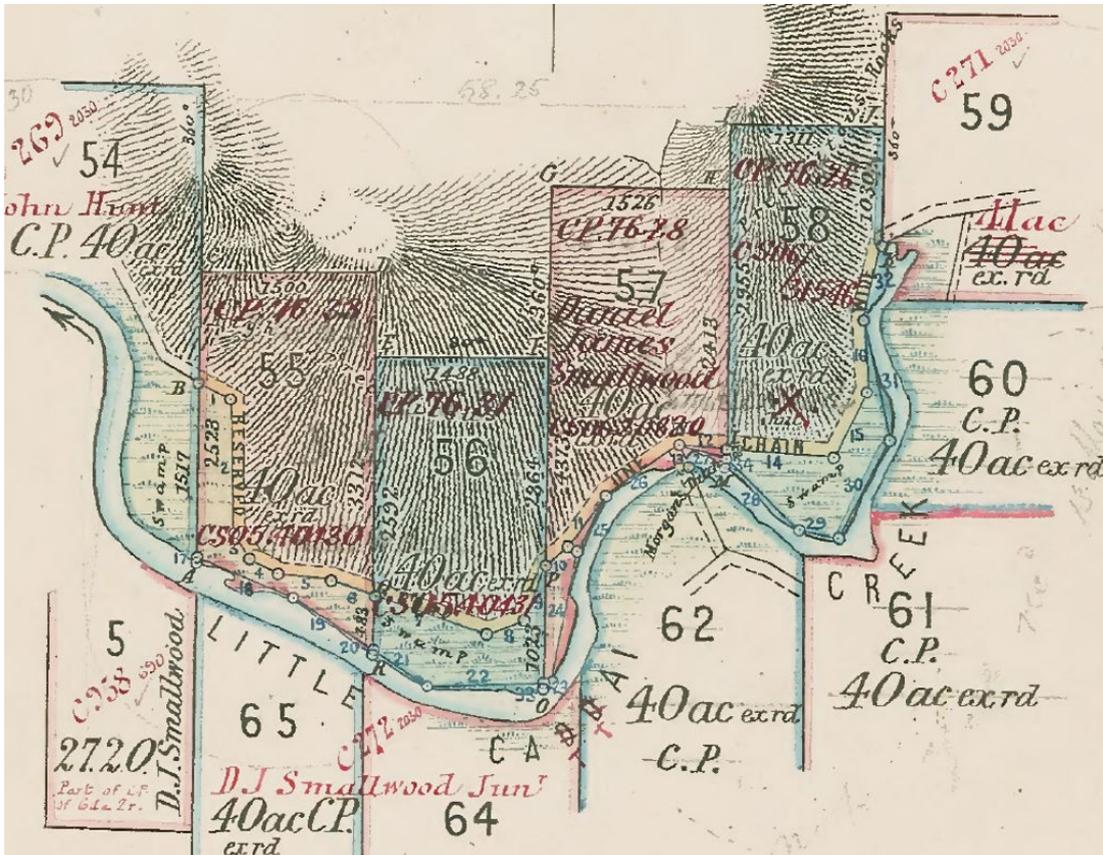
Figure 16: Detail from Crown Plan 270.2030 showing Portions 55 to 58 – 1880.

Portion 55 is 15 chains wide, Portion 56 is 14.88 chains wide, Portion 57 is 15.26 chains wide and Portion 58 is 13.11 chains wide and all adjoin, with sides on the cardinal (Figure 16).

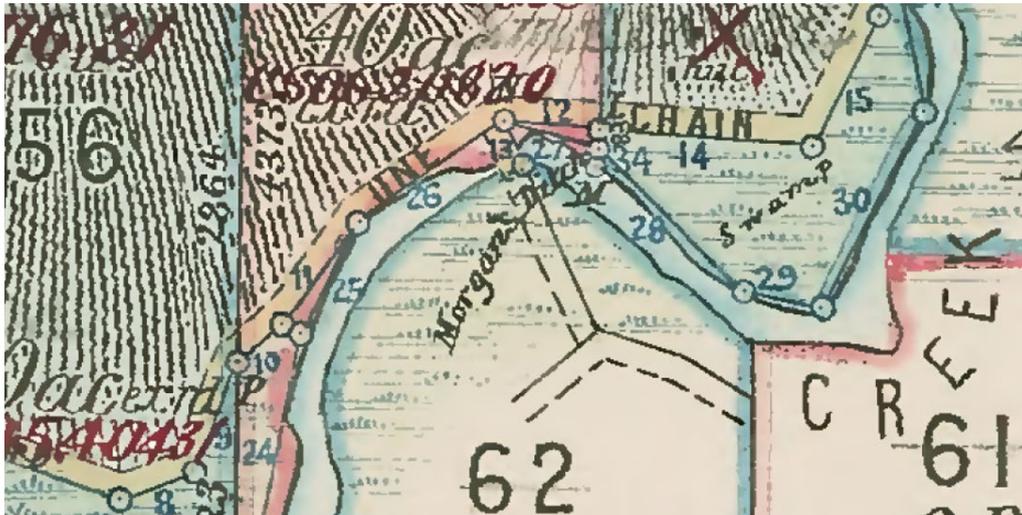
Figure 17: Detail from Crown Plan 270.2030 showing 'Morgan's Ditch' – 1880.

There is a notation of another drain, 'Morgan's Ditch', between Portions 57 and 58 (Figure 17).

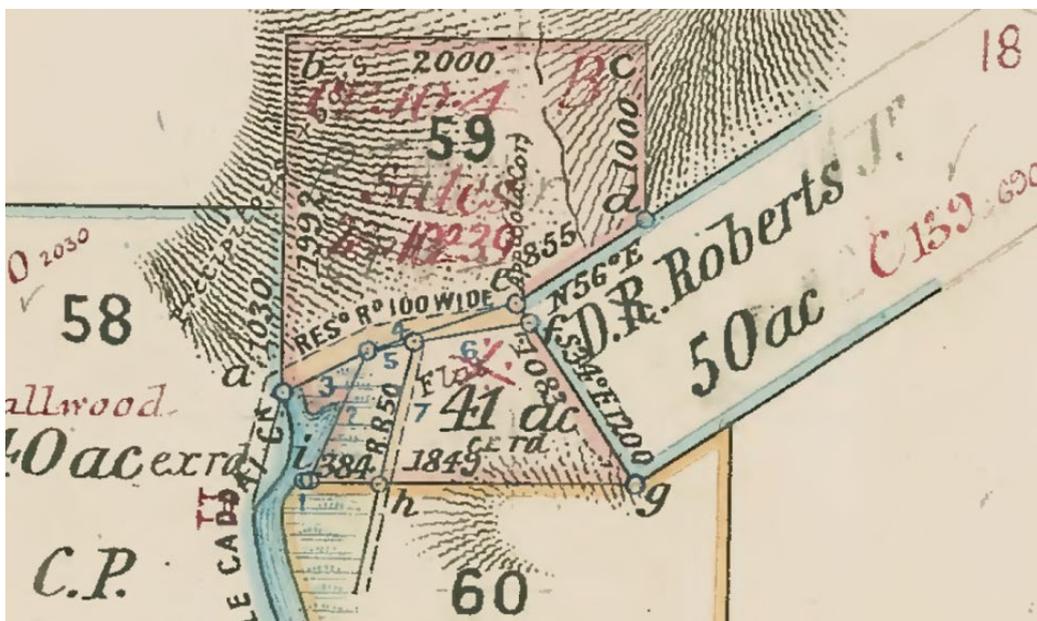
Figure 18: Detail from early Parish Map 271.2030 showing original marks as found – 1880.

Portion 59 returns to 20 chains wide but is 41 acres in area because common corners have been formed with the south western boundary line of original Portion 18 (Figure 18). A tree was found and adopted for the westernmost corner of Portion 18: 'Apple (old corner)'. A rock reference mark was cut at Corner 'g', after maintaining the original dimensions for Portion 18. Note that Portion 59 is situated at the very head of Little Cattai Creek. The grant description for Portion 58 cites the *right bank* of the creek being the boundary, while the description for Portion 59 cites the *left bank* of the creek being the boundary!

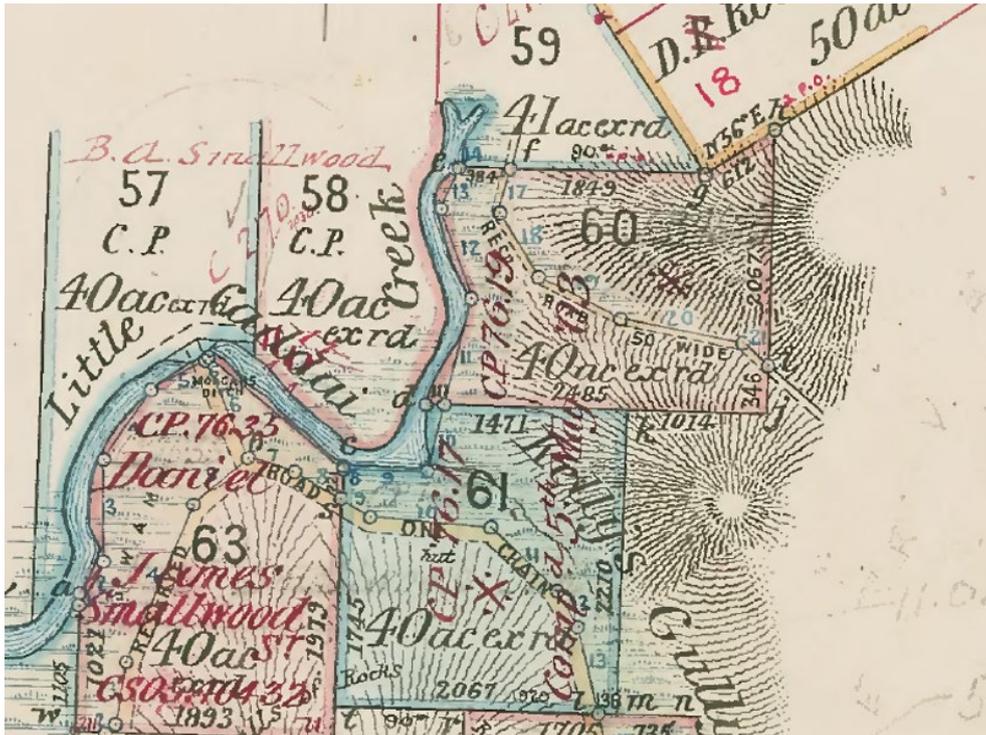
Figure 19: Detail from Crown Plan 291.2030 showing Portions 60, 61 and 63 – 1880.

Portions 60 to 65 are each of varying widths in order to achieve a consistent area of 40 acres. The original intent was for all side boundaries to be parallel and on cardinal with the rear boundary being a right-angled line (Figures 19 & 20).

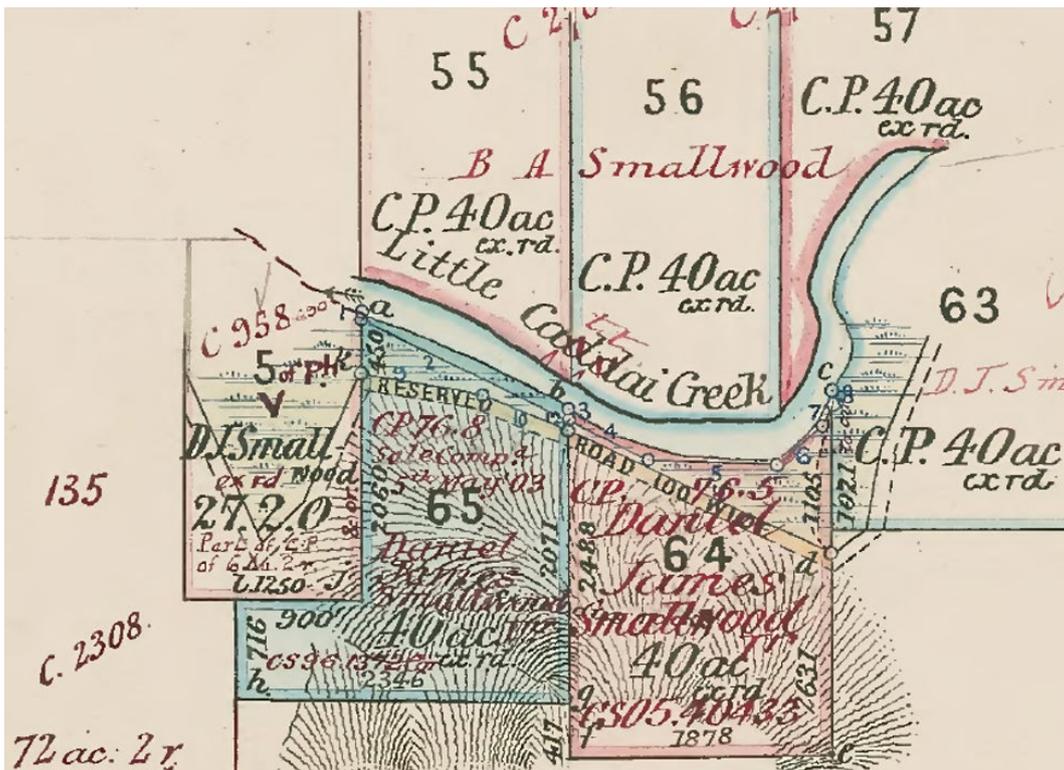
Figure 20: Detail from Crown Plan 272.2030 showing Portions 64 and 65 – 1880.

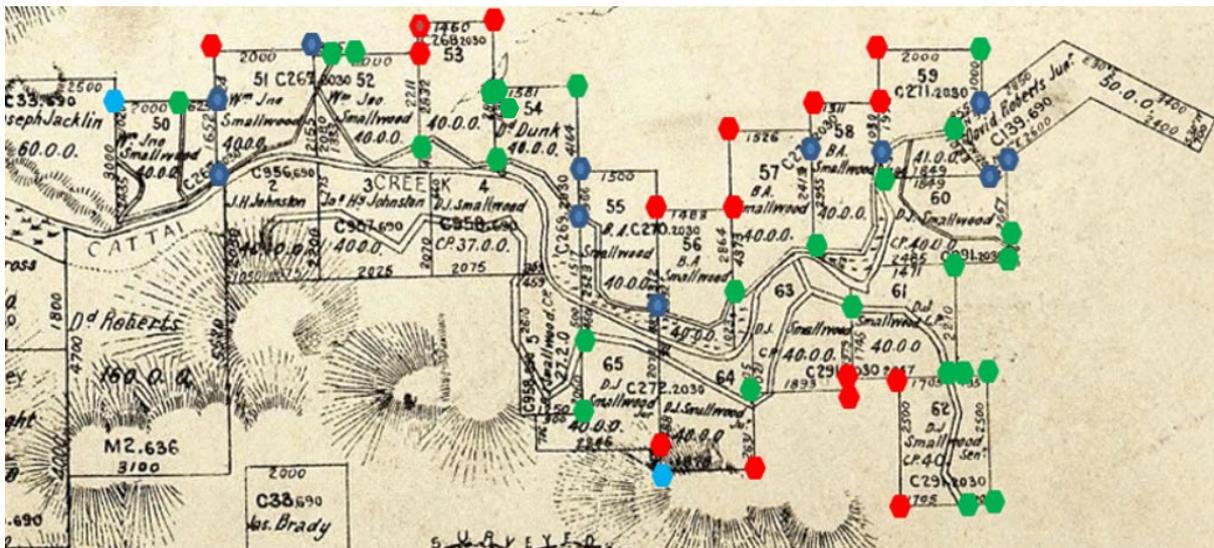
Figure 22: Grants along the upper reaches of Little Cattai Creek showing corner marking – 1880. Red = corners where marks were not placed, green = corners where reference trees were placed, blue = corners where rock marks or reference rock marks were placed, light blue = corners where piles of stones were placed, all other corners were marked by stakes.

Detail from an early Parish map shows all the grants along the upper reaches of Little Cattai Creek (Figure 22). To this map has been added a coloured symbol at portion corners to indicate the nature of the corner marking, i.e. rock marks or rock reference marks (blue), tree reference marks (green), piles of stone (light blue) or no mark placed at all (red).

In comparison to the situation in 1880 (see Figure 22), the original marks remaining after 140 years consist of 10 rock marks (blue) and one reference tree (green) (Figure 33). Two side boundaries (one on Portion 51 and one on Portion 55) both retain *pairs* of original rock marks, which the modern surveys find to be parallel.

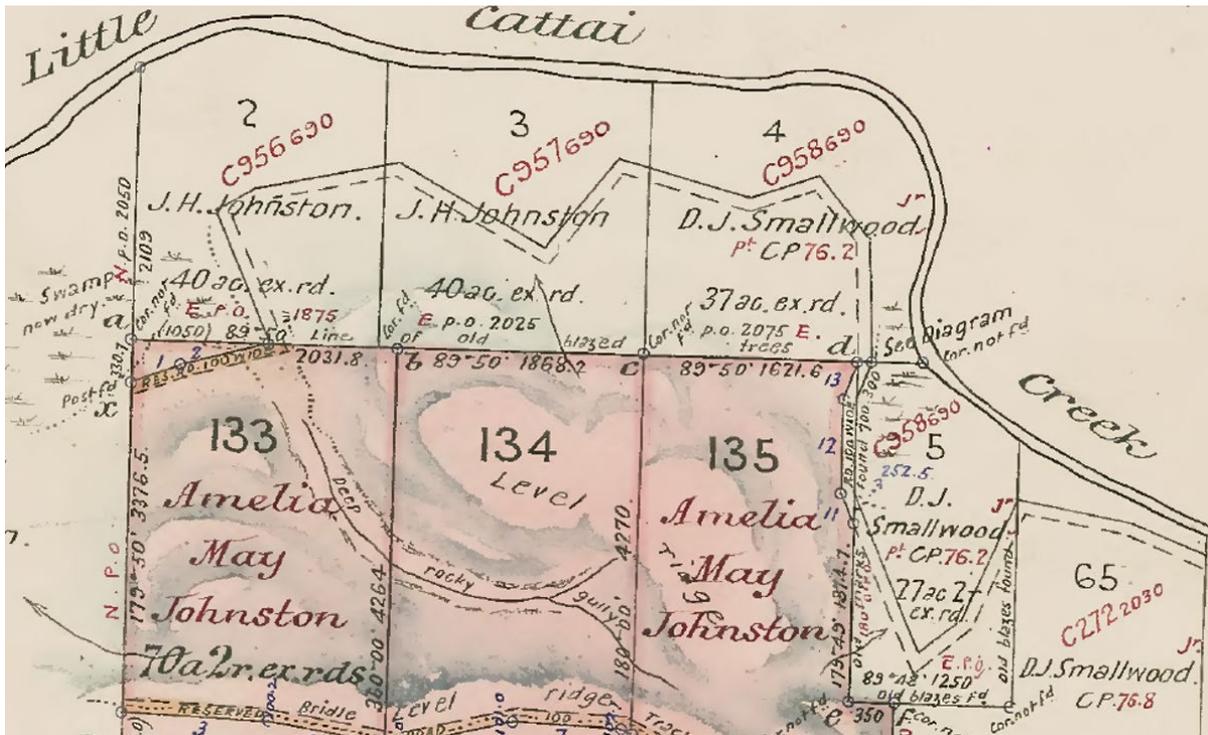
Figure 23: Later grants by Crown Plan 2308.2030 showing the abuttal with Portions 2 to 5 – 1902.

The survey of Portions 133, 134 and 135 was the first of the later surrounding Crown grants and occurred in 1902 (Figure 23), 35 years after the survey of Portions 2 to 5 and forming a common boundary with these portions.

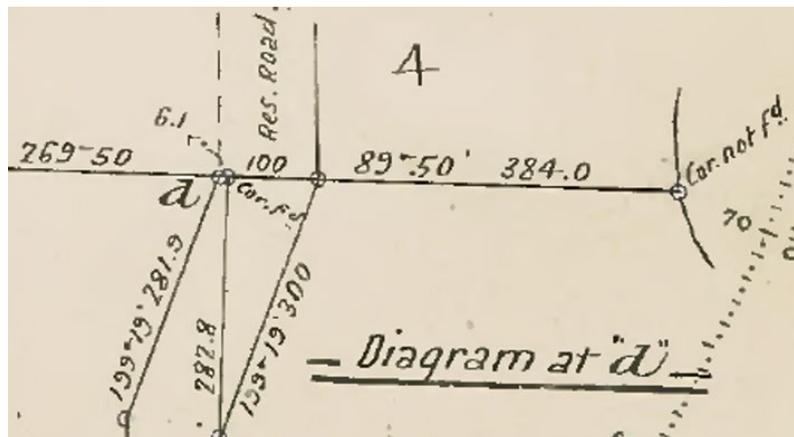
Figure 24: Detail from diagram on Crown Plan 2308.2030 – 1902.

‘Old marks found’ on the western boundary of Portion 5 and ‘corner found’ (Figure 24) determine a bearing of $179^{\circ} 49'$. Along the southern boundary of Portions 3 and 4 a ‘corner found’ at the south-west of Portion 3 and the ‘corner found’ at the north-west of Portion 5 determine a bearing of $89^{\circ} 50'$, almost at a right angle. This is interesting in that the earlier angle work was by circumferentor.

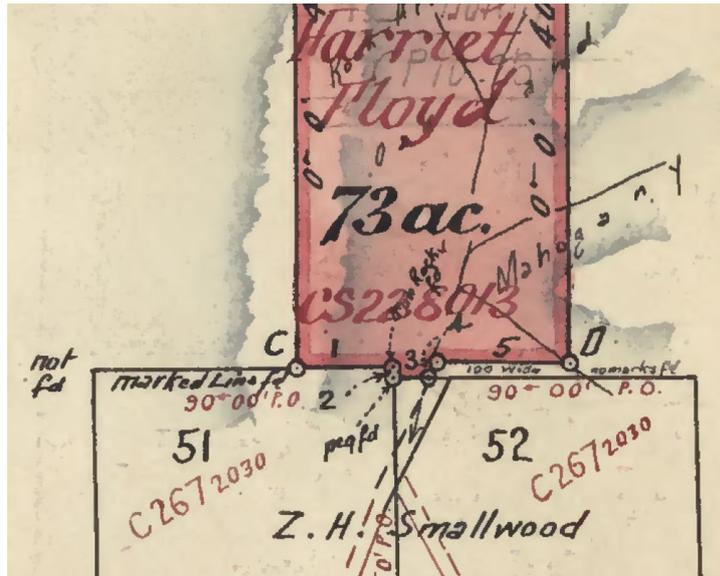
Figure 25: Later grant by Crown Plan 2826.2030 showing the abuttal with Portions 51 and 52 – 1911.

The first of the surveys north of Little Cattai Creek for later surrounding Crown grants came with Portion 141 in 1911, 30 years after the original survey for Portions 51 and 52 (Figure 25). A peg, a broad arrow rock mark and a ‘marked line’ were found at the north-east and north on Portion 51. Short lines 1, 2, 3 and 5 are all parallel or at right angle, indicating a bearing of $89^{\circ} 37'$. It is interesting that the side boundaries of Portion 141 were then created on cardinal.

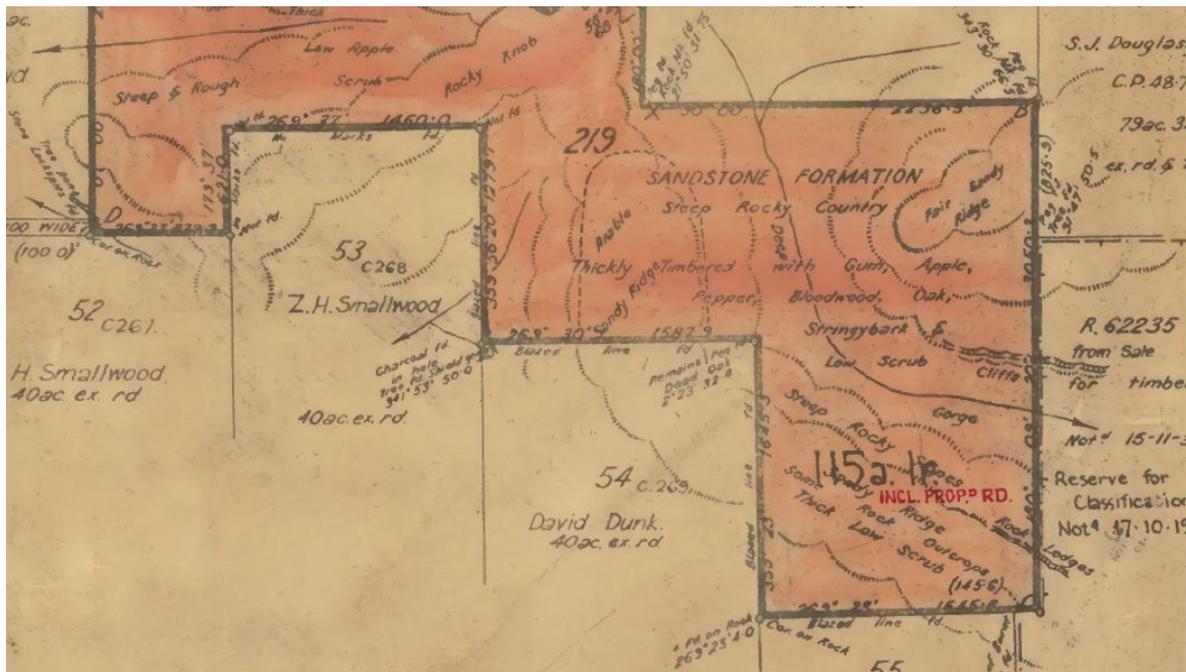
Figure 26: Detail from Crown Plan 7371.2030 showing Portion 219 adjoining the original portions – 1952.

No further Crown grant activity occurred north of Little Cattai Creek until 1952, another 40 years later, when Crown land surrounding the first grants was once again released. Portion 219 was created, with the intention of forming a common boundary with original Portions 52, 53, 54 and 55 and the more recent Portion 141 (Figure 26).

The survey for Portion 219 formed a common boundary with Portion 141, on cardinal, then continued at $89^{\circ} 37'$, laying 'per original' angle and distance all the way to the north-west corner of Portion 54, where an original reference tree was found. It is interesting that the survey of Portion 219 shows corner marks for Portion 53 (Figure 27) as 'not found'. Not surprisingly, as we know that the survey for Portion 53 placed no marks at those corners. Marks were found along the rear of Portion 54, which indicates a clear excess of 6.9 links (1.4 m). Does this suggest that laying 'per original' across the rear of Portion 53 is erroneous?

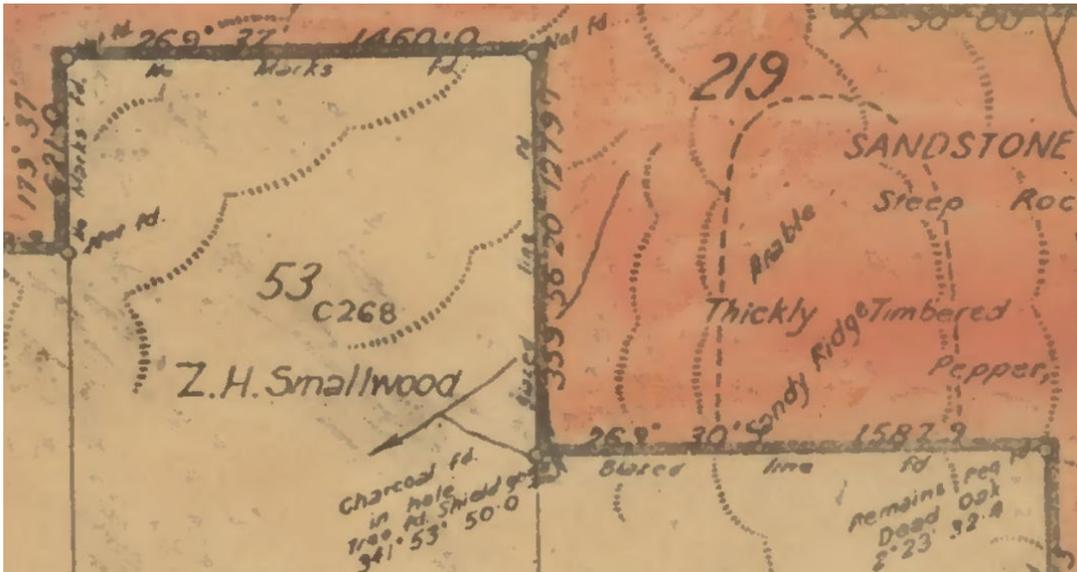
Figure 27: Detail from Crown Plan 7371.2030 showing no marks found on original Portion 53 and marks found on original Portion 54 – 1952.

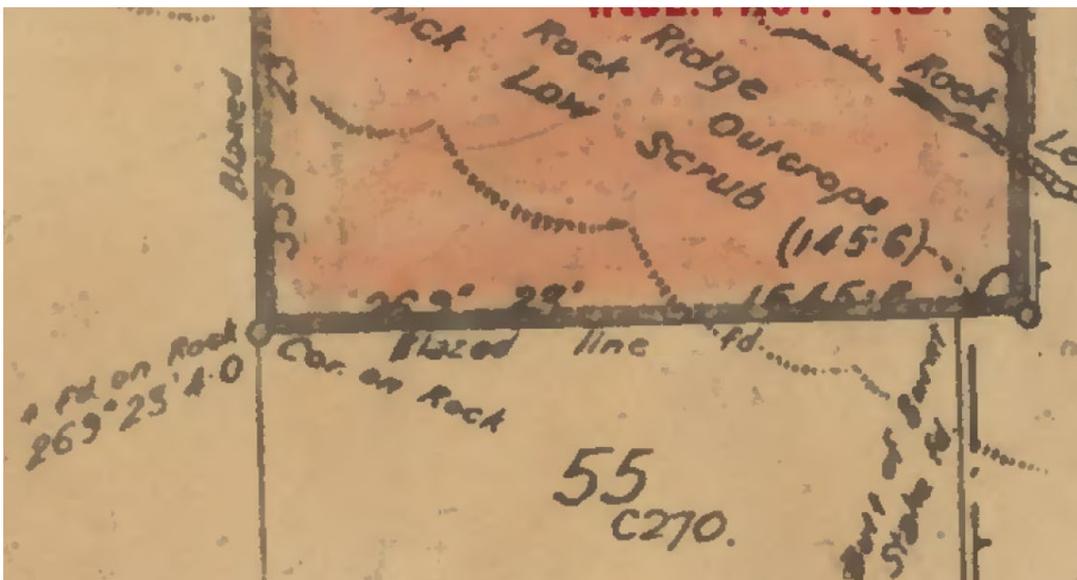
Figure 28: Detail from Crown Plan 7371.2030 showing original marks found on Portion 55 – 1952.

Crown Plan 7371.2030 also found a broad arrow in rock reference mark at the north-west corner of Portion 55 (Figure 28) and a purported burnt-out stake at the north-east corner of Portion 55.

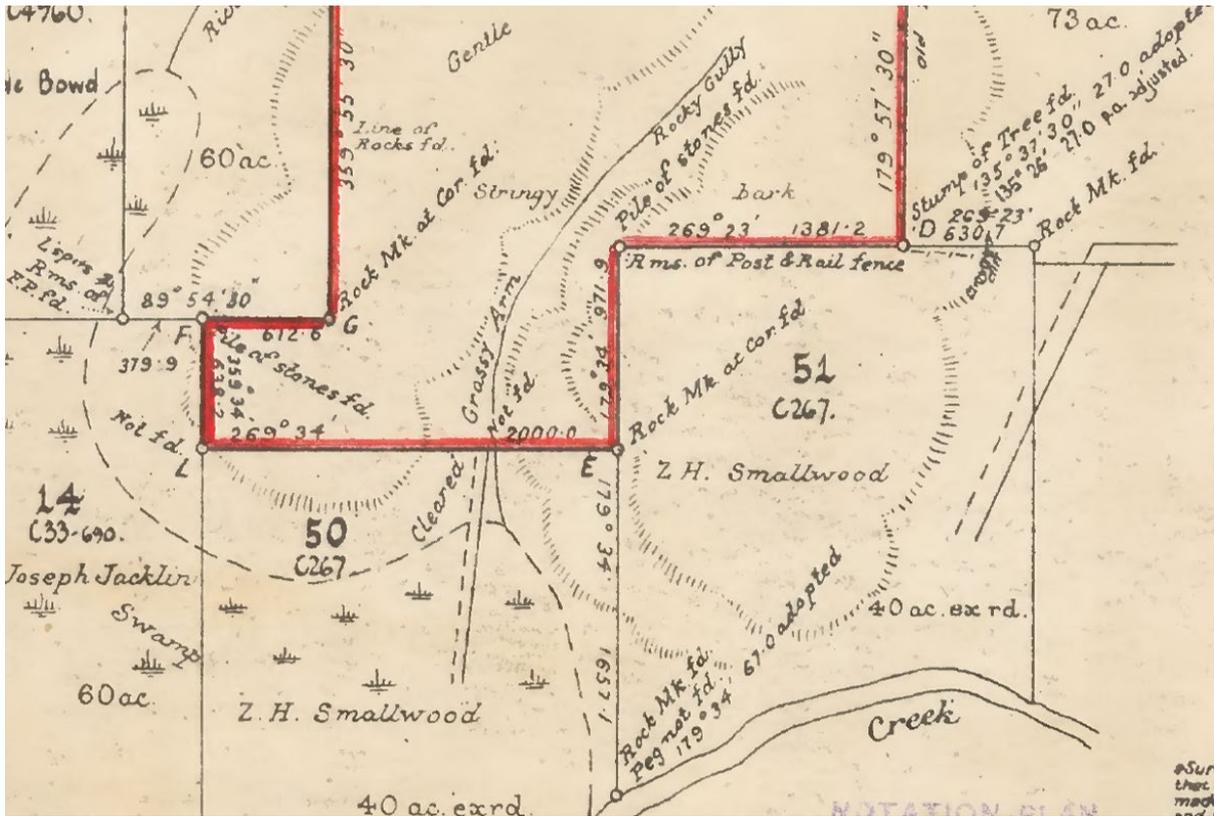
Figure 29: Detail from Crown Plan 7930.2030 showing three original rock marks found on Portion 51 – 1958.

Crown Plan 7930.2030, in 1958, connected to the western boundary of Portion 141 but also found three original rock marks from the survey of Portion 51 in 1880 (Figure 29). This was the only surrounding survey that connected back down to marks at Little Cattai Creek and displays an excess of 5 links. This is supported by mark evidence and a post and rail fence occupation along the northern boundary of Portion 51, which now displays a bearing that is 11' off being square. The north-west corner of Portion 51 was not marked in the original survey and neither corner was occupied by the original surveyor to read or set the angle from one corner to the other.

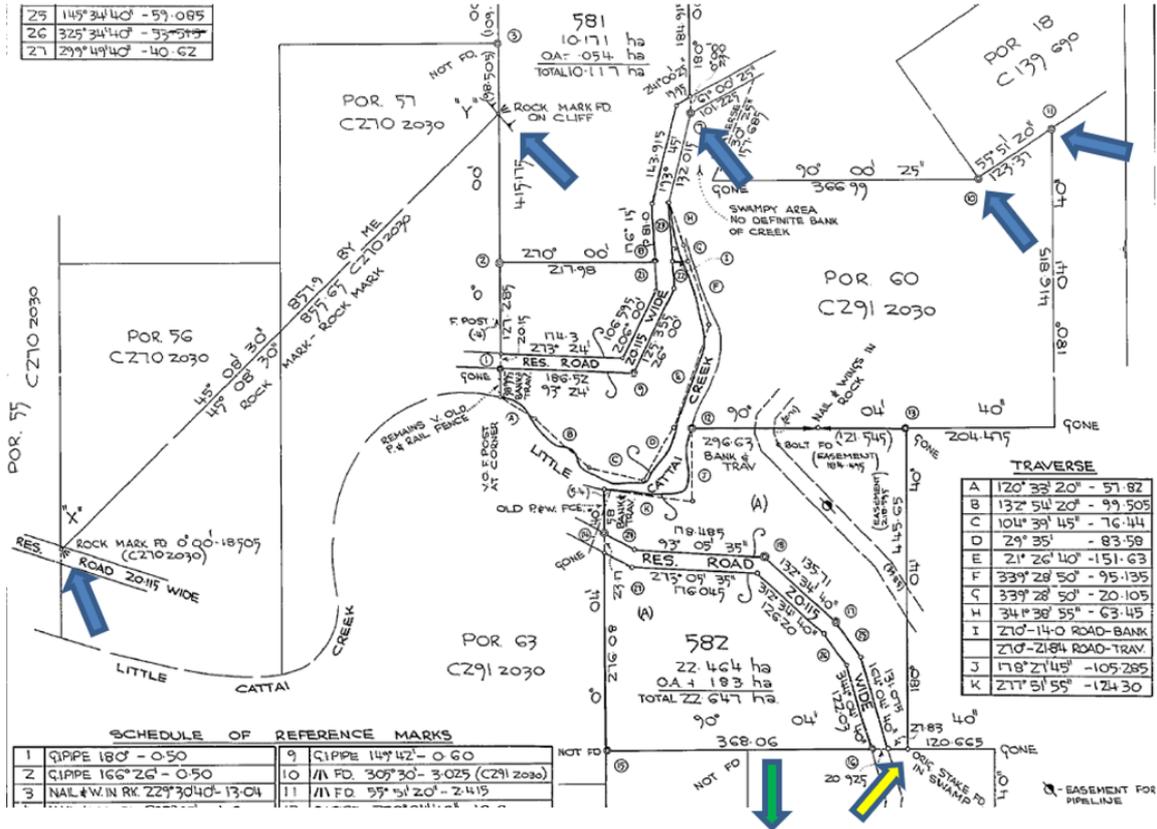
Figure 30: Detail from DP 730390 showing original marks found – 1985.

In 1985, DP 730390 subdivided Portions 58 and 61 but in so doing also surveyed across Portions 56, 57, 60 and 62 (Figure 30). Five original broad arrow rock marks were found, together with one original reference tree and one original stake in swamp. Additionally, over the last two years, several of the early Crown grant portions have been used to prepare re-definition surveys as rural projects for candidates of the Board of Surveying and Spatial Information (BOSSI) assessments. Portions 52 through to 56 were surveyed completely (Figure 31). Reference rock marks cut into the face of the cliff are examples of some of the original marks that were found (Figure 32).

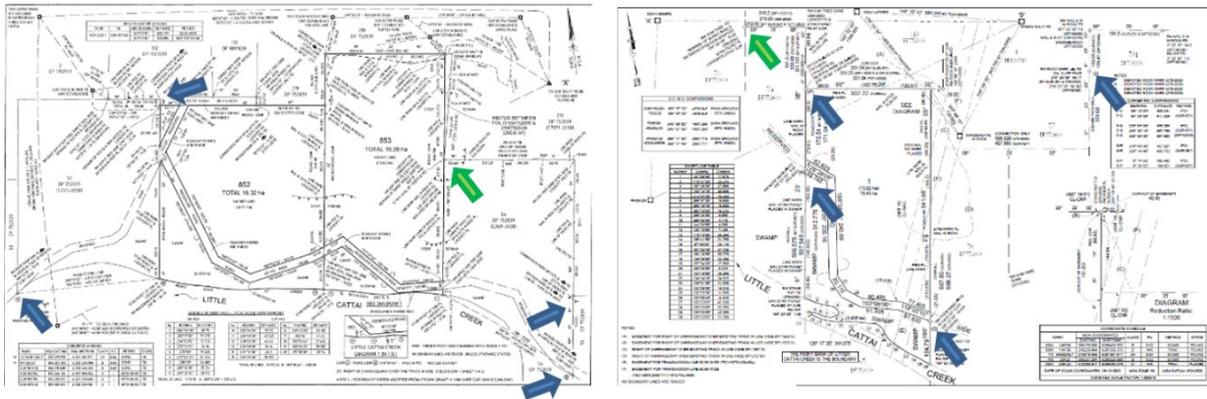
Figure 31: Detail from two BOSSI rural projects showing original marks found – 2021.

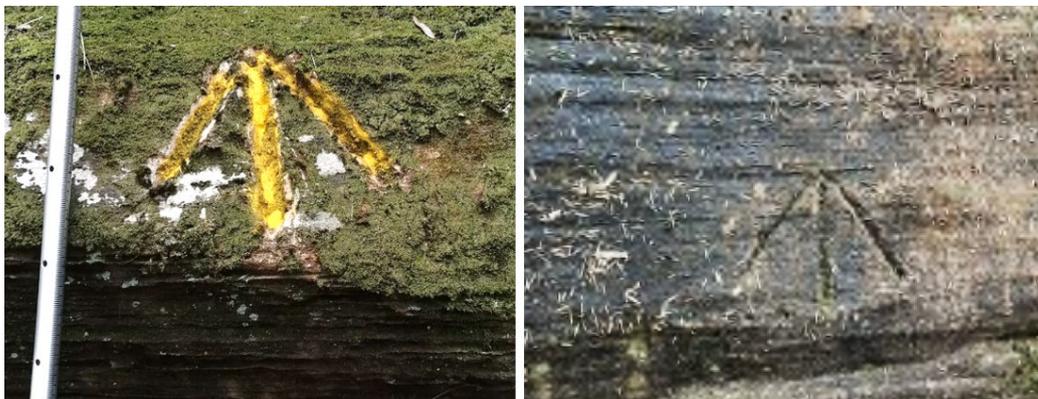
Figure 32: Original broad arrow in rock reference marks cut into vertical cliff face – 2021.

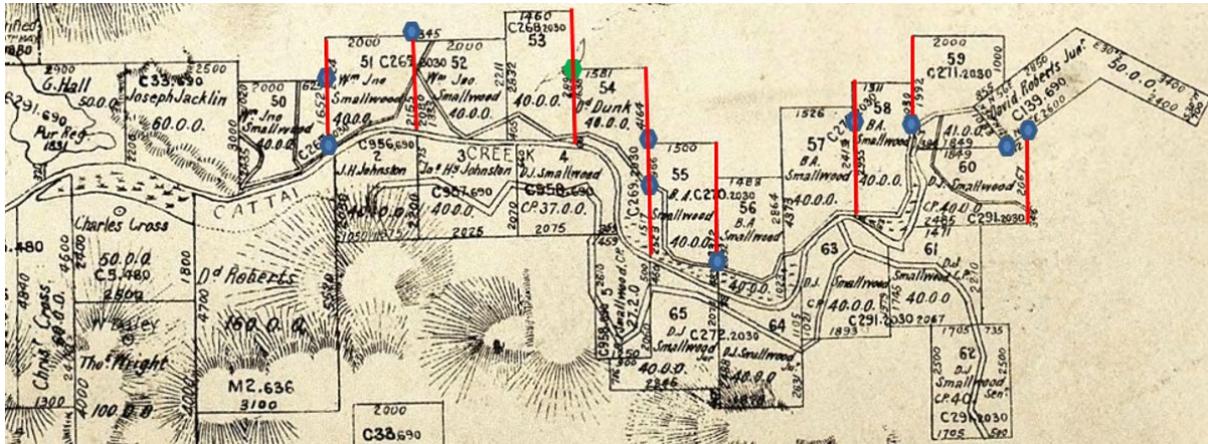
Figure 33: Original rock marks (blue) and reference tree (green) still existing – 2021.
