Pirates and Their Treasures of the Cadastre

Geoff Songberg

ABSTRACT

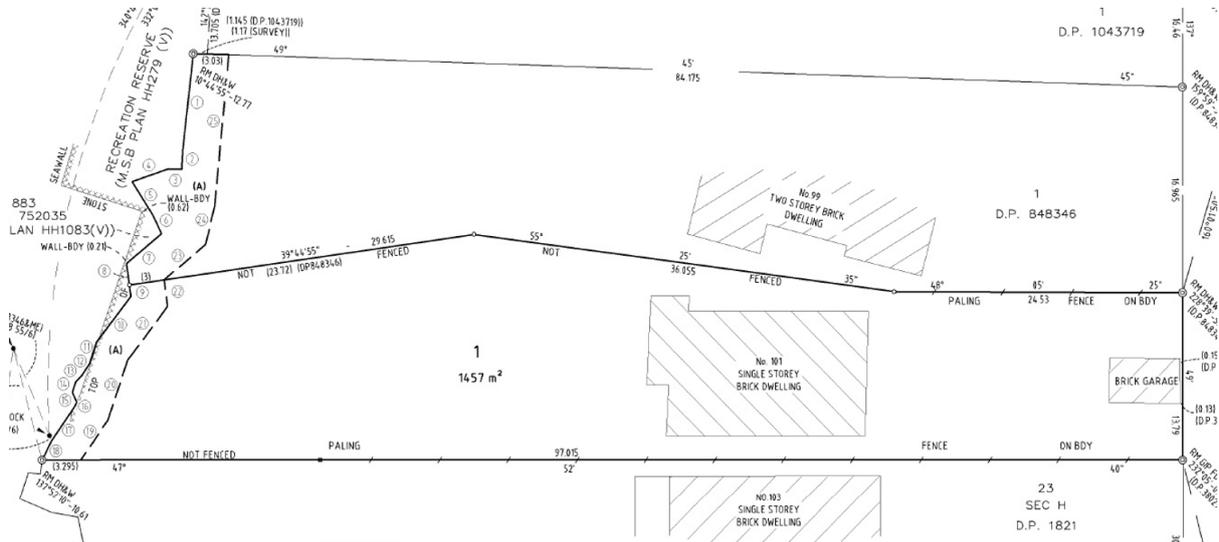
Figure 1: Plan A1.

In Figure 1, an approval has been given to the tidal riparian boundary and so all seems to be correct and the survey plan is registered. However, if you dig a little below the surface and examine the previous plan (Figure 2), it is discovered that the boundary at the bottom of the image is 5.145 m shorter than on the new plan and there is a reclamation extending out from the tidal boundary to a sea wall. A good setting for hidden treasures...

The Surveying and Spatial Information Regulation 2017 (NSW Legislation, 2023), the current regulation at the time of writing, states at Clause 48(3): “If the change in the position of the mean high-water mark arose otherwise than from natural, gradual and imperceptible accretion or erosion, the position of the mean high-water mark, as defined by a survey plan, survey report or survey record filed or recorded by the Registrar-General or a public authority before the change, is to be adopted.” A clause of the same wording existed in the regulation of the time of survey. This rule is an extension of the doctrine of accretion and erosion. Because the change, i.e. the reclamation, has not occurred gradually and imperceptibly, but rather deliberately, the riparian boundary does not change in subsequent plans and the reclamation remains part of the land below the old line of mean high water. Plan A1 (Figure 1) clearly shows the new boundary about the retaining wall around the line of the new boundary and not where it should be at the old line.

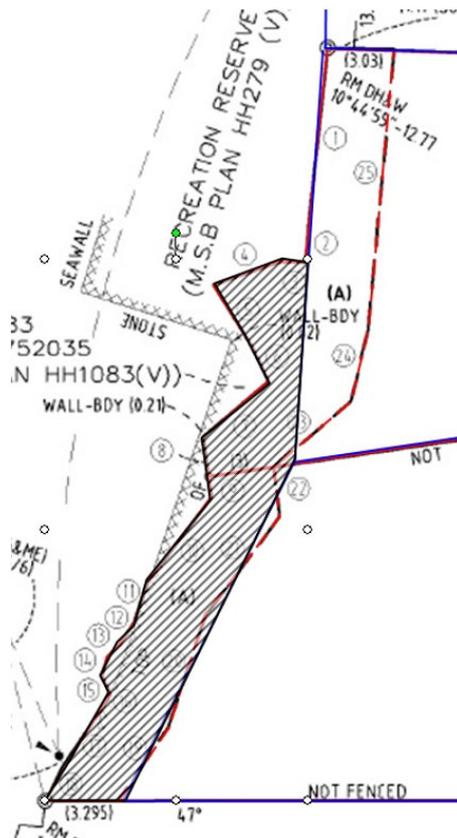
Figure 3: Plan A1 treasures – gain of hatched land and easement shown in brown.

This example contains two treasures (Figure 3). The first is a gain of land shown hatched in Figure 3. This was all reclaimed land and according to the regulations should not have been included in the survey. The other treasure is the easement, which derives a benefit to two other lots. The easement allows two sets of landowners to pass along the foreshore across one lot to the foreshore facing a road.

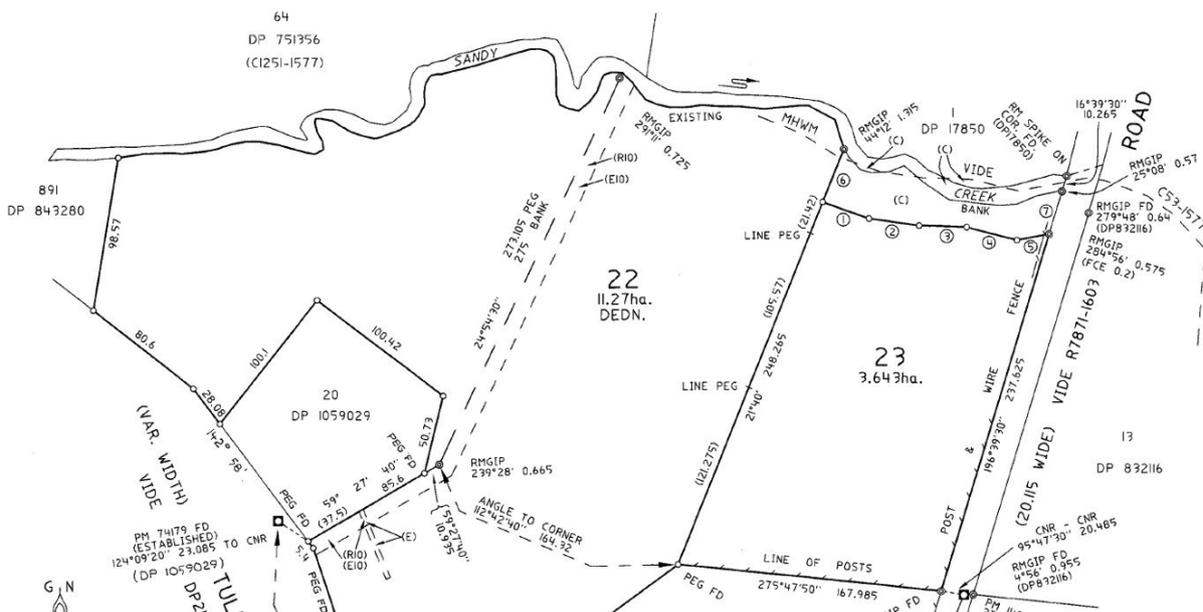
Figure 4: Plan B.

This example consists of another plan with an approved MHWM, but this time combined with the landward boundary of a 100' reserve definition. Figure 4 shows a plan that has successfully gone through the approval process for the riparian boundary and subsequently been registered. Inspection of the plan and information pertaining to local conditions provides a slightly different perspective as to whether or not this plan hides a treasure.

The Crown grant that this plan is within did not display on the face of the plan any notation as to the existence of a 100' reservation from mean high water. The grant itself, however, has included in the exceptions and reservations "all land within 100 feet of High Water Mark." The land is on the edge of the flood plain for the very tidal Clarence River, and Sandy Creek is tidal (or at least is shown to be tidal) to the east of the road on the east side of the plan. Information on local conditions relevant to Sandy Creek reveals that there is a weir west of the road that prevents the tide from reaching its natural extent up the creek. Now the situation does not seem straight forward and perhaps there should have been a bit more to the plan.

The survey practice regulations, for quite a few incarnations, have required the surveyor to show any structure within 1 metre of a property boundary and provide offsets from that boundary. Riparian boundaries are not an exception from this requirement, and a weir would actually cross the MHWL and extend into the land a short distance. So where is the weir? It is not shown.

If the barrier is at the eastern edge of lot 22, the limit to which the reserve has been shown along the creek, then how much further up the creek would the tide naturally reach? Despite the weir, the creek is deemed tidal to its natural limit, yet that limit is not shown. The plan shows a half-completed tidal symbol on that part of the creek fronting lot 22 and also labels the riparian boundary as existing bank as opposed to the MHWL dashed from the grant plan. There is a lot to suggest that lot 22 should also show a 100' reserve, even if it is not defined by the plan. Should the tidal limit, and thus the reserve, extend beyond the easements (E10 and R10), then there would be an impact on the terms and conditions of those easements. It seems that this plan is not as complete as it should be, and there could be hidden treasure.

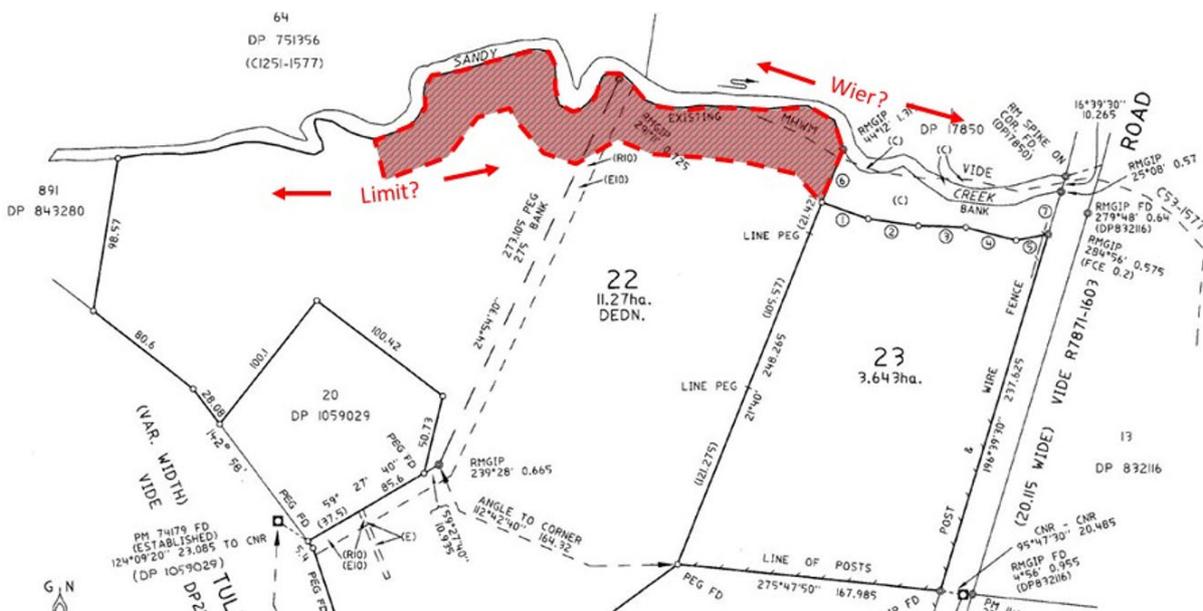
Figure 5: Plan B treasures.

The missing reserve information from the plan gives the impression that there is more land available to lot 22 than that indicated. This is not the only plan, starting with the grant plan, that does not show the 100' reservation. There is even a plan in the sequence of subdivisions east of the road that does not show the reserve despite having an approval for MHWL. Lot 22 is not the only lot to have gained a treasure (Figure 5).

The non-disclosure of the weir does not produce as physical treasure but rather gives the treasure of greater simplicity to the land than what actually is. In some ways, the situation might even be considered as a hidden burden rather than a treasure.

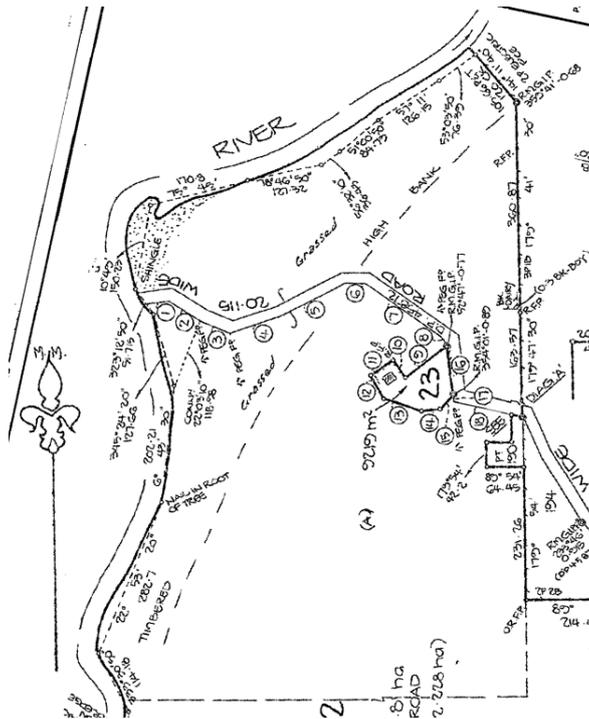
Figure 6: Plan C.

Figure 6 shows a section of a plan for the property along the river. At first appearance, it seems like a job well done, but this is another land where pirates (intentionally or mistakenly) roam. Thoughts of hidden treasure start to appear when the previous plan and charting map are examined (Figure 7). These indicate that the bank was much further inland than that shown in Figure 6, and in between is a wide shingle bed. The latest plan does indicate the location of that bank as the high bank but only refers to the shingle as being grassed. The plan also identifies a lower shingle inside a bend of the river in the northwest.

To determine the error(s) in plan C, an understanding of what constitutes the bank is required, particularly at the time of the surveys. In this example, there is no obvious error. It could also be suggested that there is no purposeful error but only a misguided judgement. Another consideration should be the changes that have occurred throughout time and their influence on where the riparian boundary should be located.

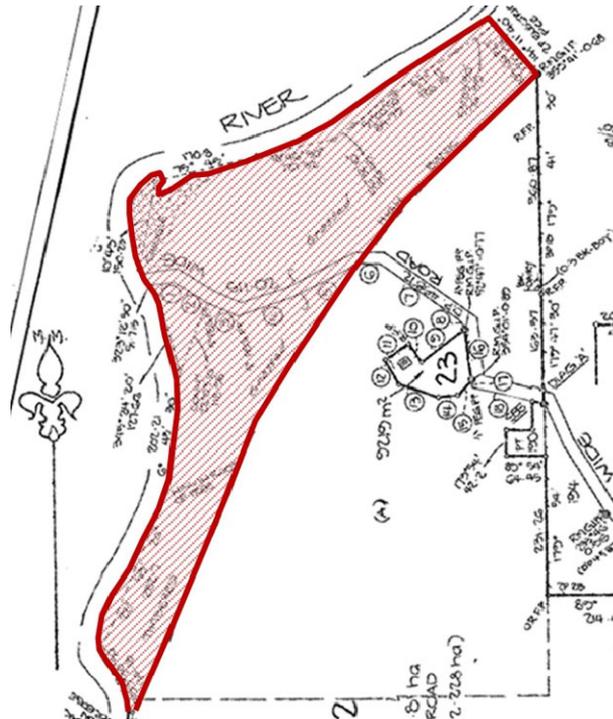
Figure 8: Plan C treasure – consideration 1.

The estimation of the amount of treasure depends on interpretations and opinions. If it is considered that the property boundary should remain as it was according to the original survey, then the high bank should have been retained as the boundary. The location of the high bank does not appear to have changed and so all the land in between the high bank and the water channel edge (the new boundary) would be considered as treasure (Figure 8).

The river forming the boundary can run at very high levels, which can change the nature of its banks and bed considerably. Conversely, the channel in which the river usually flows is smaller than the bed of the river and the flow rate not of sufficient force to change the alignment of the channel, or the bank. Only the higher irregular flow can achieve that. Moving the boundary in the manner that has been done in plan C would not have conformed to the doctrine of accretion and erosion. A consequence of moving the boundary would be the impingement of any possible *ad medium filum* rights of landowners on the other side of the river.

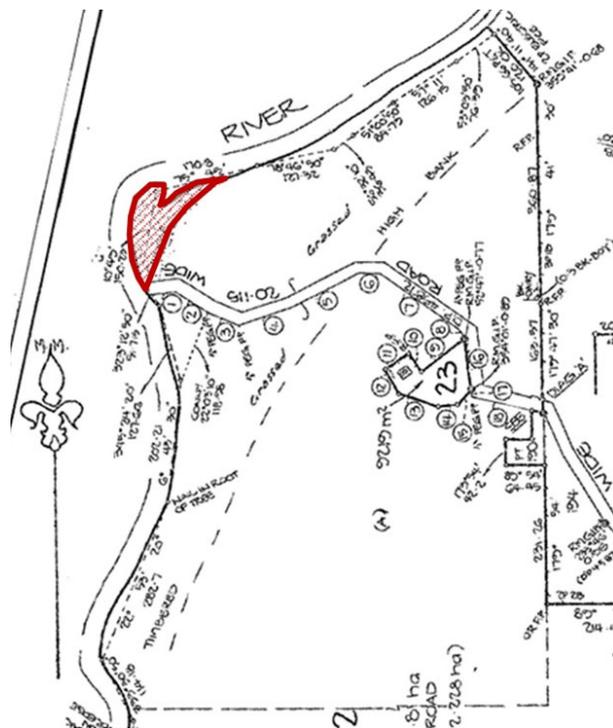
Figure 9: Plan C treasure – consideration 2.

Assuming that the more modern definition of the bank should have been the chosen location of the boundary in both the new and old plans, then only the smaller low level shingle bed would be considered as the treasure (Figure 9). The upstream limit of the low shingle bed is controlled by a concrete bridge structure, and the bank upstream is a few metres high and quite steep. There would be little lateral difference between the low flow water channel and the mean stage bank position. Downstream of the shingle bed, the bank is of similar condition, so the treasure only extends as far as depicted on plan C.

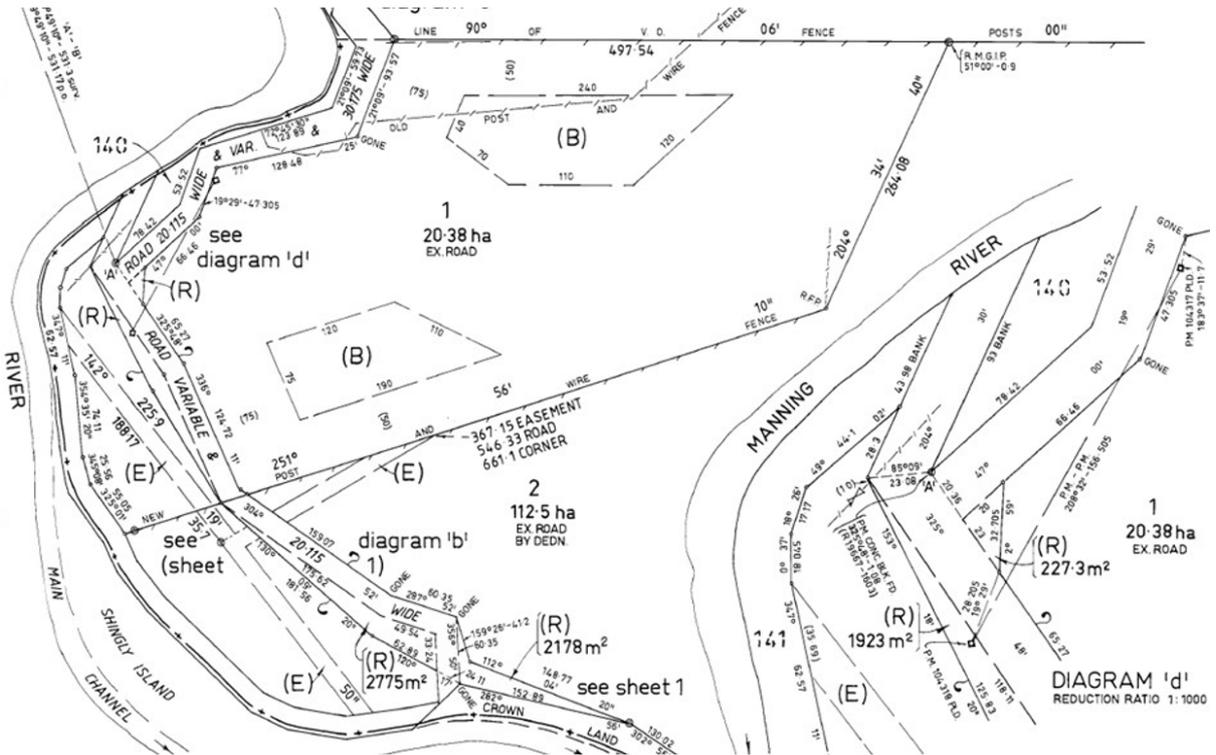
Figure 10: Plan D.

Pirates and treasures seem to be appearing quite significantly in riparian boundaries. Here is yet another example. The relevant segment of plan D shows a strip of land along the bank of the river, which is identified as lot 141 (Figure 10). Investigating the previous plan, we find that the plan has been compiled from the original portion plan (Figure 11), and a notation on the plan states “the boundaries between lot 139 and lots 141 and 142 are intended to be 20 metres from the bank of the Manning River as at the date of survey of” the original portion plan.

The error immediately evident is that the surveyor did not comply with the requirements of the landward boundary and did not locate the bank as was defined by the portion plan. Instead, the surveyor chose a different interpretation of that requirement and determined their own bank at the edge of the water.

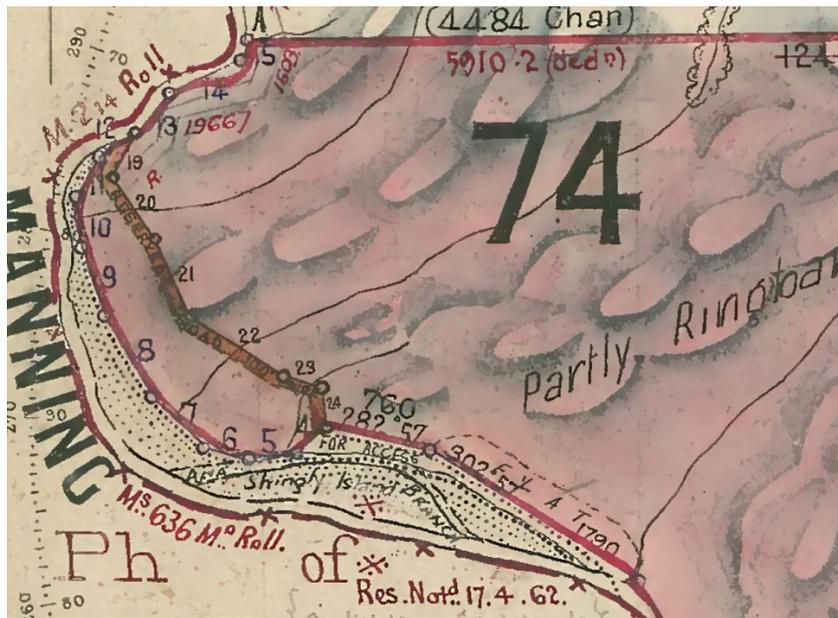
Figure 11: Original portion survey plan D.

From the portion plan, it is clear that the bank is well defined by a creek traverse, and at the time of survey there is a shingle bed plus a shingle island within the river. The modern surveyor in conducting plan D states on the face of the plan that the location of the riverbank is substantially the same as on the original portion plan. So, it looks like everything is fine and there are no treasures. However, when the banks of the old and new plans are compared, the story is a little different.

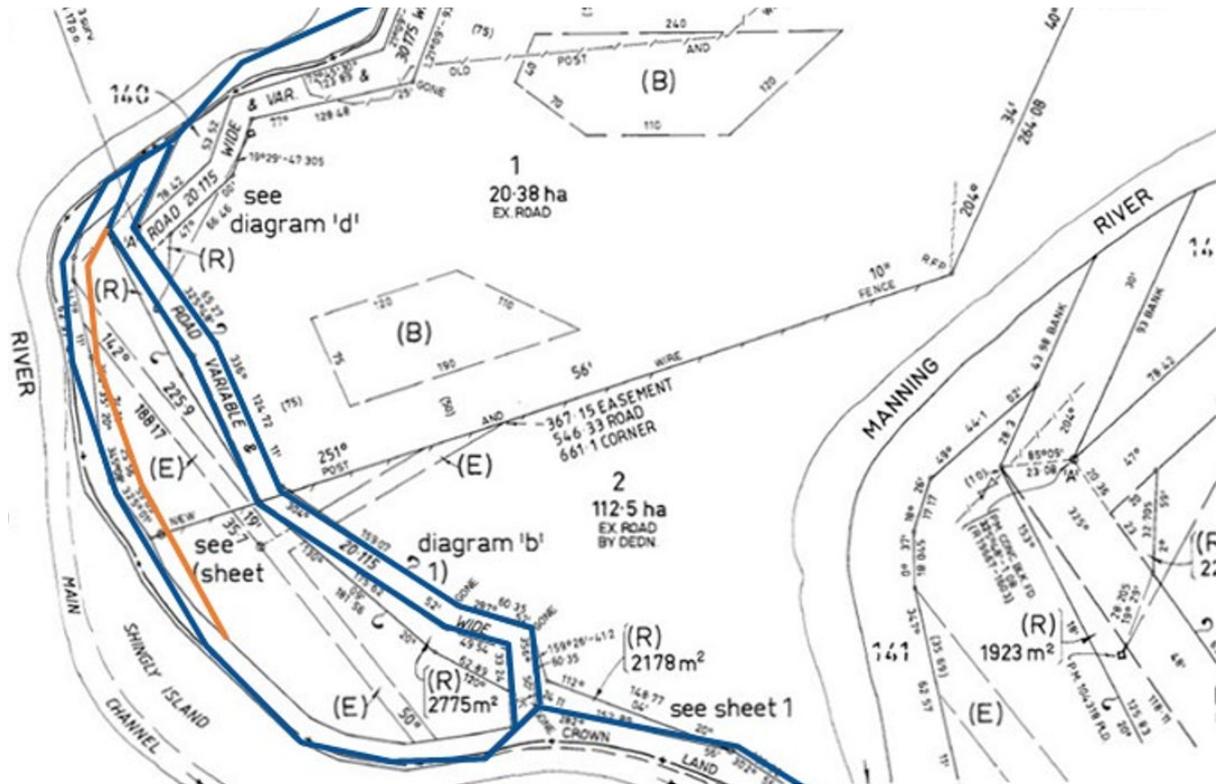
Figure 12: Plan D and portion plan overlay in blue, with the reserve boundary shown in orange.

With a graphic overlay of the portion plan over plan D (Figure 12), it becomes evident that the landward boundary of the river front strip of land is different between the two plans. There is also a difference between the two bank determinations of the river. Furthermore, the shingle bed evident on the portion plan has disappeared off plan D. On-site examination found that the riverbank chosen by the surveyor was the water's edge of the stream channel evident at the time of survey. The old bank as defined by the portion plan was still in its original location at the back of the shingle bed.

Because of the shift in location of the bank, and subsequently a shift in the location of the landward boundary of lot 141, the treasure is the land gained by moving the bank out into the bed of the river (Figure 13).

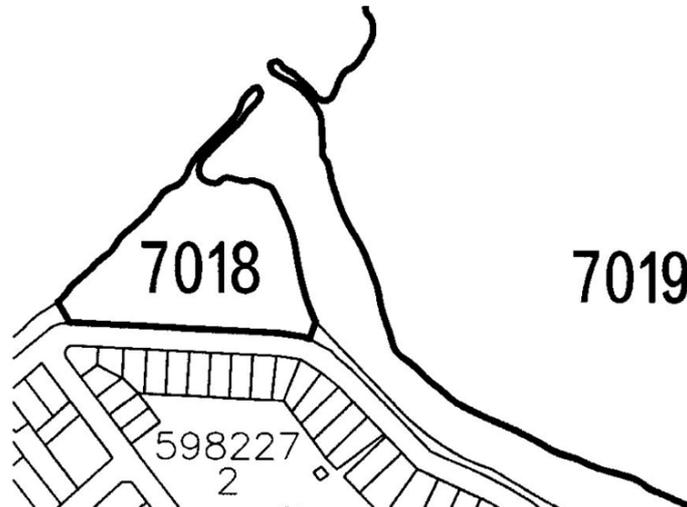
Figure 14: Plan E.

Plan E (Figure 14) covers part of the Crown estate and was created during the development of the Digital Cadastral Database (DCDB), identifying Crown lands for inclusion into the Torrens register. The process did not make Crown land become Torrens title but simply enabled it to be recorded into the register for the developing digital identification of all land parcels. There are many of these parcel identifiers throughout the state.

A base assumption is that these plans are correct. Unfortunately in reality, they are too often erroneous. It takes a fair bit of not so in-depth research to show that this plan, i.e. that part pertaining to lot 7018, is erroneous. The plan shows a road between lot 7018 and the land parcels to the south. The road in the location as shown does not exist, although a road does exist in the area but not in this location.

The first error that occurred is the drafting of the linework creating lot 7018 by the builders of the mapping component of the DCDB. They were simply wrong. Lines were drawn around anything that was observed despite whether or not it should have been included. Sometimes

not even similar features were included. Lot 7019 in plan E included mangrove swamps, constructed rock walls of the new entrance, open water and a small island (Songberg, 2019). The next error is that the linework was not checked for validity. The final error, which is not discernible by just looking at the plan, is that the designation of what the lot entails (i.e. the status of the land) was not verified, and if queried with Crown Lands, the resulting data would be incorrect.

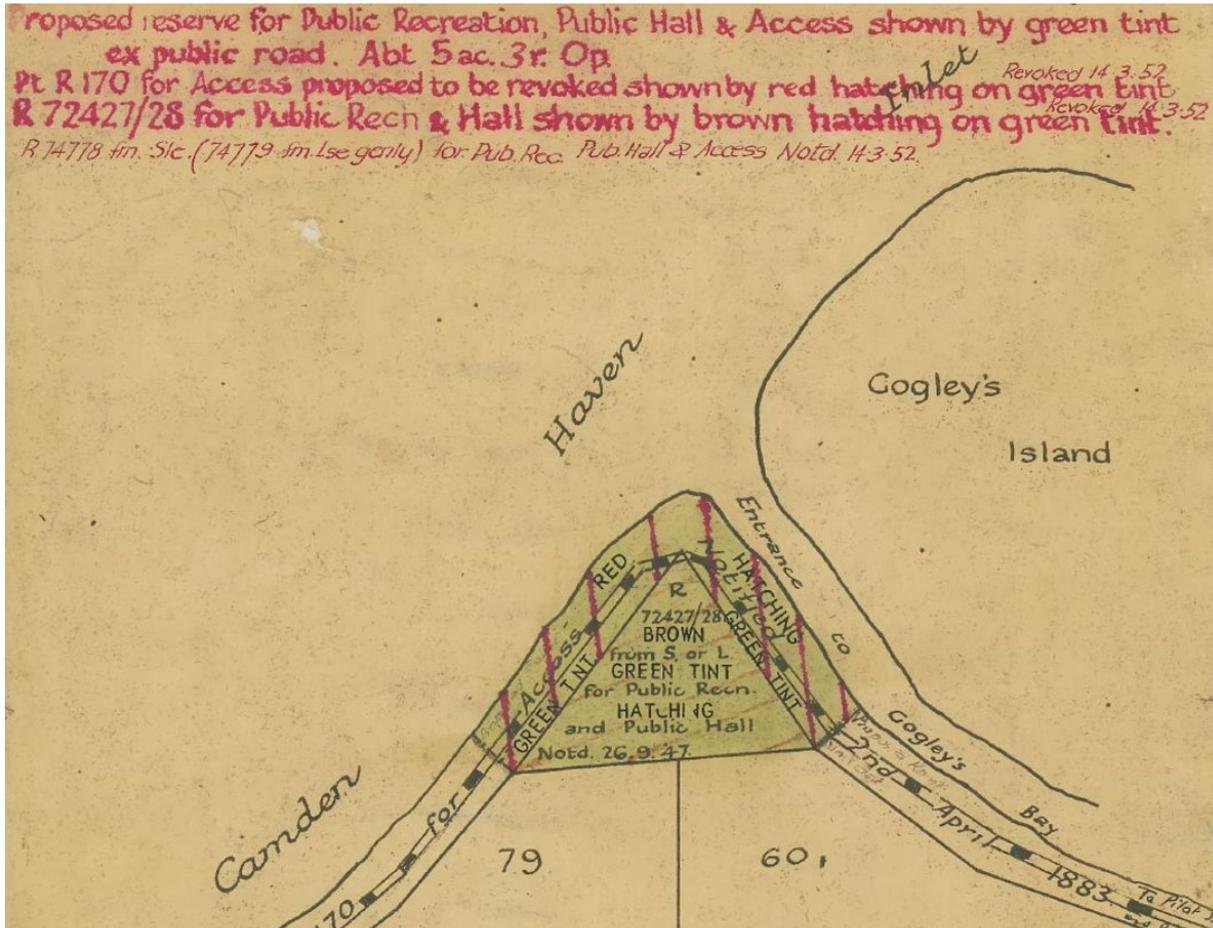
Figure 15: Prior plan to plan E.

There is an older plan, showing in depth the status of this peninsular of land (Figure 15). This plan shows the changing circumstances of the reservations on the point. Noted on the plan is that the public road is not included in the new reserve and that it is shown to be located within reserve 170 and not against the parcels of land to the south. Checking the gazette for the public road verifies that it should be within the reserve and not against the southern land.

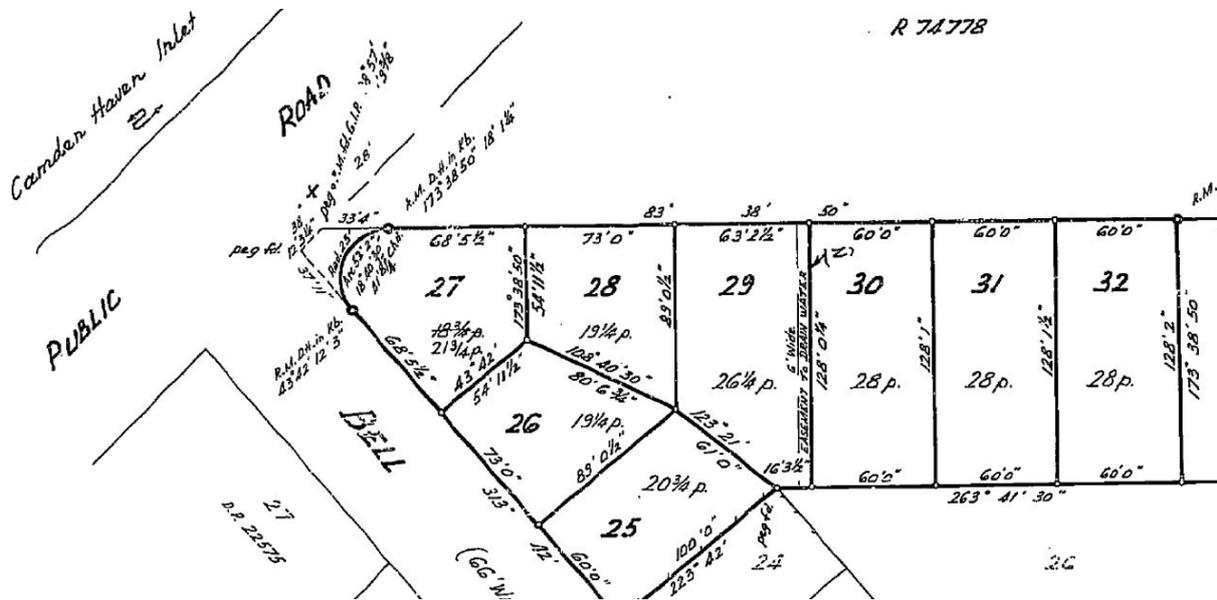
Figure 16: Subdivision plan south of plan E.

A check of the subdivision plan (Figure 16) creating the lots depicted in plan E shows that, in this instance, the surveyor got it right and identifies the land immediately north of the subdivision as a reserve and not as a road as shown by plan E.

For once, the surveyor is not one of the pirates. If you consider the surveyor of the subdivision in Figure 16, then it could be said that the surveyor was a purveyor of the truth.

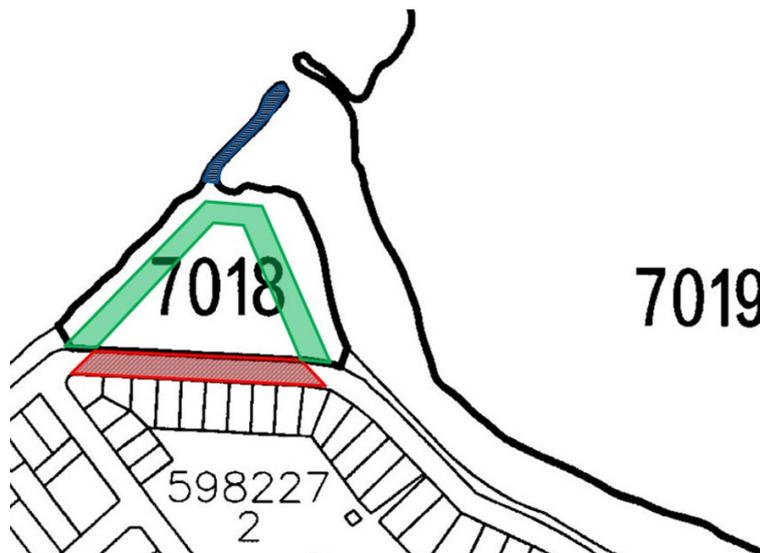
Figure 17: Plan E treasures.

In this example there are three treasures (Figure 17):

- In red, the apparent road fronting the house lots, which is not a road but part of the reserve. The situation gives the owners of the house lots the belief that they have access to their land from a public road. This belief could be considered a treasure. The reality is that they do not. Their access is through a reserve for public hall, recreation and access.
- In green, the part of lot 7018 that really is the public road and not part of the reserve. The gazettal of the reserve excluded the road, so it is not part of the reserve but instead a public road.
- In blue, the constructed revetment wall built around 1901 for the river entrance reconstruction that is not part of the reserve. The wall should be part of the riverbed if you consider the true status of that feature.

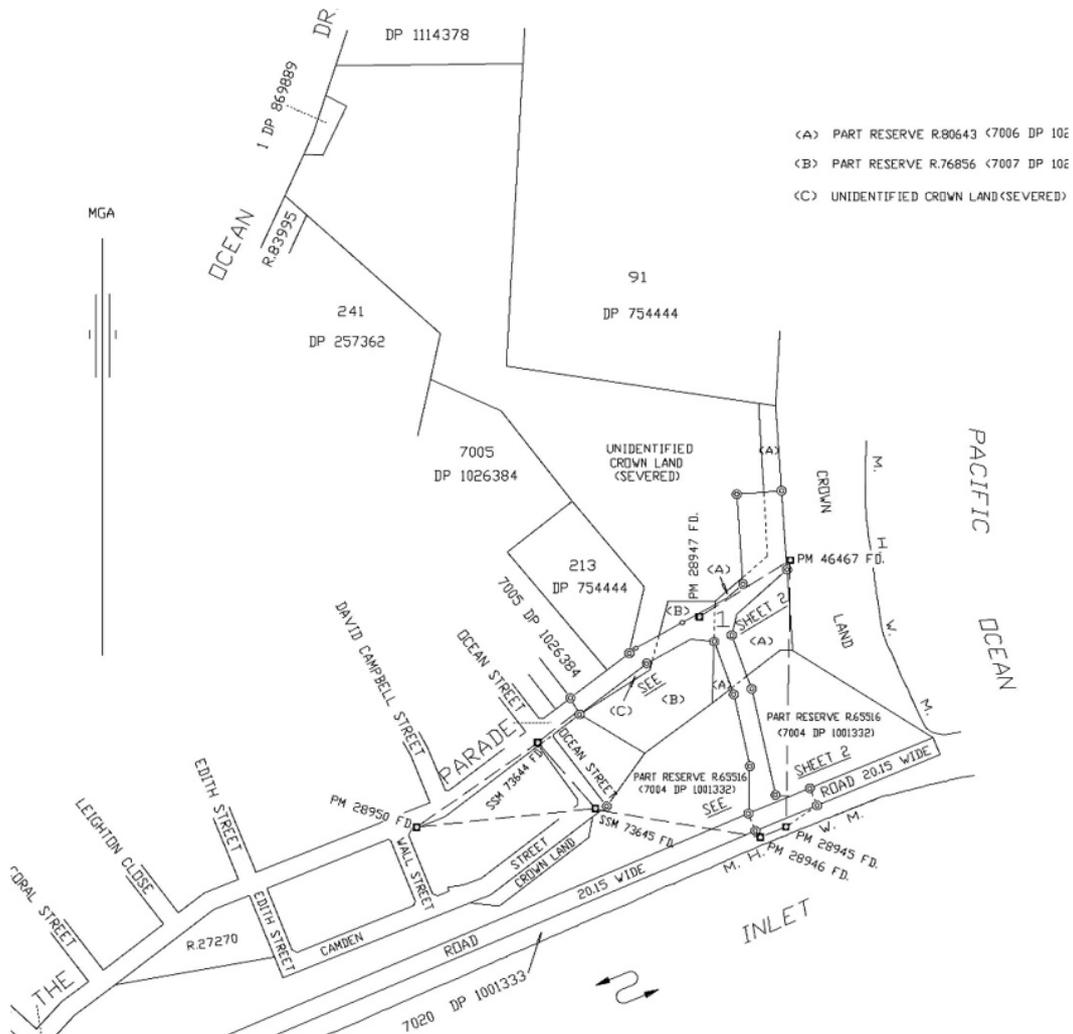
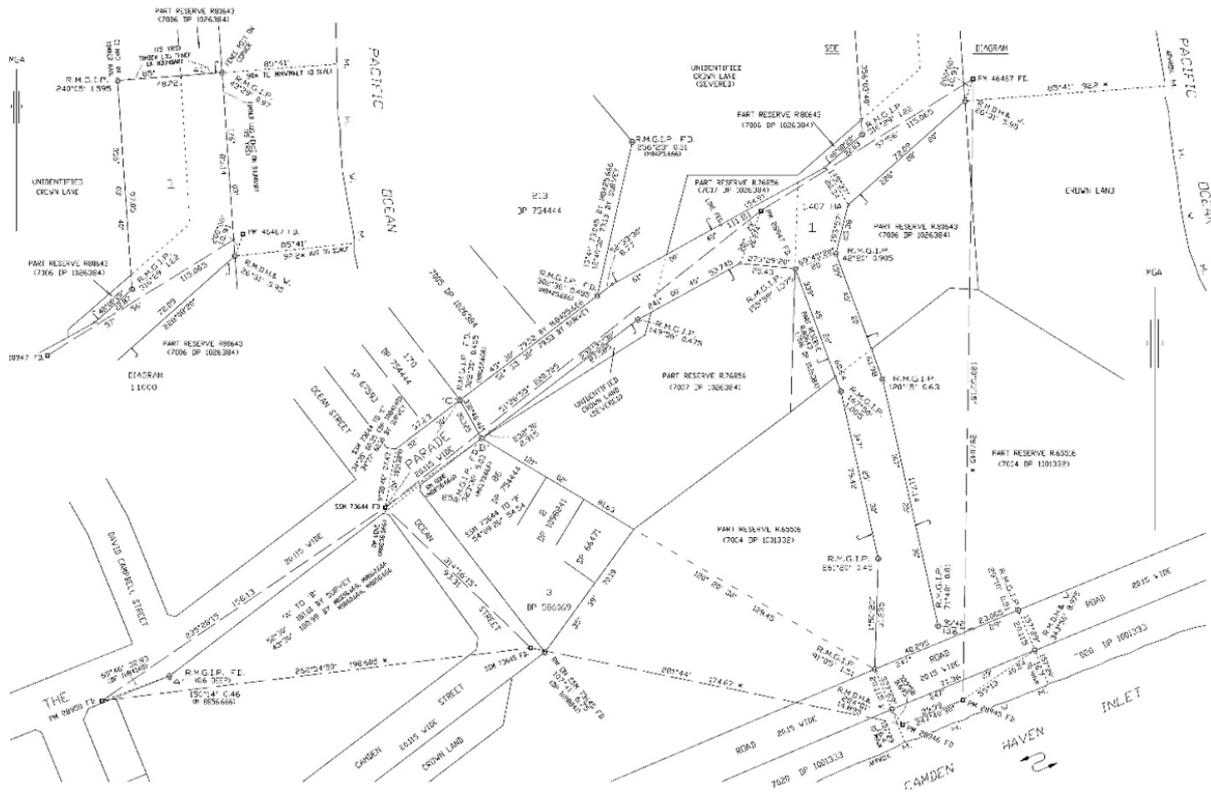
Figure 18: Plan F1.

The survey undertaken for plan F (Figures 18 & 19) is quite comprehensive and within itself very good work. However, there is one fundamental problem the surveyor did not foresee, which eventually brought the project unstuck. The land on which the survey was conducted is Crown land, managed through various reserve designations and purposes. Over time, the graphic records of the reserves and their extents became corrupted with the introduction of the DCDB graphics, pushing that corruption into the realm of nothing was right, including the public road depicted in the south to which the survey connects the survey (Songberg, 2019).

The fundamental error in this example is the DCDB. It could not be more wrong if it tried. Admittedly, the source of the errors does not fully land on the shoulders of the builders and verifiers of the DCDB across the Crown estate. In this area, the errors have crept in over time and been compounded upon. Mapping of the cadastre, particularly in this area, has been problematic. Unfortunately, errors such as those seen here and in the previous example are quite common when it comes to the Crown lands component of the DCDB. Users of this part of the cadastre, including surveyors, often do not realise that it is prone to errors. A golden rule that should be applied when navigating this part of the cadastral sea is to firstly assume it is wrong. This should be followed by doing the research to prove it is either right or find out what is correct, and then use the end result.

The other error is that the surveyor did not realise that the cadastre was fundamentally corrupt. They scaled, straight from the cadastral mapping, the positioning of the various components and used this as the basis of definition. This made the survey and its impact on the land invalid. The plan thus could not proceed to registration.

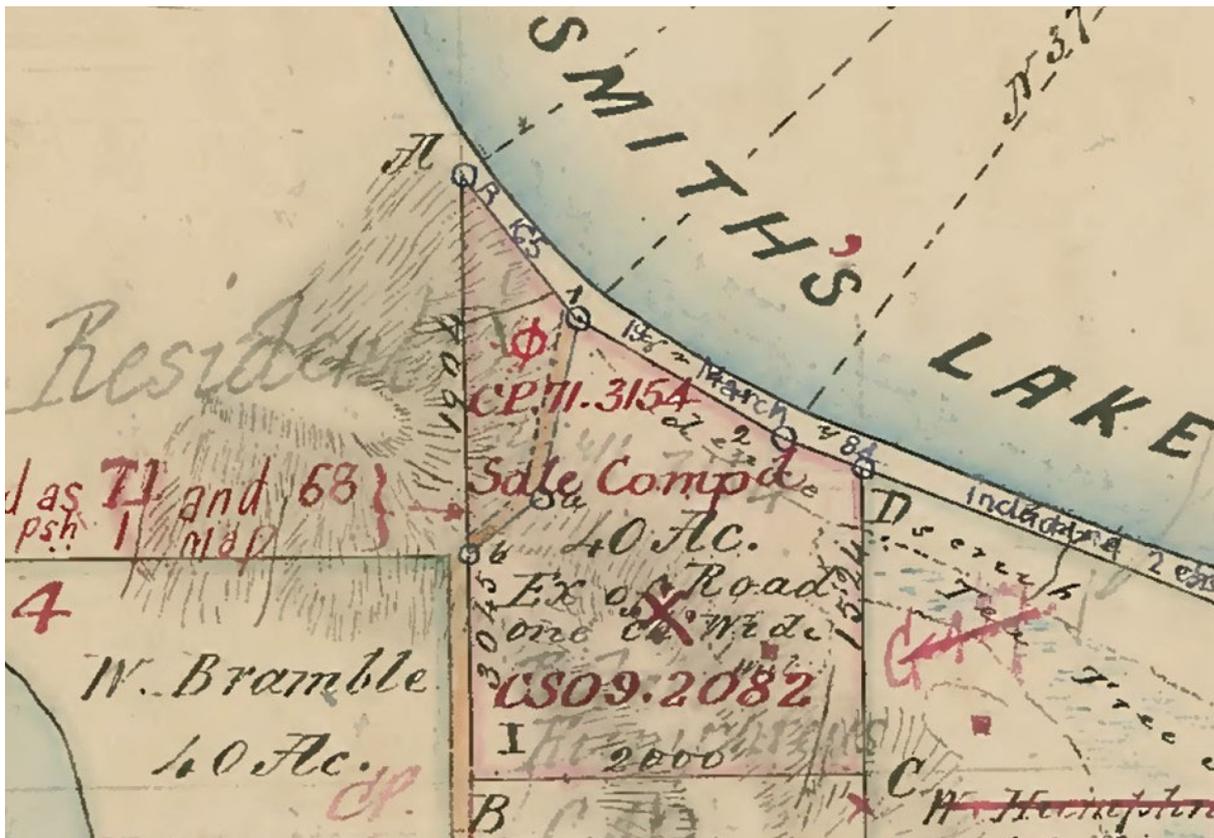
Figure 20: Plan G, the original portion plan.

This example seems to be too old for buried treasure to still exist (Figure 20). After 152 years one would think that any treasure would have eroded into the background or dug up many years ago and dispersed. But that is not the case.

To understand how a treasure still exists after so much time, a bit of survey plan history that occurred following this plan needs to be understood. On plan G, corners A, B, C and D are marked with reference trees. In 1880, another crown plan is conducted encompassing land to the south and east in a single large portion. That plan locates corners B, C and D but does not investigate corner A. After another 8 years, in 1888, two plans are finalised, covering the village to the northeast of plan G. Both plans are signed by the same surveyor on the same day. Both plans locate corner A but do not investigate any other corner. One of the plans also locates the northern corners of portion 4 to the west of plan G.

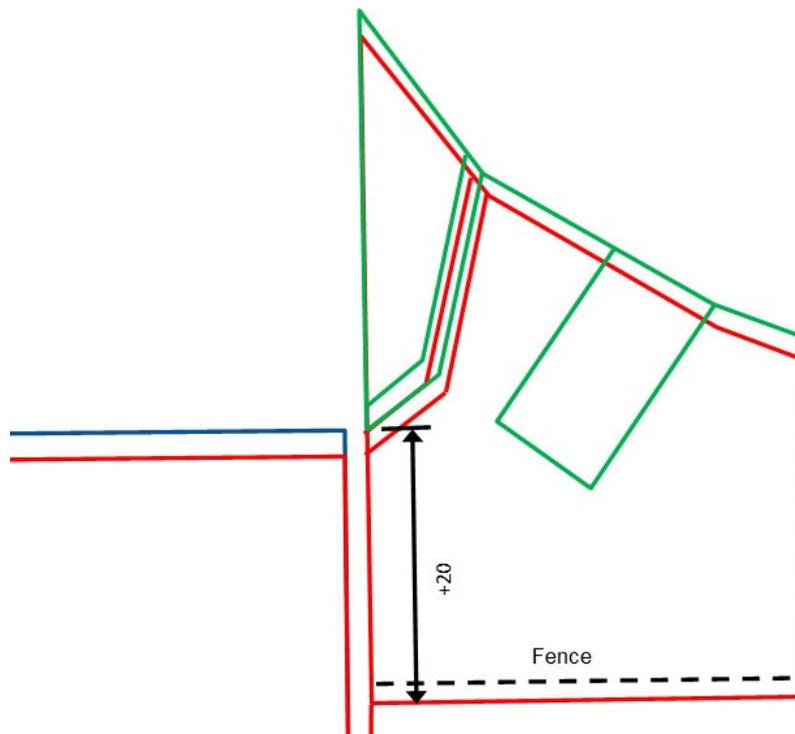
Figure 22: Overlay of (red) plan G with relation to portion 4, (green) 1913 plan tied to shifted NE corner, and (blue) north boundary of portion 4 tied to village plans and NE corner.

The connections across plan G to the 1972 and 2013 plans reveal that there is an extra 20 m between the south boundary of plan G and the internal road. The eastern boundary does not have that extra length. The eastern boundary of plan G is found to be essentially confirmed in its length and location as per plan G. The whole of the northeast corner, the village plans, the 1913, 1972 and 2013 plans appear to be too far north by about 20 m when compared to the south boundary of plan G (Figure 22).

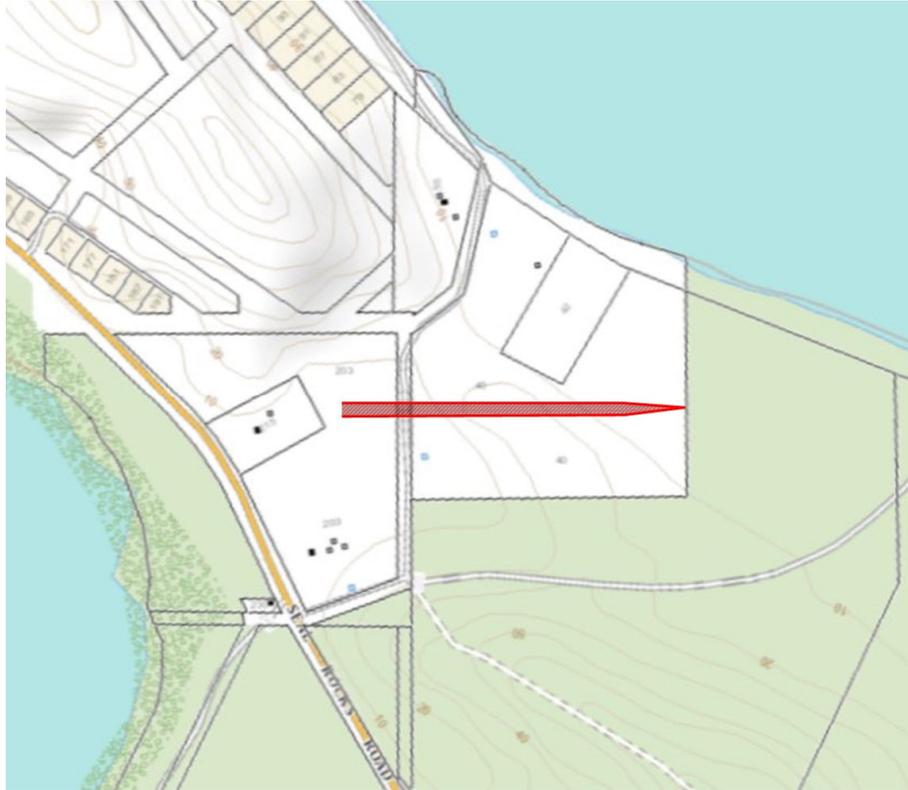
Figure 23: Hiatus treasure within plan G extended west into portion 4.

Perusal of plans associated with portion 4 reveal that there is also an additional 20 m north-south across that parcel. Similar to plan G, portion 4 has been surveyed, in part only, as early as 1947 with pieces taken out. Only the pieces have been surveyed and the residue given as a deduction. Such was repeatedly occurring as late as 2002. But only 5 years later, in 2007, one surveyor does survey the eastern part of the residue, but the east boundary dimension is about 20 m longer than the residue deduction. It is apparent that a 20 m wide hiatus or treasure within plan G extends westward into and possibly through portion 4 (Figure 23).

How far the treasure extends westward is unknown. Whether it passes north or south of the internal parcel is also unknown. It could be that finding the extent is not possible.

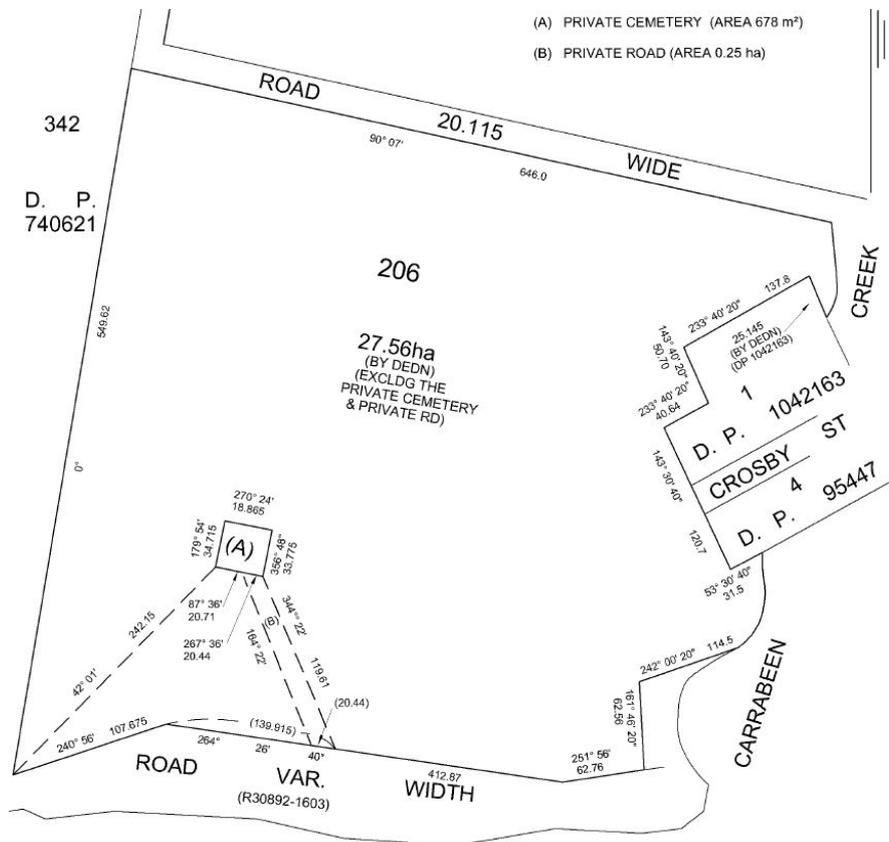
Figure 24: Plan H.

The plan in this example (Figure 24) is not a plan of survey. It is a departmental plan that has been prepared solely for the identification of land and no boundaries have been investigated or surveyed. Anyone would assume that the titling authority would be able to get it right but that is not the case. There is a hidden treasure buried within.

The error in plan H is the status of the road marked (B) private road. It is instead a council public road, and how to work this out is not simple as there is no plan that will provide the necessary information. The subdivision which created lot 206 is a very old private subdivision. The land was part of the Australian Agricultural Company (AACo) grant that ran from Port Stephens north to the Manning River. When the company divested itself of the land it was divided into parishes, similar to Crown parishes, and subdivided within each parish. Giving access to each parcel was a network of roads. Whether or not any particular road has the status of private road, public road or remnant of title will depend on the history of the road itself. Each case can only be determined on its own merits.
