# Coastal Erosion: An “Elegantly Simple Solution” at Harrington

**Grant Calvin**

MidCoast Council

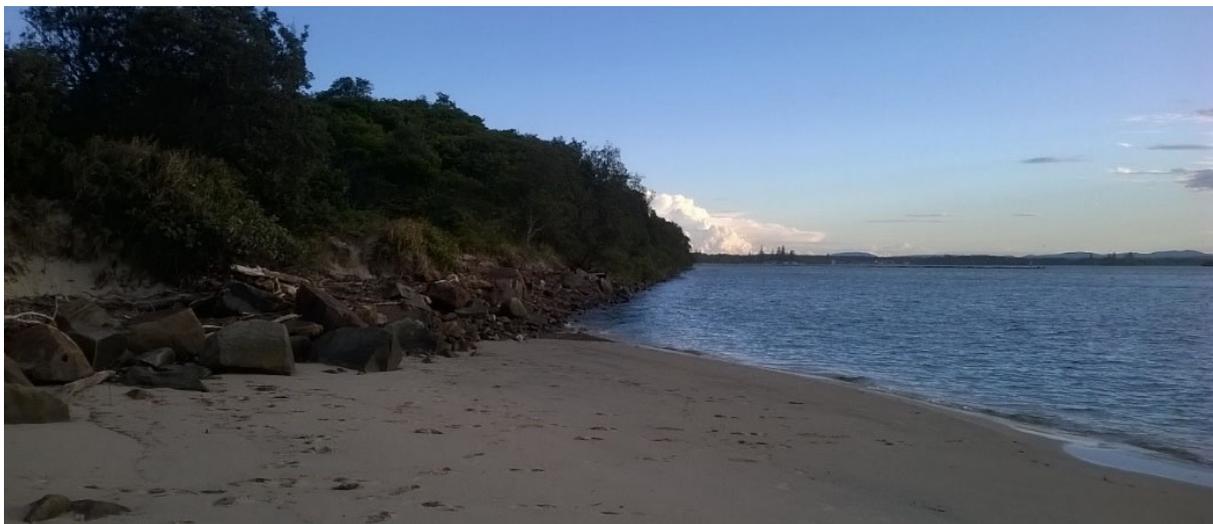
Figure 32: Looking upriver, June 2015.

Looking upriver south from the sand spit, the rock barrier bank can be seen along the edge of the river, with the village and pine trees of Manning Point in the background (Figure 32).

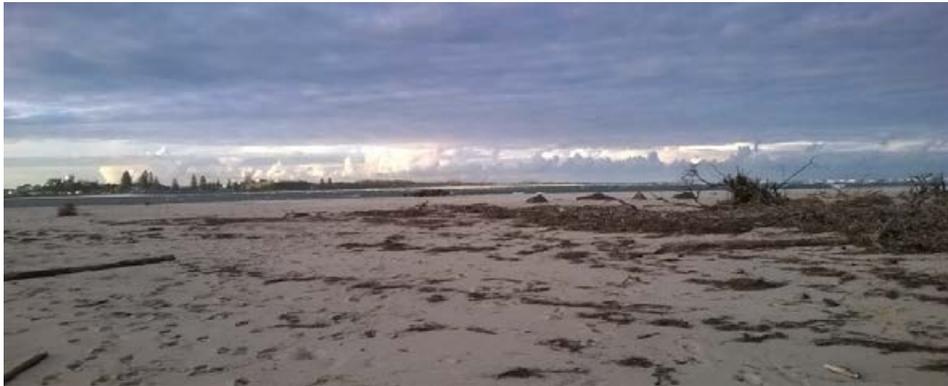
Figure 33: Looking north across the sand spit, June 2015.

Looking north, the expanse of the sand spit between the vegetation and the end of the rock barrier wall is evident. The end of the rock barrier was now well out into the river. Tops of small waves can be seen breaking along the shoreline.

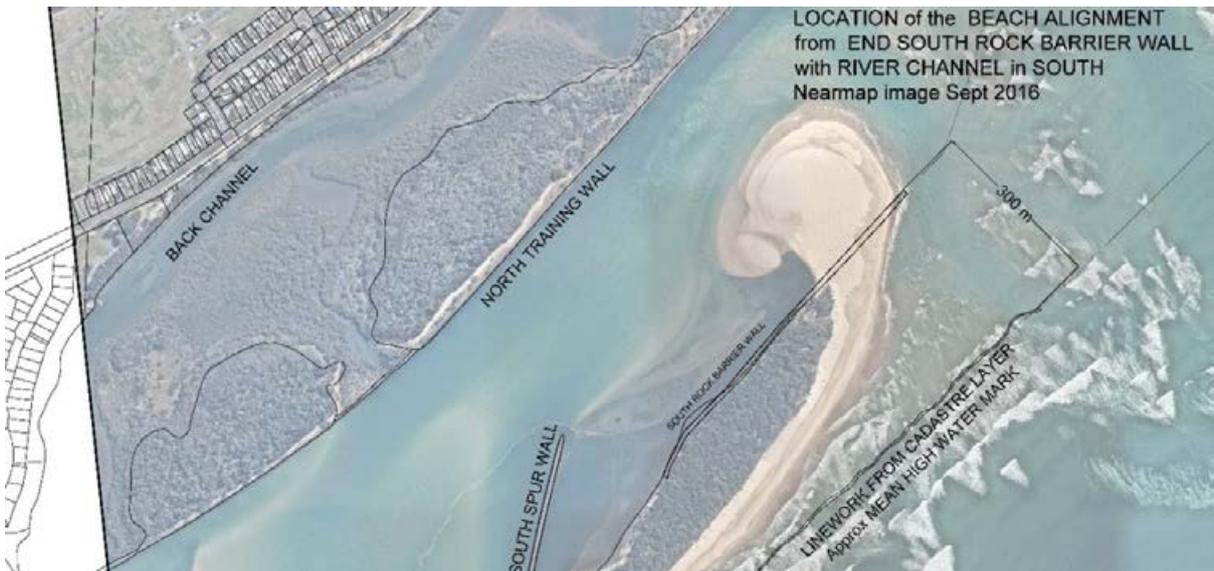
Figure 37: Aerial Nearmap image, September 2016.

When the river flows interact with this remnant section of barrier bank rocks, tidal flows and waves cut off the beach in a south-westerly direction. The beach alignment has shifted landward by 300 m. Waves now break directly over these rocks that are usually on the river side of a wide sand spit (Figure 37). The original cadastre linework of the Mean High Water Mark (MHW) can be seen out in the ocean waves well off the beach.

- When the river entrance shifts to the south, it interacts with the unfinished south barrier bank rocks (see Figures 23-33).
- This interaction causes the beach alignment to shift westward 300 m to the northern tip of the incomplete south barrier bank rocks (see Figures 36 & 37).

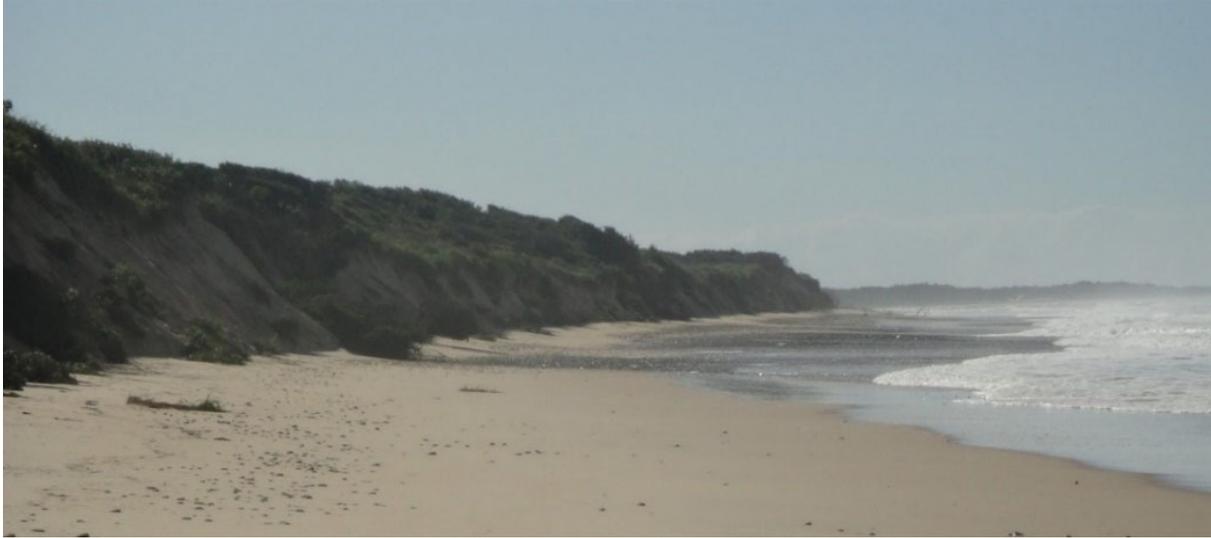
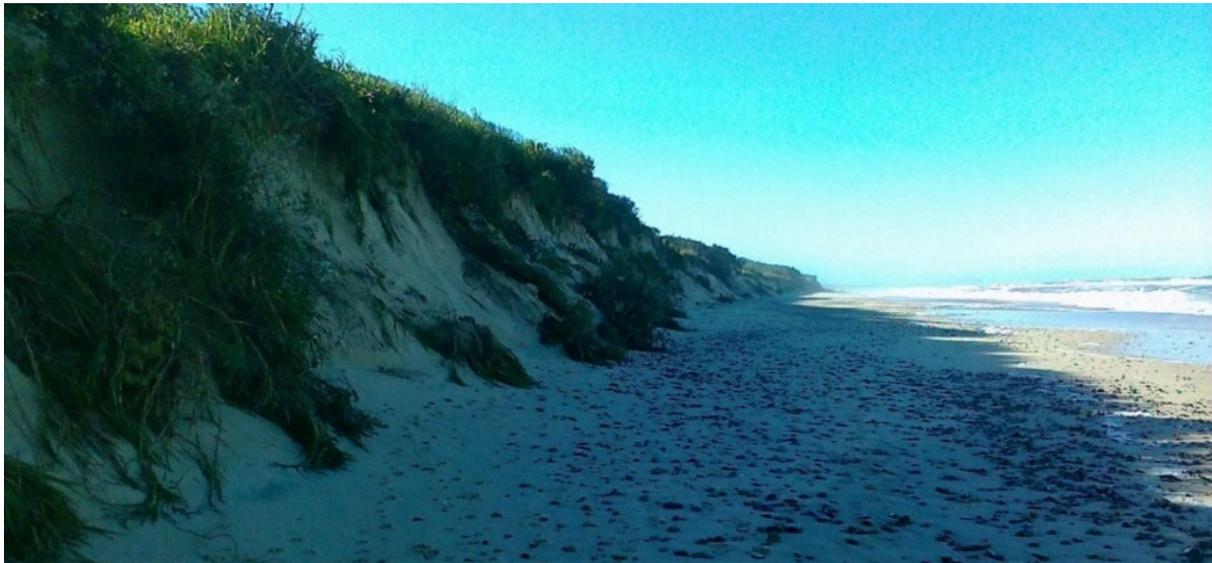
The photographs in the following figures show what was happening along the frontal dune system between the beach access and the river entrance during this time. The erosion along the beach is obvious. The scarp in 2012 was not full height. The peak of the foredune is behind and higher (Figures 38 & 39).

Figure 38: Adjacent beach of Mitchells Island, September 2012.

Figure 39: Adjacent beach of Mitchells Island, July 2013.

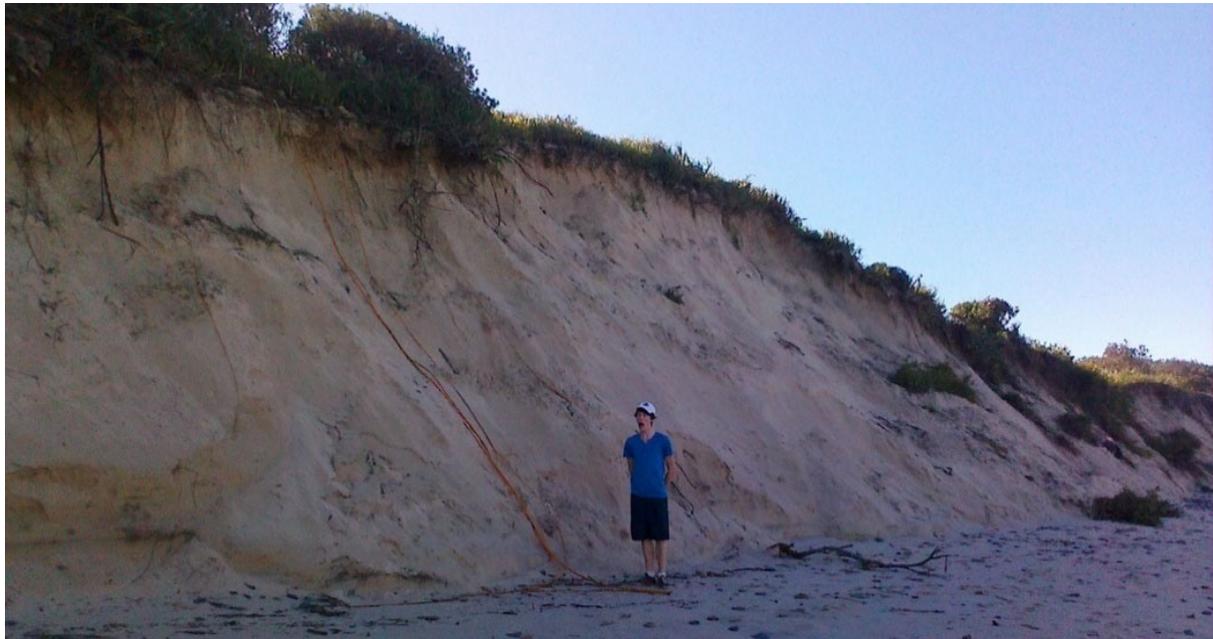
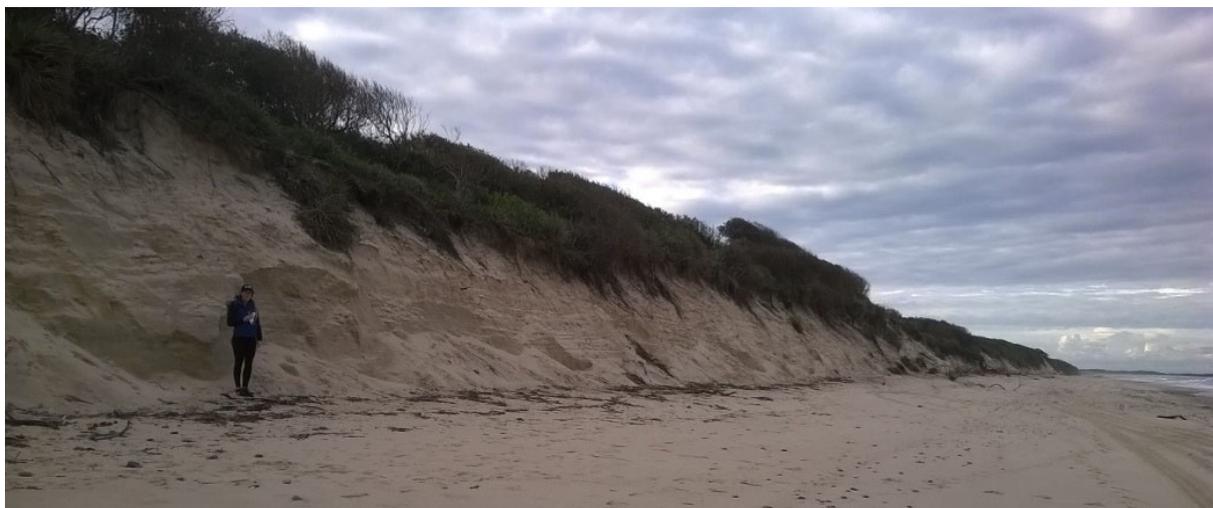
The sand scarp is nearing the peak of the foredunes all the way along the beach. On a human scale, the dunes are quite high in places. The wave action at the toe of the dune is evident by the lack of debris. The whole beach front is actively eroding, and the erosion scarp appears to be at full height of the dunes (Figures 40 & 41).

Figure 40: Adjacent beach of Mitchells Island, July 2013.

Figure 41: Adjacent beach of Mitchells Island, June 2015.

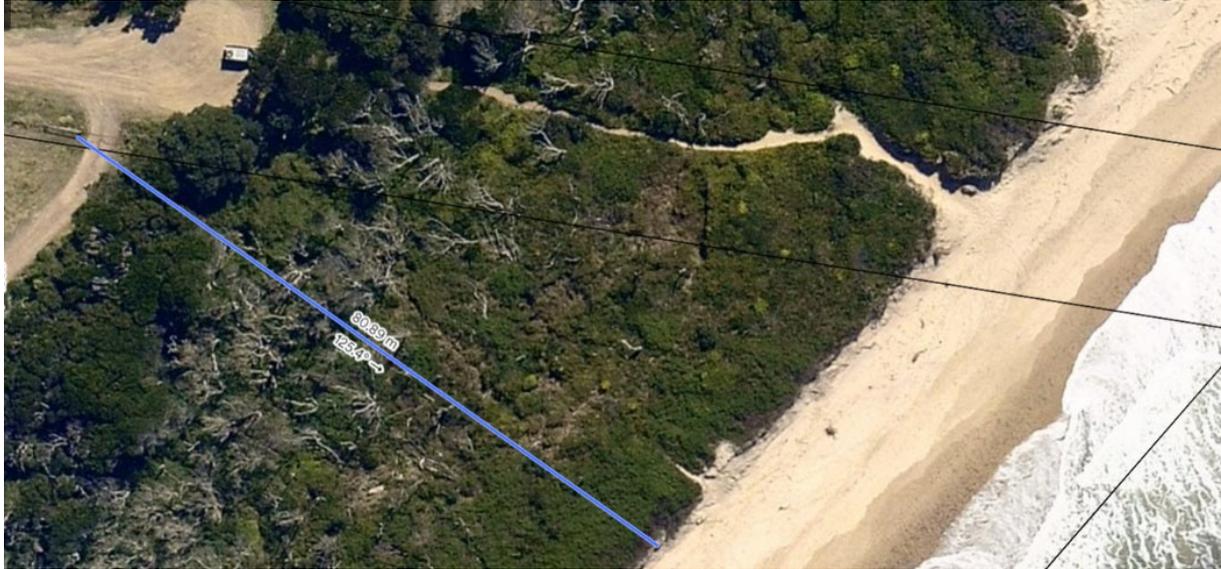
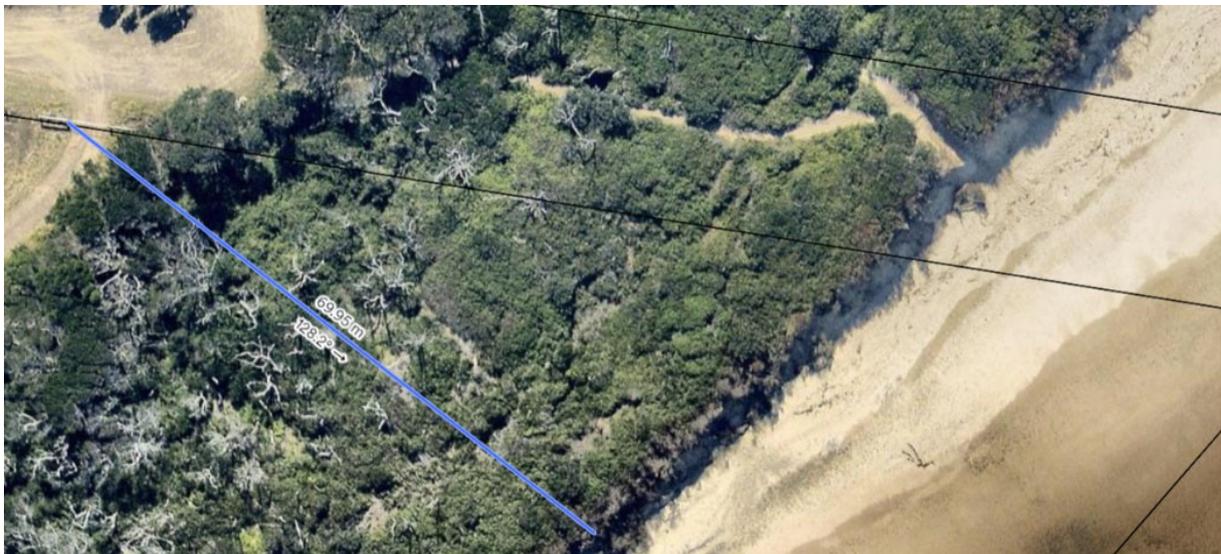
Smiths Beach, partway along Mitchells Island, is a popular fishing spot. At the end of Beach Road is a small carpark and a sandy pedestrian access track. At Smiths Beach, 3.2 km south of the south barrier bank rocks, the beach scarp progressed about 10 m westward, from 81 m 2011 to 70 m in 2016 (Figures 46 & 47). The lines seen in the images are the cadastral layer in the Nearmap imagery.

Figure 46: Smiths Beach (Nearmap image, September 2011).

Figure 47: Smiths Beach (Nearmap image, August 2016).

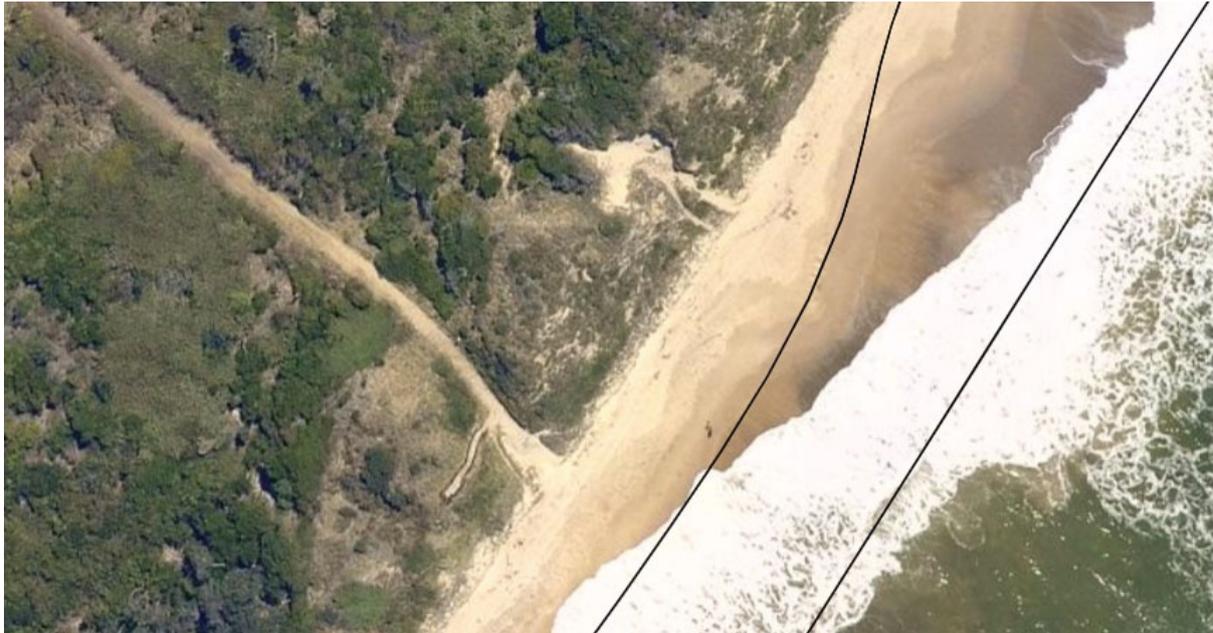
Figure 48: Second corner beach access and viewing platform (Nearmap image, 2011).

Closer to Old Bar, a small reef (Urara Reef) lies just offshore, which creates good surf breaks. The energy lost by the waves breaking around the reef creates a salient. The surf breaks are known as first and second corner, named as such from the apparent bend in the alignment of the beach behind the reef. At second corner, there is a carpark, shower and (there was) a 4WD timber slat access ramp onto the beach, used to beach-launch small fishing boats. A viewing platform was constructed on the edge of the dune to check out the surf and limit damage to the dune (Figure 48).

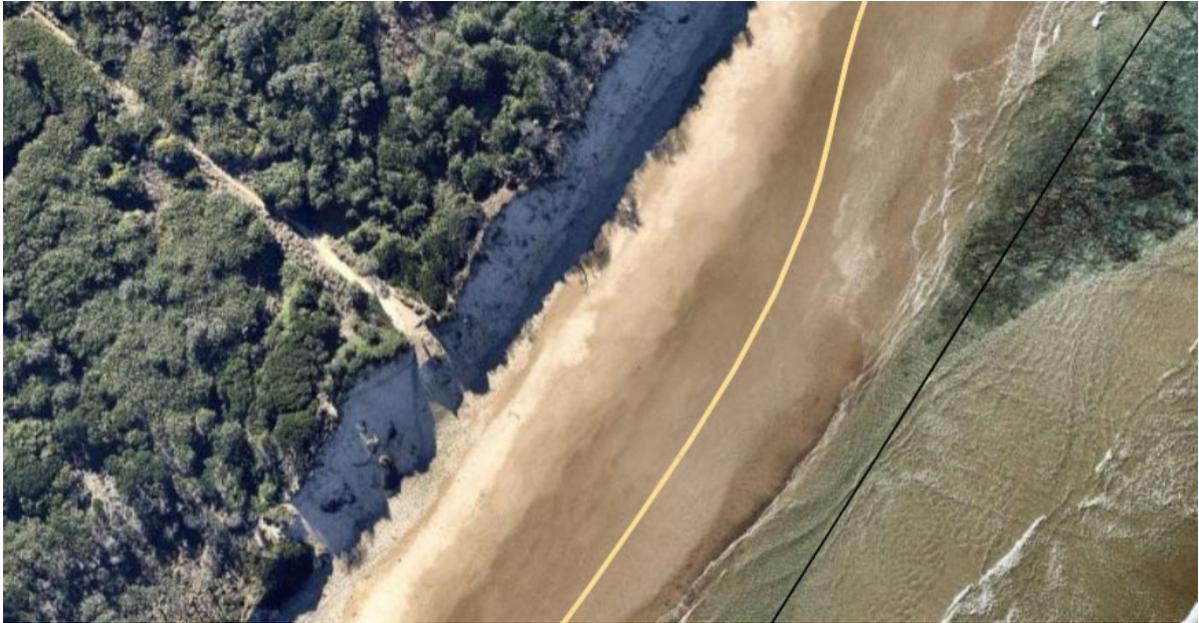
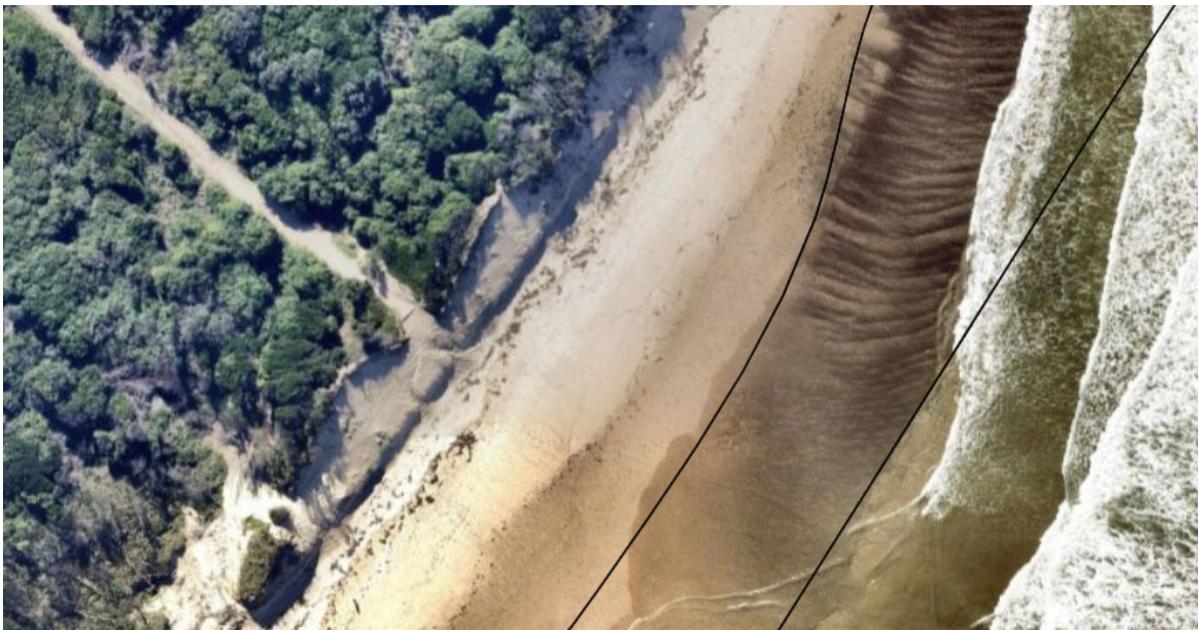
In 2018, a near vertical drop was evident. Council's GIS airborne laser scanned contours provide an elevation higher than 14 m (AHD) at the top of the dunes (Figure 50). By 2022, the top of the beach scarp had progressed beyond the top of the foredune and was starting to reduce in height down the rear of the dune (Figure 51).

Figure 50: Second corner (Nearmap image, 2018).

Figure 51: Second corner (Nearmap image, May 2022).

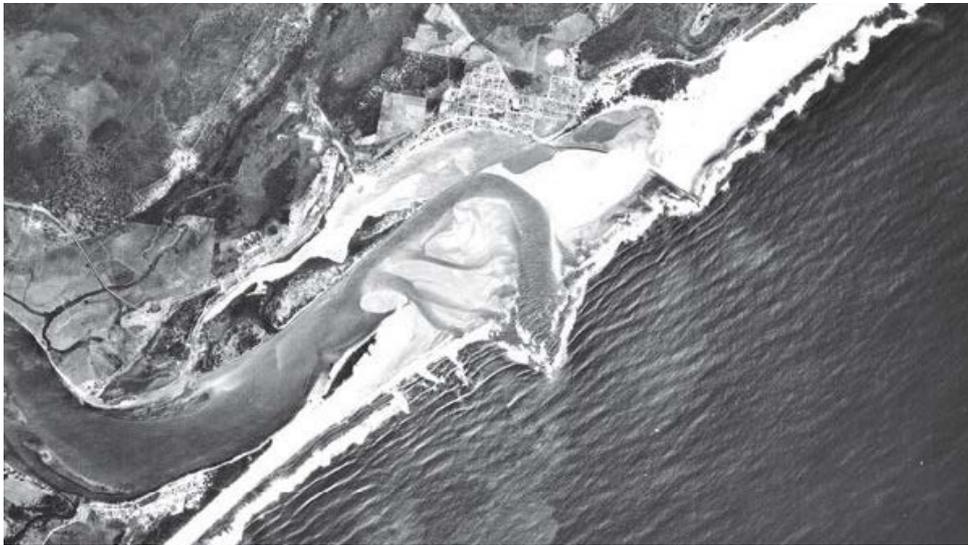
Figure 54: Aerial photograph of Harrington entrance, 1965.

The 1965 aerial photograph shown in Figure 54 indicates that a similar southern migration of the river entrance had occurred at some time prior to 1965:

- The northern rock sea wall is covered by beach sand.
- The main channel of the river appears to be directly in front of the gantry opening.
- The river has interacted with the northern tip of the southern barrier bank rocks.
- The tip of the rocks is visible near the southern most channel in this image.
- The face of the beach has been torn off almost exactly as it has been around 2016 (Figure 55).
- Vegetation on the coast between Manning Point village and the river entrance has been stripped back to a slender island of dark-coloured vegetation.
- In comparison, the vegetation strip in 1965 (Figure 54) appears to be even more slender than in 2016 (Figure 55).
- Significant influx of sand into the river channels upstream of the entrance and south spur wall has occurred with the entrance in this southern location.

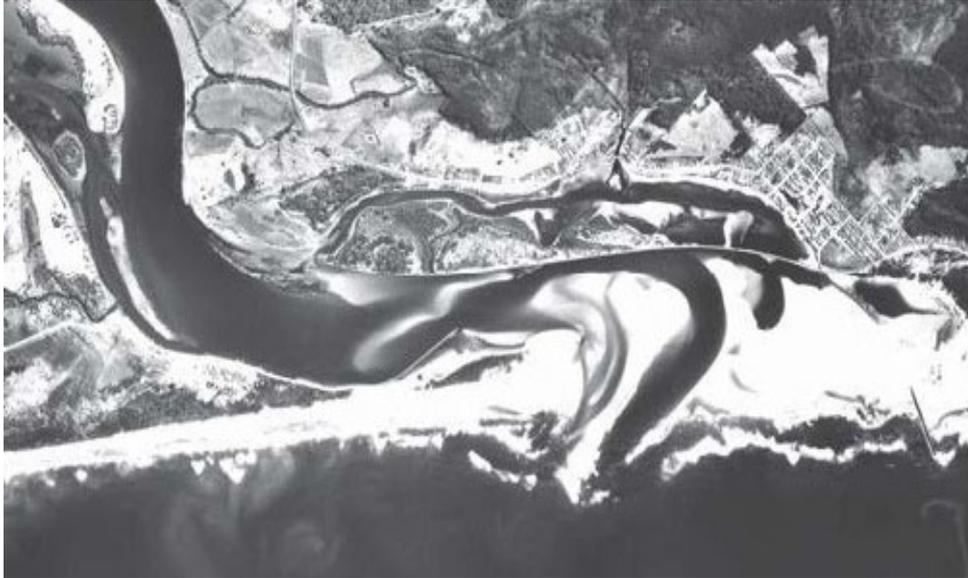
Figure 56: Aerial photograph of Harrington entrance, 1969.

Similar points can be seen in the aerial photograph of 1969 (Figure 56). Looking at these images from the 1960s, one might expect that coastal erosion similar to that recorded between 2012 and 2015 and presented earlier in this paper would have occurred along the coastline in the late 1960s. PWD (1990) recorded that erosion commencing around 1965 at Old Bar. It is a pity that they did not look up the beach to Manning Point to find a reason for this behaviour.

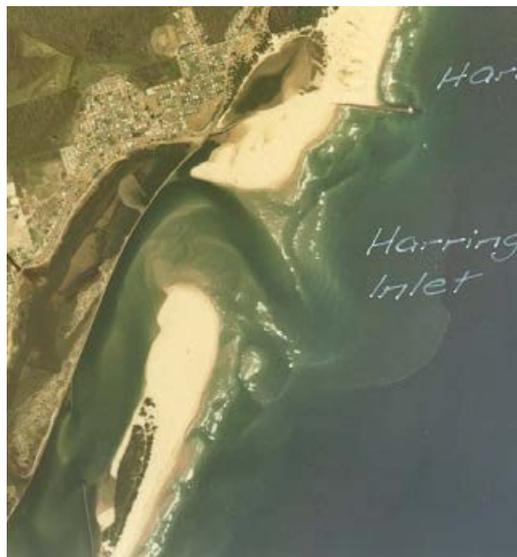
Figure 57: Aerial photograph of Harrington entrance, December 1972.

The aerial photograph of December 1972 (Figure 57) shows that the main river flow had started to migrate back toward the northern sea wall, which is still buried by beach sand for much of its length. The plume of sand in the back channel from the gantry flows is clearly visible. The main river channel is just downstream of the gantry. The width of the southern spit had started to recover. The vegetation on the spit appears to have started to take hold once again. There is a thin line visible that probably indicates the sand scarp location visible in the 1965/69 aerial imagery.

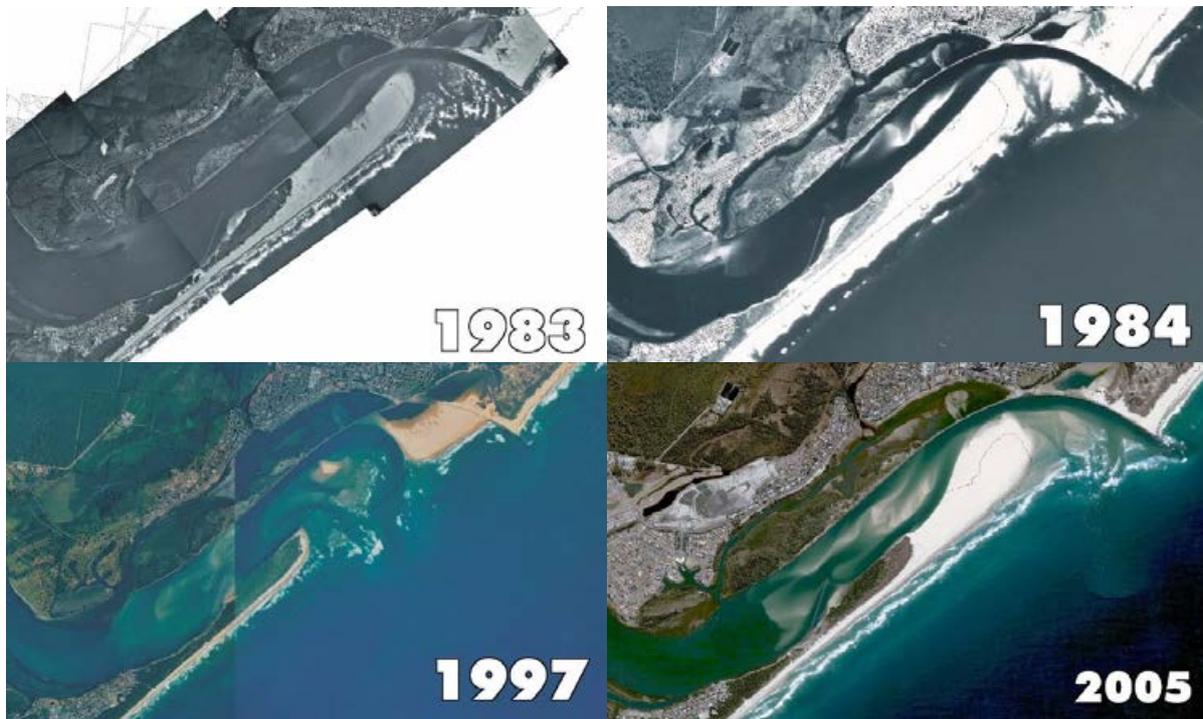
The series of aerial photographs in Figure 58 shows the recovery of the river channel back to the sea wall and subsequent shifts over time. The cadastral line work visible in these images is the same shown in part in Figures 36 & 37.

Figure 58: Aerial photographs showing the recovery of the river channel over time.

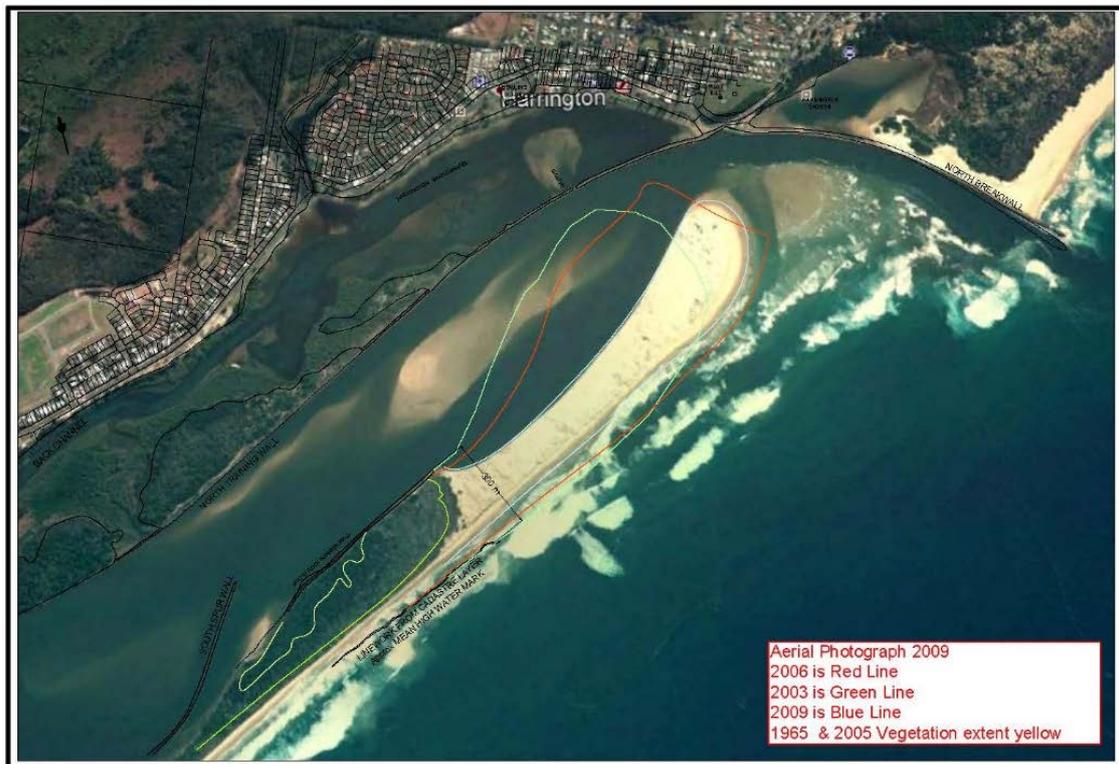
The July 2009 aerial image (Figure 61) depicts the continued migration of the southern shore of the river eastward. From the 2003 shoreline, it has travelled almost 300 m closer to the ocean. Channels across the beach in this image show signs that the sand spit has been over-topped, probably by flood water. The beach alignment has receded marginally. The channel against the north break wall remains restricted. Council records show significant flows were encountered in the catchment in April and September 2008 and also in February and May 2009, not long before the image in Figure 61 was flown in July. Minor flooding also occurred in October and November 2009 and in December 2010.

Figure 61: Aerial image (July 2009) overlaid on the cadastre and the sand bank outlined blue.

Lines depicting the extent of vegetation traced from the 1965 and 2005 aerial images have also been added to this image. Between 2005 and 2009, the vegetation band along this section of Manning Point beach had actually progressed marginally seaward. At the minimum, the 2005 vegetation line is more than 50 m east of the 1965 vegetation strip. At the northern tip of the 1965 vegetation strip, the vegetation in 2009 is over 200 m seaward, indicating good dune recovery occurred in that time period.

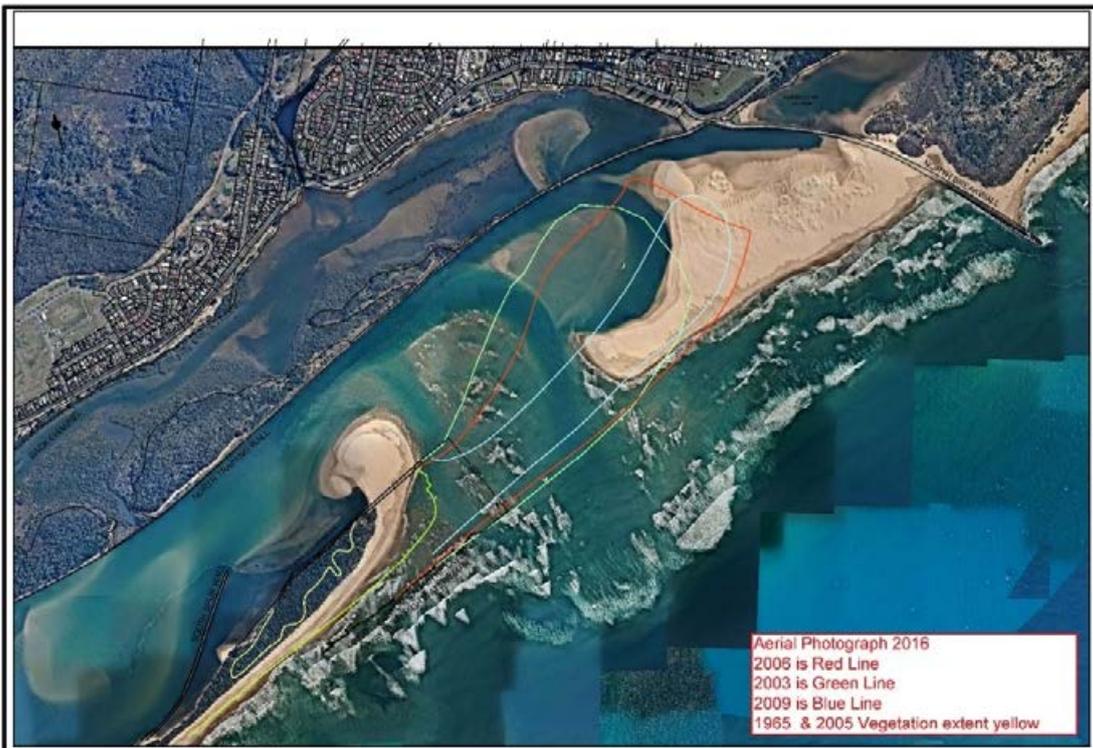
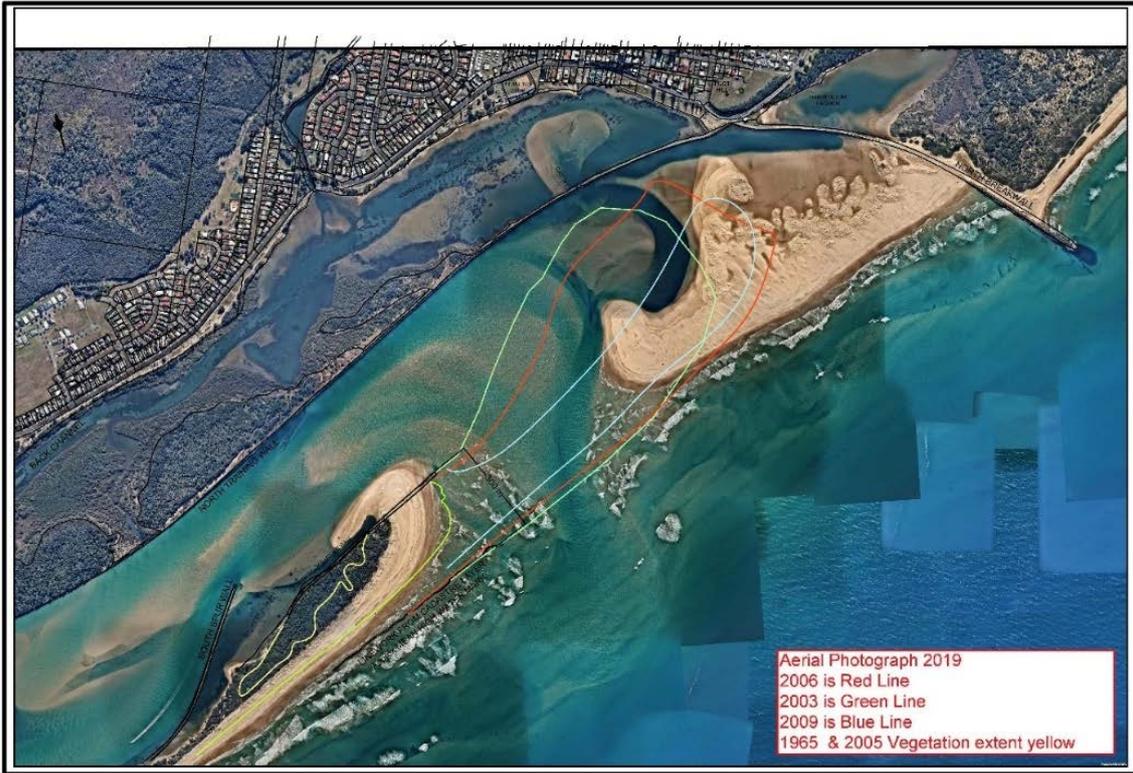
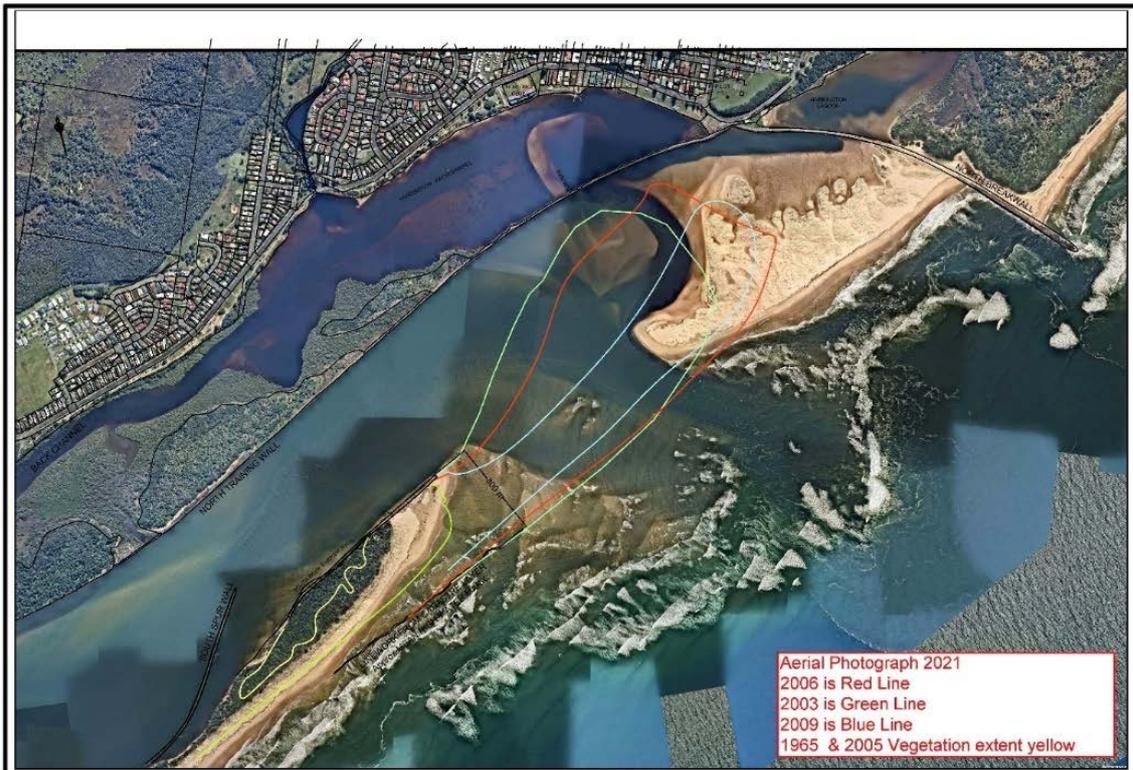
The frequency of available imagery and its resolution has increased dramatically in the past decade. The following images show changes at Harrington between 2011 and 2021 (Figures 63-65). A major flood occurred in the Manning on 20 March 2021, only a couple of weeks before the image of 9 April 2021 (Figure 65) was flown. The reduction in sand noticeable in the inlet can be explained as a result of this flood event.

Figure 63: Aerial image (Nearmap, 2016) overlaid on the cadastre and the sand bank outlined.

Figure 64: Aerial image (Nearmap, 2019) overlaid on the cadastre and the sand bank outlined.

Figure 65: Aerial image (Nearmap, 2021) overlaid on the cadastre and the sand bank outlined.

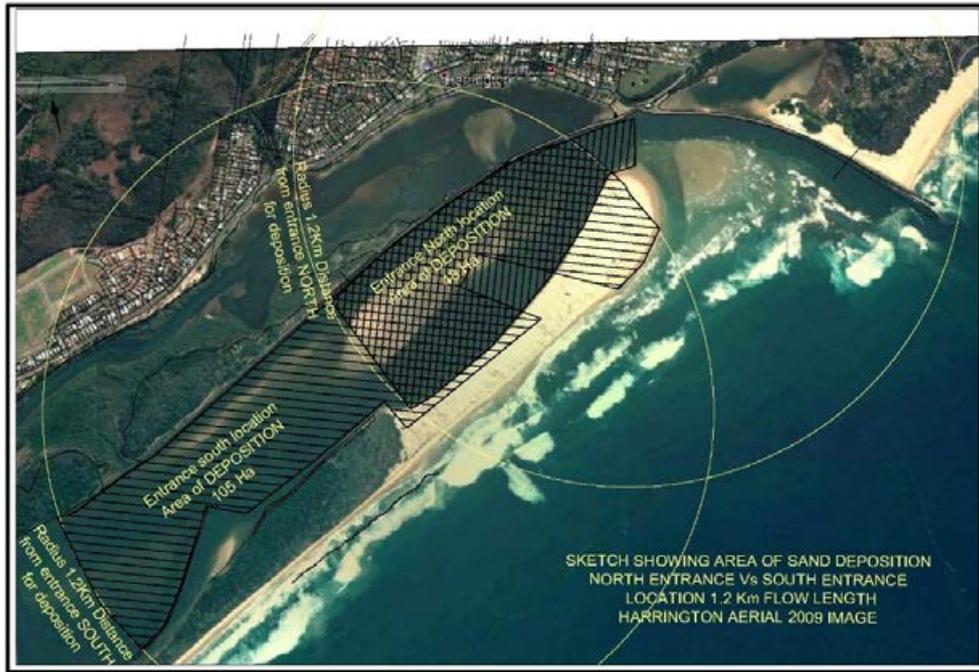
Figure 66: Sand deposition areas at Harrington.

For Harrington, the 2009 and 2014 images were used with the entrance located (Figure 66):

- North – Area of deposition: 48 ha.
- South – Area of deposition: 105 ha.

With the entrance located in the south, by the south barrier bank rocks, the area of sand deposition within the estuary is over twice that of when the entrance is in the north near the northern breakwater. The implication of this at Harrington is that the northern entrance location is by far the preferred location in respect to sand that is deposited into the estuary and lost to the surrounding beaches.

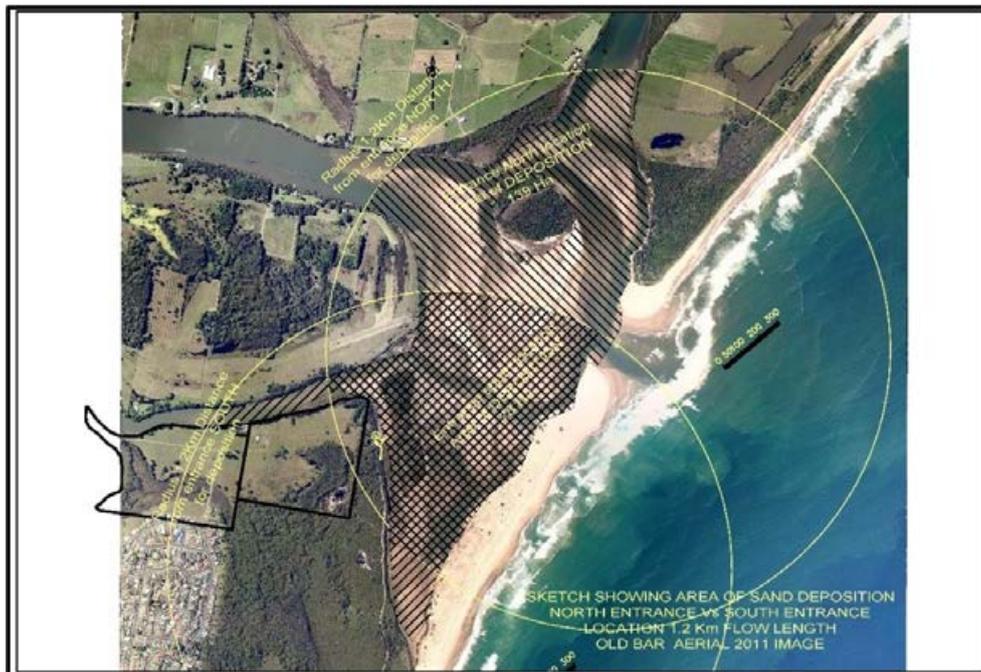
Figure 67: Sand deposition areas at Farquhar Inlet, Old Bar.

A similar exercise was performed for Farquhar, using the 2011 image with the entrance located (Figure 67):

- North – Area of deposition: 139 ha.
- South – Area of deposition: 78 ha.

With the entrance located in the south by the soft rocks, the area of sand deposition within the estuary is almost half that of when the entrance is located in the north. Therefore, at Old Bar, the southern entrance location is by far the preferred location in respect to sand that is deposited into the estuary and lost to the surrounding beaches.
