Cadastral Corner (Tales from the Crypt... Shock, Horror)

Fred de Belin

City of Ryde

KEYWORDS: *Primary Application, party wall, curved boundary, reference mark.*

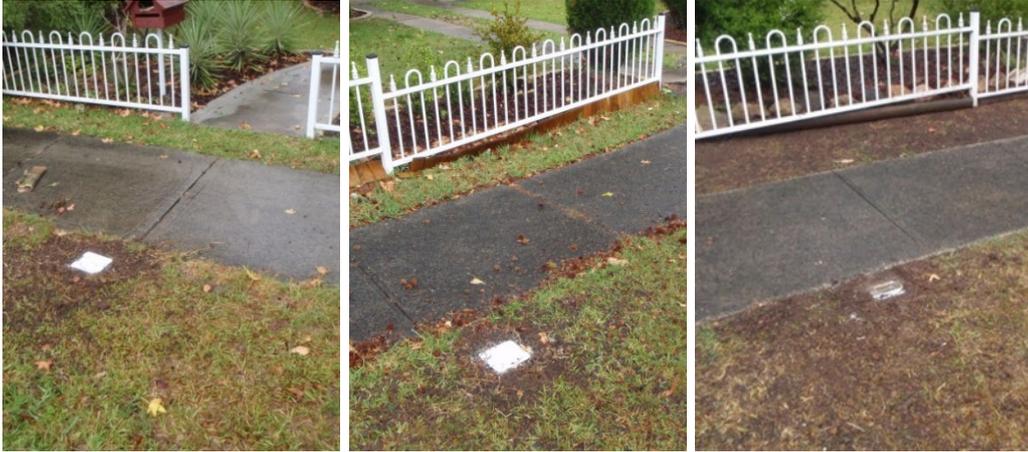
Figure 3: Three of the concrete blocks (under cover box) in Walsh Street, outside Lot 4.

DP 218164, in 1962, placed 24 concrete block reference marks at 6ft 3in (1.905 m) “owing to the existence of concrete pavements” (Figures 2 & 3).

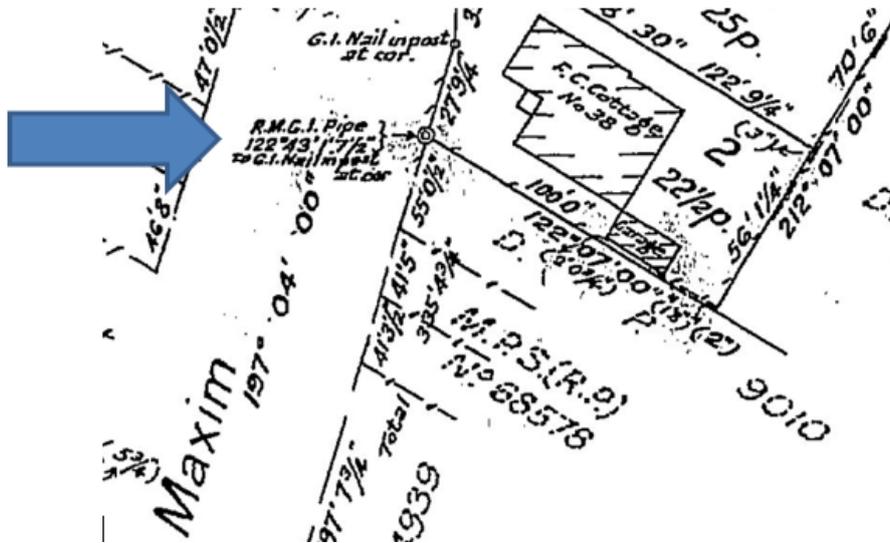
Figure 10: Detail from DP 420990, showing a reference mark GI pipe placed at 0.495 m on the prolongation of the side boundary line – 1961.

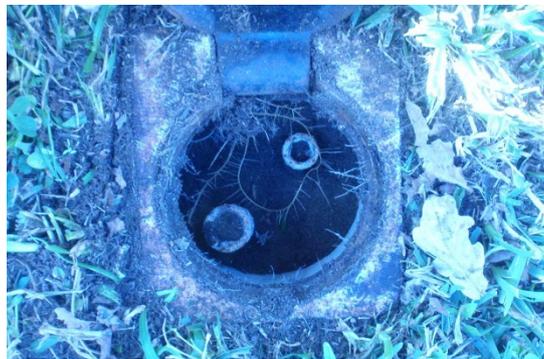
Figure 11: The two close GI pipes within the one metal cover box – 2020.

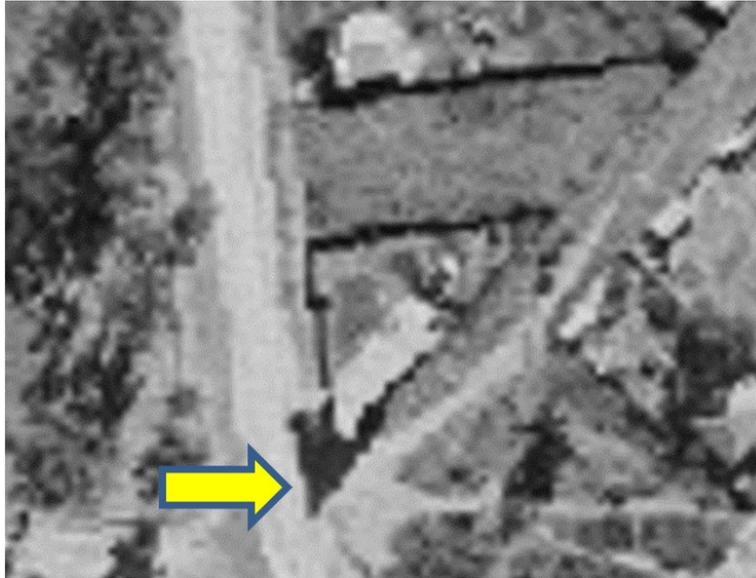
Figure 14: Detail from 1943 aerial photo, showing a definite 2-storey shadow being cast.

So, the party wall is both single-storey and two storeys in height! A subdivision by compilation plan DP 367316 in 1950 (Figure 15), shows the same shop as in 1928 and no evidence of any road widening having taken effect. Lots A, B and C have been truncated only at the southern boundary of the private right of way.

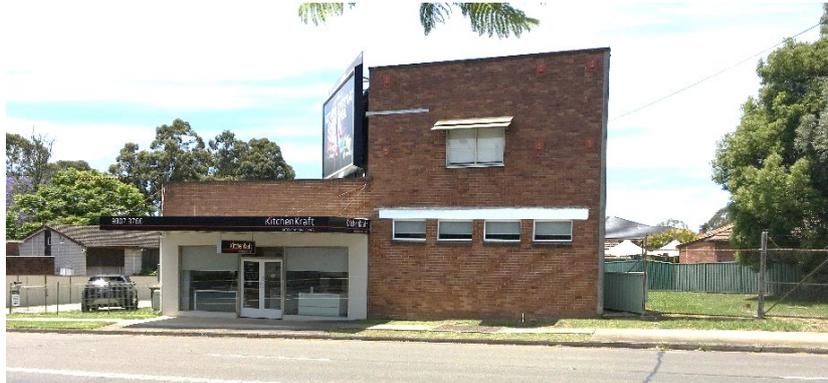
Figure 17: Image of structures on Lots B and C – 2020.

Subsequently, the façade of the building on Lot C was rebuilt on the new road boundary and a single-storey brick shop was erected on Lot B, abutting the party wall (Figure 17).

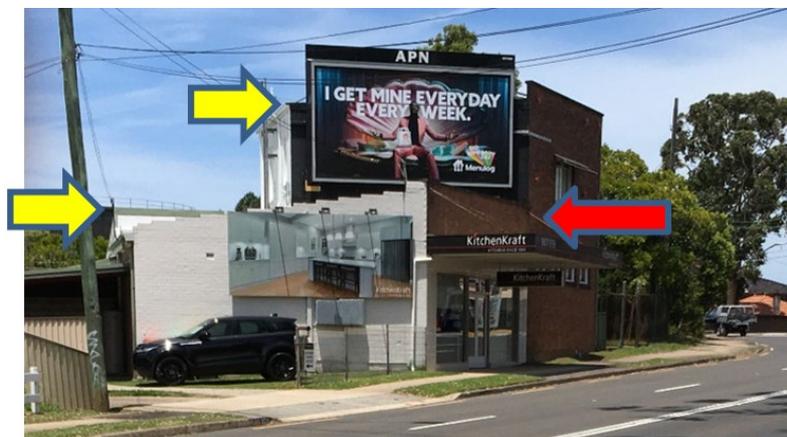
Figure 18: Image showing the brick party wall not supporting the new shop's roof structure – 2020.

The party wall, however, does not support the roof structure of the new shop. Notice, that above the flat roof of the new shop, the top of the single and 2-storey brick party wall of the original building is evident (Figure 18). So, the brick wall, which is called a party wall, still only supports one building, although there has been a shortening of its length.

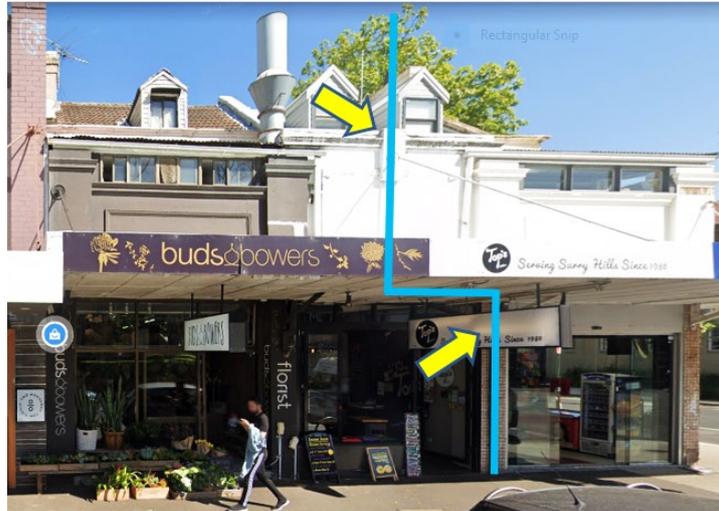
Figure 19: Crown Street building where the party wall between two first-floor residences does not sit directly upon the ground floor party wall, but is offset by 1.9 m.

Is this what happened before the Strata Act? In this example, the original building was erected prior to 1904, with three shops below and two residences above (Figure 19).

From Figure 19, it is evident that Lot 2 occupies up to 1.9 m of Lot 1 at the first-floor level! The problem was rectified in 2001 when a re-definition survey was carried out and a new subdivision was created in stratum (Figure 21), which was attached as sheet 2 in DP 590359. Part of Lot 1 is limited in height to a horizontal plane which becomes the base of Part of Lot 2. The first-floor party wall for Lot 2 is supported by steel beams which cross over the ground-floor shop below. The only problem is: What are the rights of support between the owners of Lots 1 and 2 when it comes to the ceiling of Part Lot 1 and the floor of Part Lot 2?

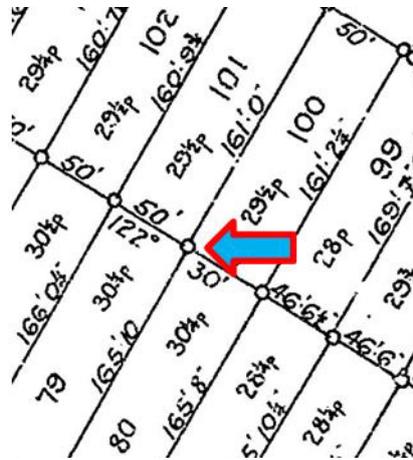
Figure 22: Detail showing four lots intersecting at a single point.

Most cadastral surveyors have seen examples of four lots intersecting at a single point (Figure 22). The question is: Do Lots 79, 80, 100 and 101 share a common *boundary*? No!

One would say that Lot 79 shares a common boundary with Lot 80, and that Lot 79 also shares a common boundary with Lot 101, but never say that Lot 79 shares a common boundary with Lot 100. A metes and bounds description for Lot 79 would say ... *bounded on the north east by the south western boundary of Lot 101 being a line bearing 122 degrees 30 minutes for 50 feet to the north western corner of Lot 80 then bounded on the south east by the north western boundary of Lot 80* ... Lot 100 does not even get a mention!

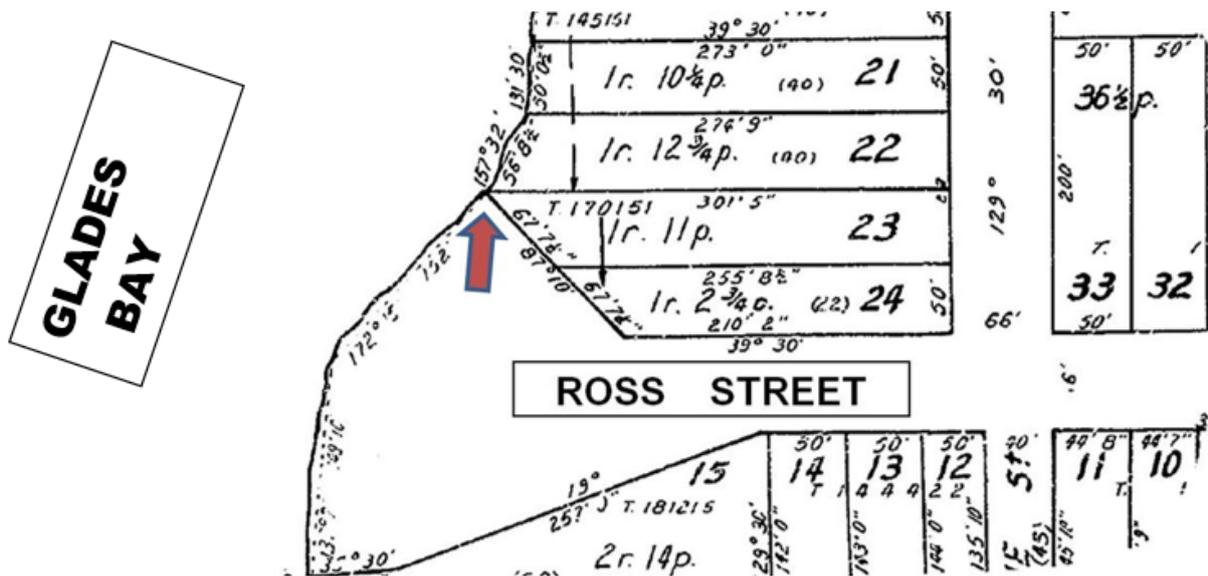
Figure 23: Detail from DP 1821, showing Lot 23 having point contact with the tidal water of Glades Bay, and Lot 22 and Ross Street each having a full frontage with the water – 1886.

A situation emerged in City of Ryde recently, where the four ‘lots’ joining at one point are Glades Bay, two residential lots (Lot 22 and Lot 23) and Ross Street (Figure 23). Lot 22 has a tidal water frontage and Ross Street also has a tidal water frontage. Does Lot 23 have a tidal water frontage? Does this point constitute a boundary? What happens if the road or water boundary migrates as the result of redefinition? Is there prolongation of boundary lines? Is there change of angle in boundary lines?

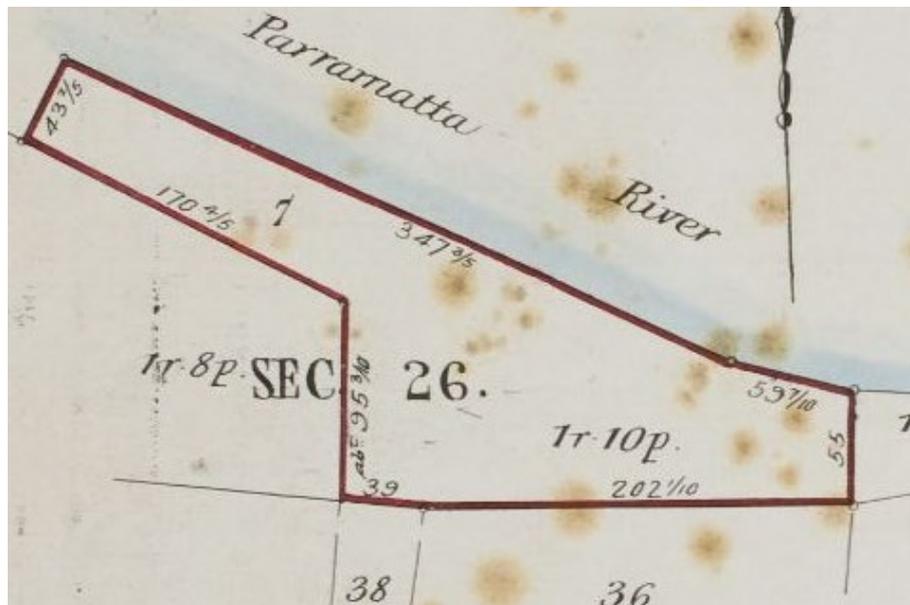
Figure 29: Detail of title diagram in Crown Grant Volume 1248 Folio 1 of Allotment 7 in Section 26 – 1898.

In 1898, Crown Grant Volume 1248 Folio 1 was issued for Allotment 7 (Figure 29). This land, which was granted to William Richard Murray and Edward Nicol Murray, not only abutted the parcel of land subject to the RPA in 1894, but *overlapped*, to the extent indicated by the abovementioned yellow line. The proprietors of the land subject in the RPA were the same William Richard Murray and Edward Nicol Murray who were granted Allotment 7. The Grant was dated 1898, coming *after* the RPA.

Notice that the adjoining area of “1r 8p” shown in Figure 29, is of the same magnitude as the area of the land remaining after the exclusion described in RPA 8783. Notice that the plan for the RPA (Figure 26) notates “Quarry Reserve”, which comprises the land granted to the Murrays in 1898.
